FIELD ASSESSMENT NOTES

Subwatershed: Turpentine Run

Site Name: Whispering Hills ~~Woods~~ (TR-4) & Flag Hill (TR-1)

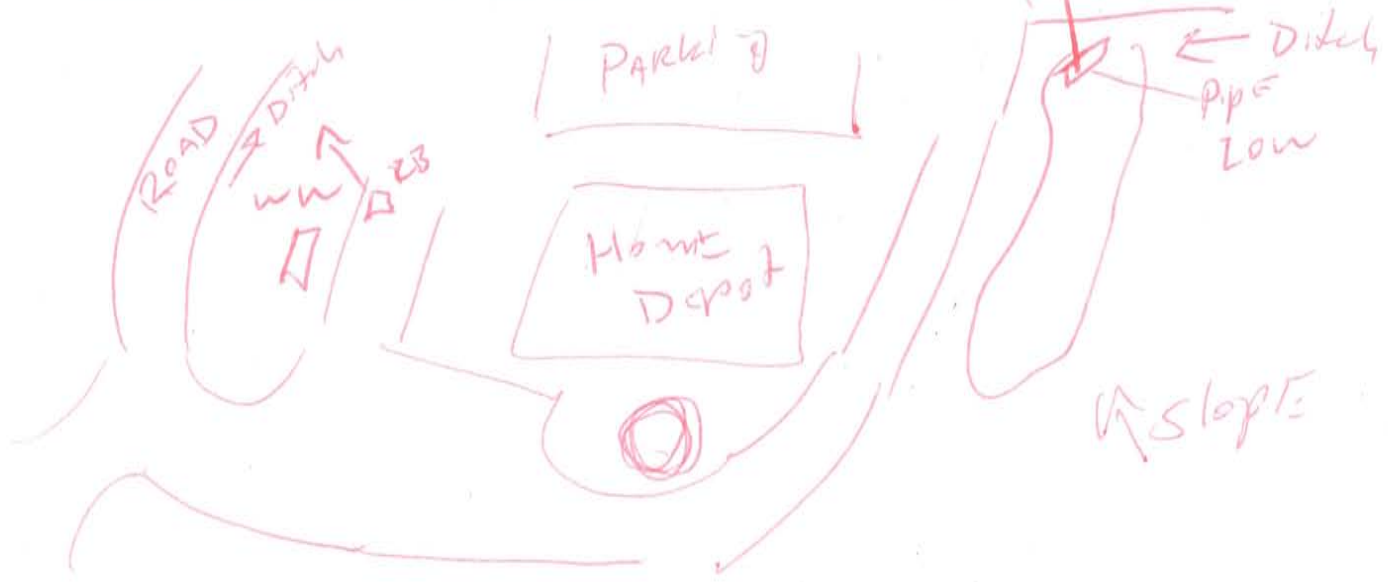
CBS → Discharge to ^{stone} swale/ditch
 Parking is larger than needed
 28' DRIVE AISLES
 CURBED Islands → Potential Bios
 Have wastewater TREATMENT → small system
 out back that looks like it discharges
 to A LSA under parking AREA
 WATER HARVEST system for FIRE protection
 with LARGE storage tank Fed from
 Look like ROOF

Possible potential cost v Less Detention
pond w/ riser to capture ~~water~~ ~~water~~
more SW.

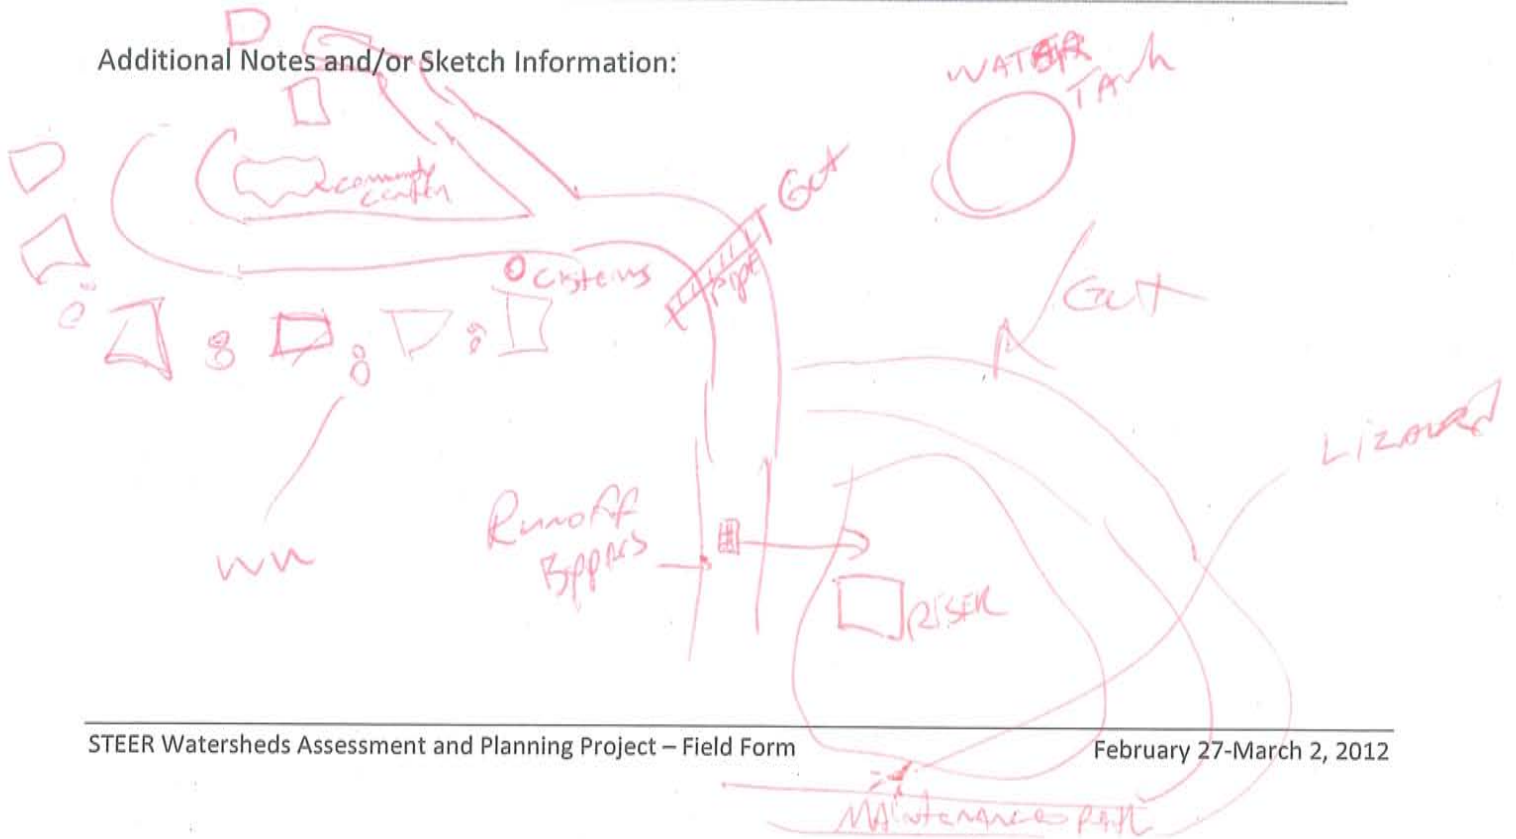
Detention Pond near start of subdivision
 → Does not look like it is getting
 much runoff

SPEED Hump to Get more Runoff To Ex.
Detention Basin

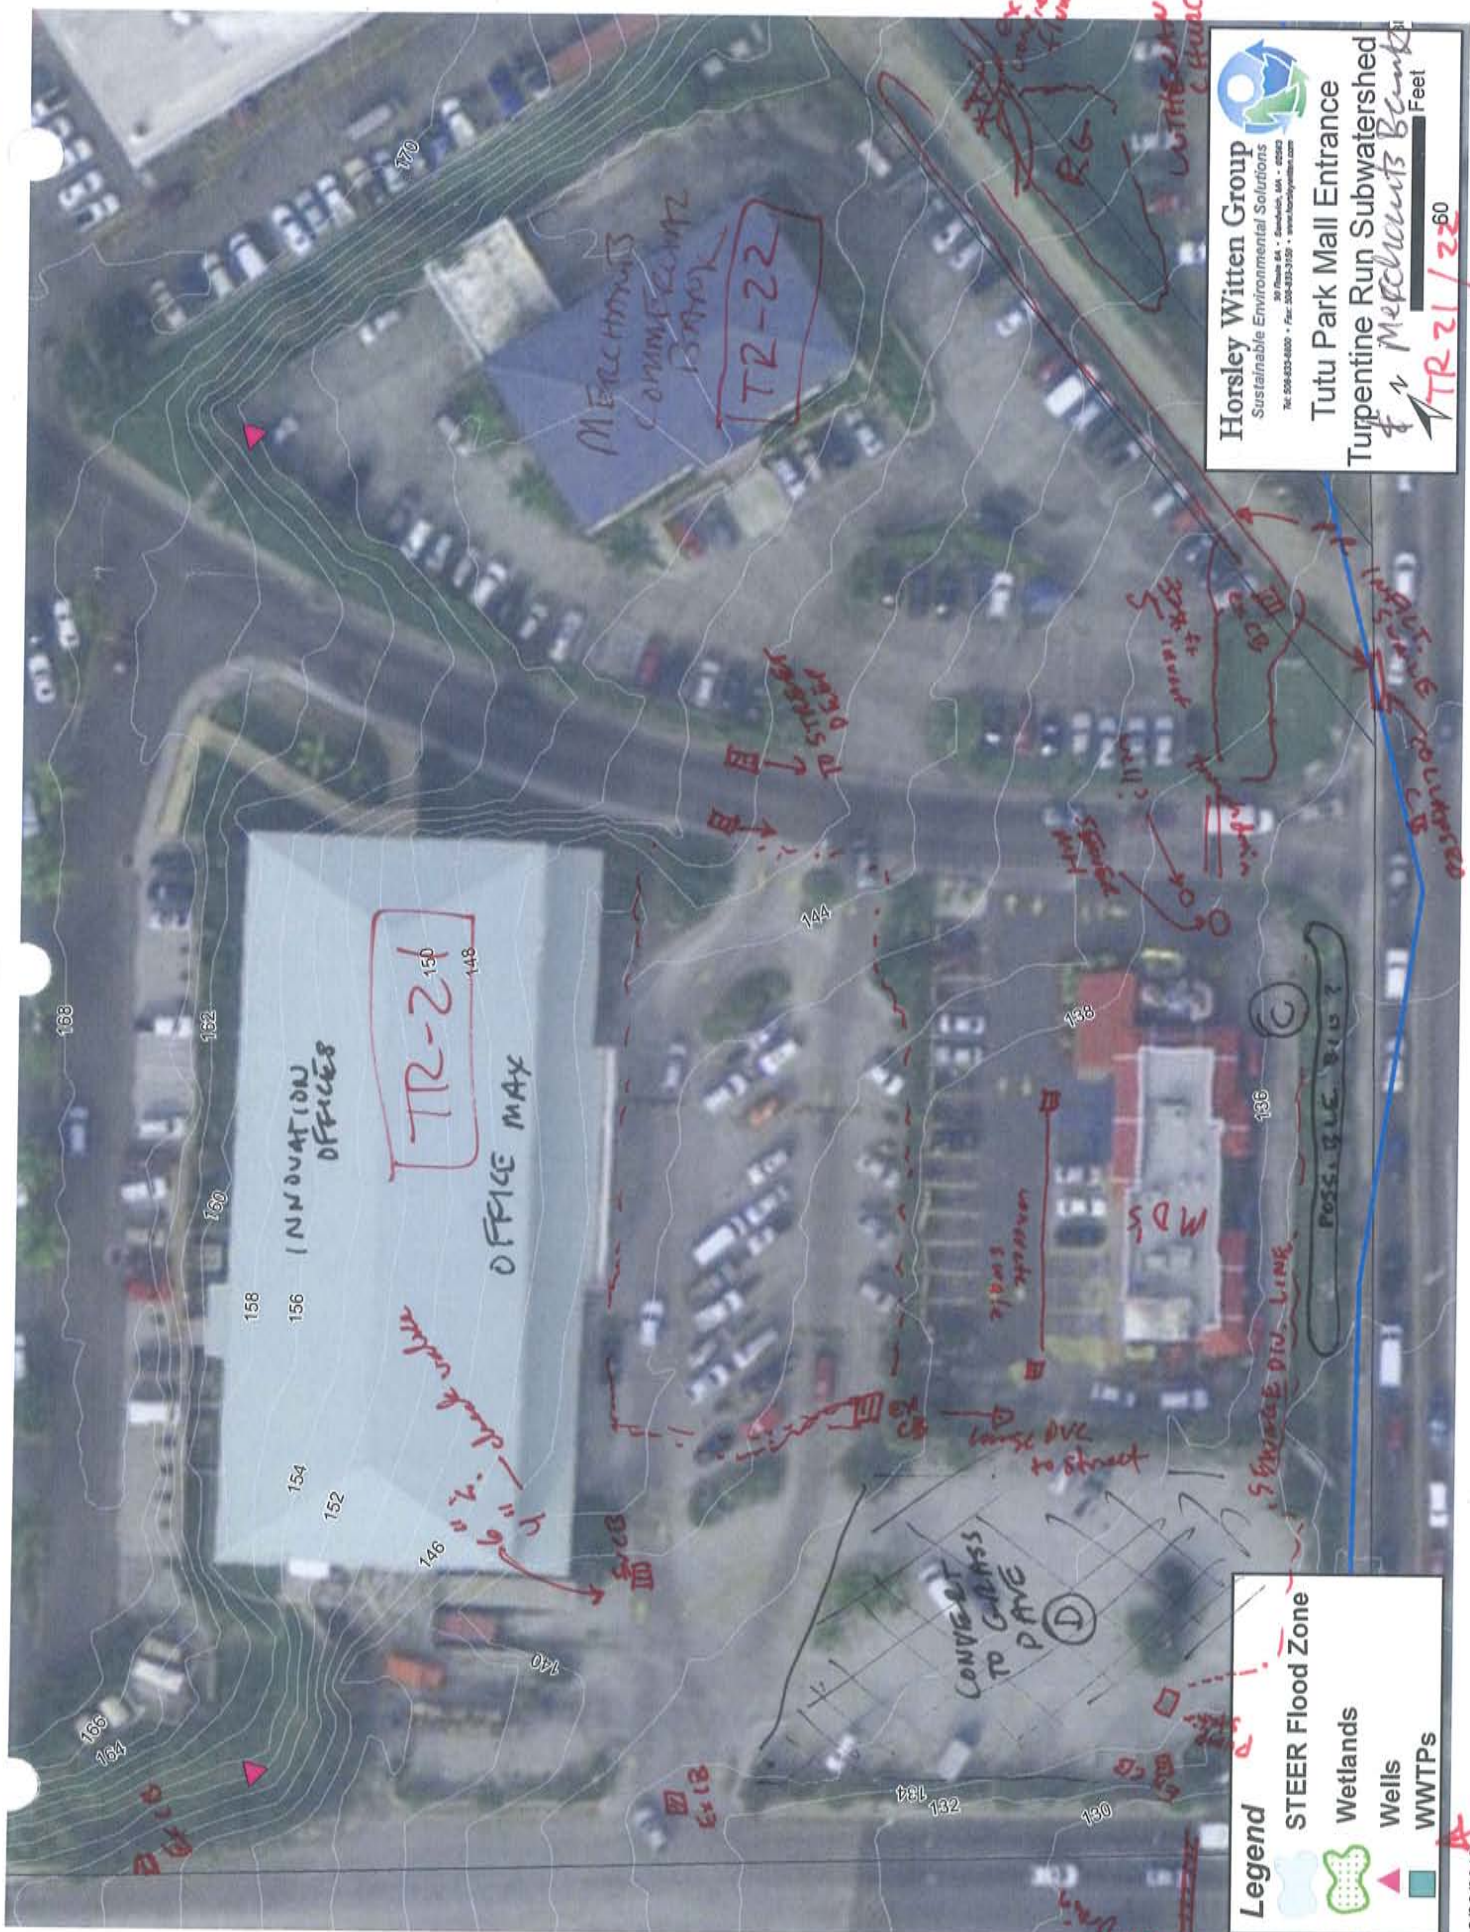
Tutu Park Mall Entrance
 Turpentine Run Subwatershed
 & Merchants Bank

Parking lot and adjacent road drain to ~~bottom~~ south corner of lot. Convert ex. pervious area in corner to bioretention. install a veg. swale along ROAD ROW. Tie overflow into ex. catchbasin.
