FIELD ASSESSMENT NOTES

Subwatershed: TR-26

Site Name: MR. RODRIGUEZ / TOTAL GAS

Near Tutu Park Mall 3
Turpentine Run Subwatershed

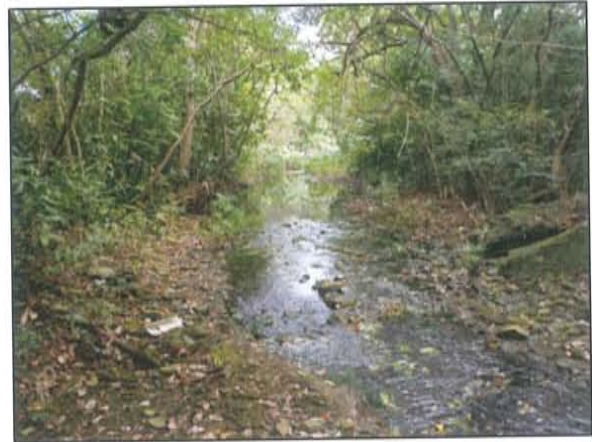
Approximately one-half mile north of the main entrance to Heavy Materials, Turpentine Run flows beneath Turpentine Run Road. There is a box culvert at this location (TR-35) that is reportedly overwhelmed during significant rain events. At the public meetings that were held in February 2012, many residents commented on the observed roadway flooding at the site. The culvert is approximately 4'x8' which is not sufficient for handling large storm flows given the hydrology of the gut. Increasing the culvert size or constructing a bridge in its place would offer the most improvement for flow capacity and for better managing the flooding. One significant design constraint is the elevation of Turpentine Run Road at the culvert location. There is only ~18" above the culvert to the top of the roadway, therefore limiting the improvements to options that create a wider channel cross-section. Installing a bridge would be the least flow restrictive option but it will likely be the most expensive to construct and cause the longest traffic delays. An alternative to a bridge would be to target better floodplain drainage by installing multiple small culverts adjacent to the existing culvert. This option may provide a reasonable balance between effectiveness and cost.

TR-35 culvert. USGS gauging station is upstream from here.

TR-35
Box Culvert
(undersized)
• Not much room
for size increase
• Need bridge?

There is not a lot of space available for larger culverts, probably need to replace with a bridge.

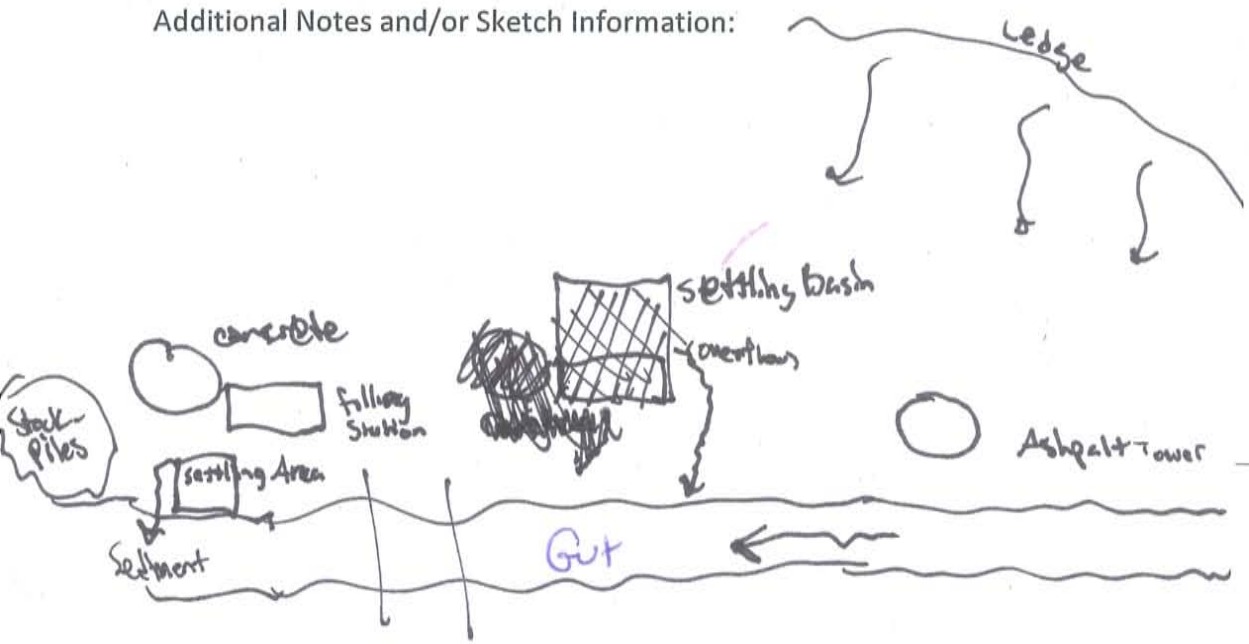
- No stormwater management
- Direct discharges from concrete truck filling station
- Leaking septic pipes / septic discharges
- Human waste area along gully bank
- Heavy sedimentation in gully from stockpiles/runoff
- Settling basin overtops (very turbid) and flows overland to gully, only silt fence protecting gully (currently filled in).
- No containment for asphalt/oil facilities
- Major earth change activities

Proper sediment containment was also lacking at the concrete truck filling stations on the Heavy Materials property. The process for producing concrete involves mixing water with cement and aggregate. During the filling process, water was allowed to spill from the truck, creating a stream of cement slurry that was flowing directly into Turpentine Run with little or no treatment. A small containment bay was observed in one location near ghat but the flow of slurry at the time of observation was much greater than the capacity of the bay. Impacts from this process were observed in Turpentine Run at and downstream of the truck filling station, including cement deposits and highly turbid stream flows.

Bacterial pollution was observed along the banks of Turpentine Run at the Heavy Materials facility. A latrine, of sorts, was discovered near concrete truck filling station. Human waste was present along the banks of Turpentine Run in close proximity to the cement slurry flows.

flocculation processes are recommended in conjunction with the existing settling strategies.
