FIELD ASSESSMENT NOTES

Subwatershed: NAZARETH

Site Name: DOLPHIN COVE / SECRET HARBOR ESTATES

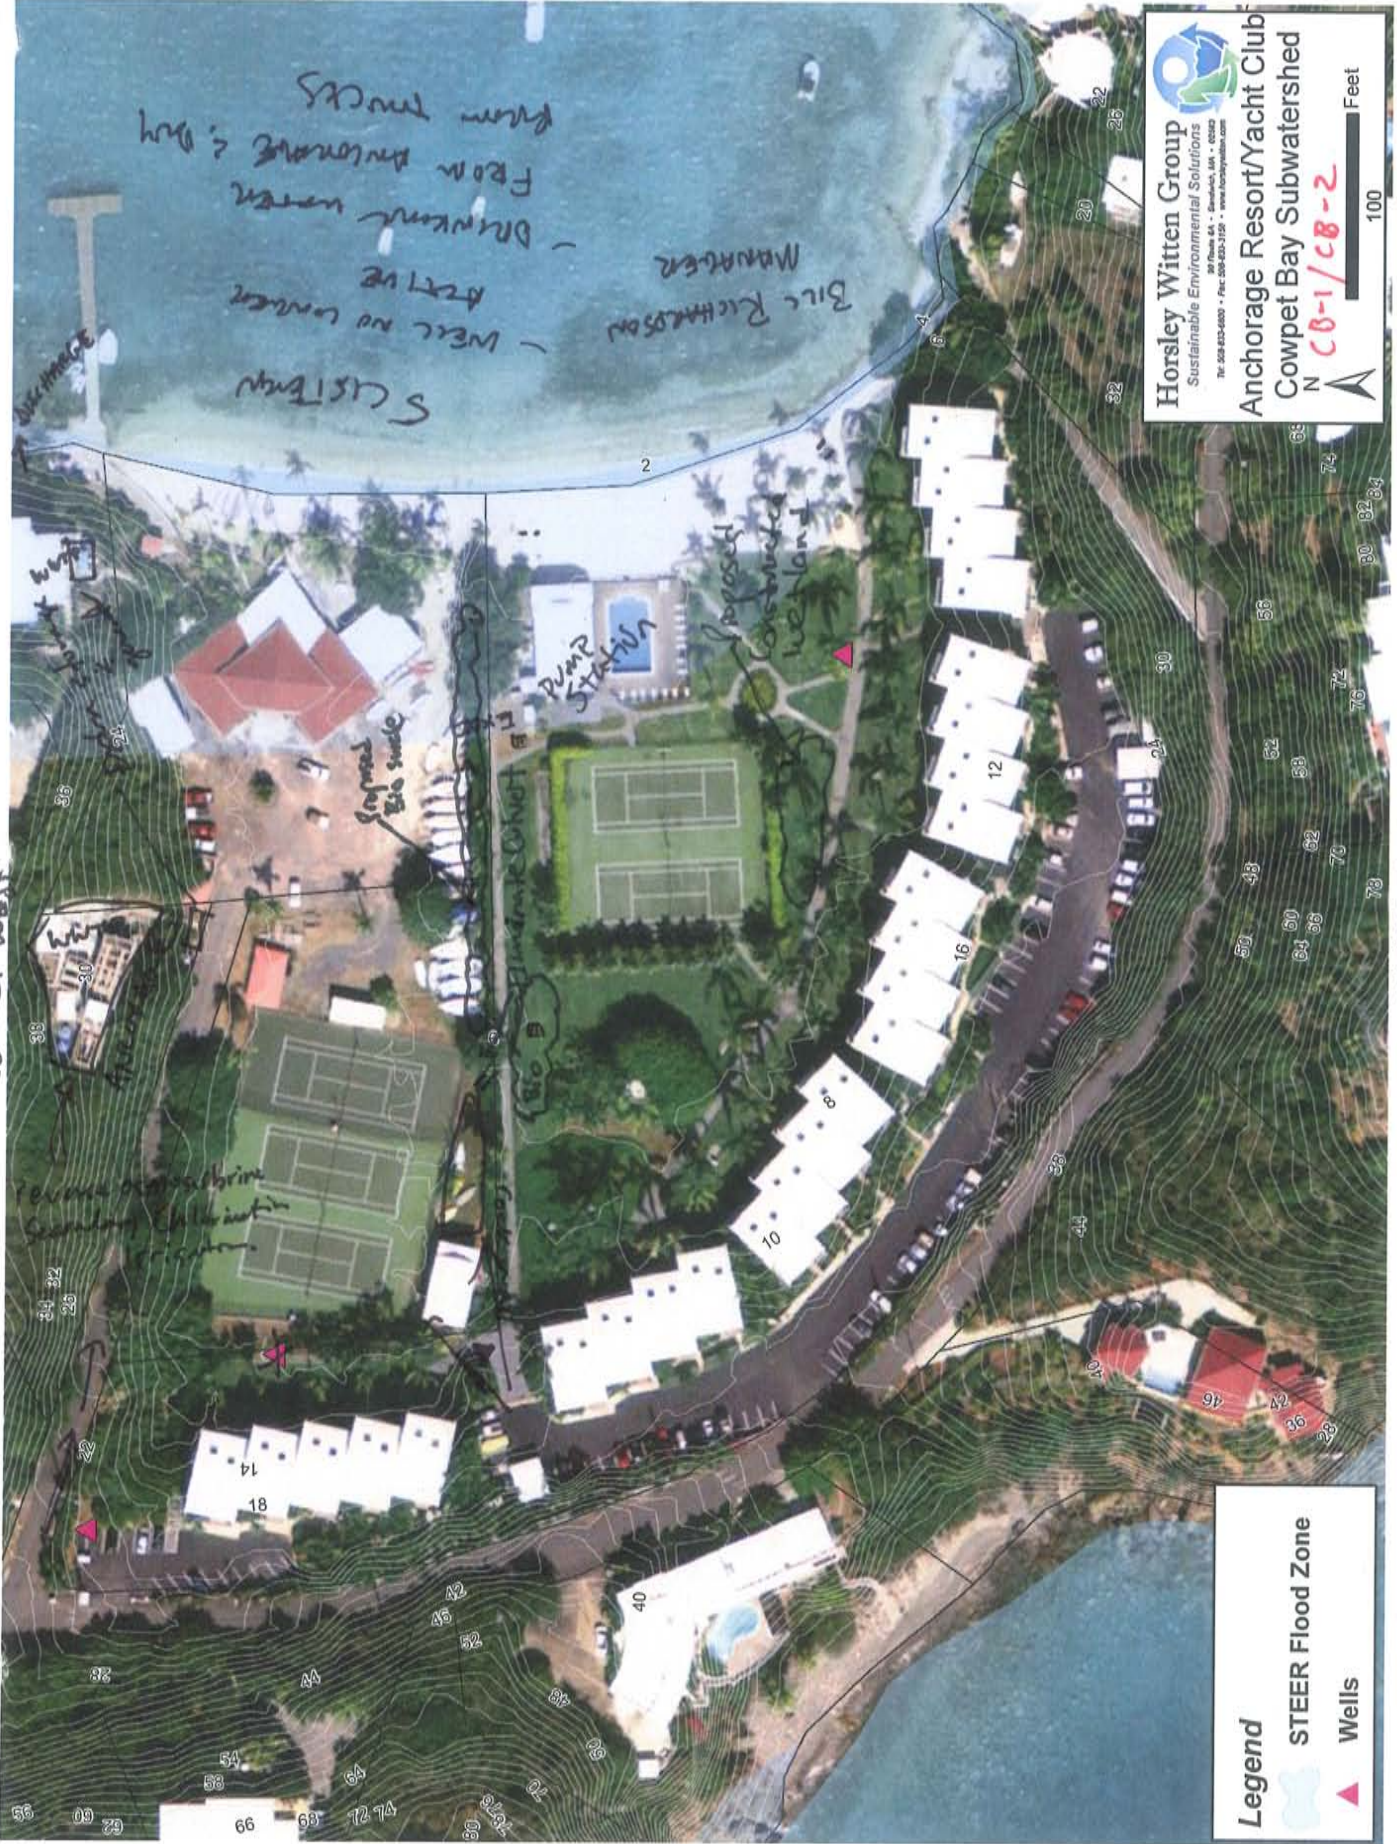
Anchorage Resort/Yacht Club
Cowpet Bay Subwatershed

Drainage above yacht club/Anchorage comes down on causes flooding by the boathouse at Yacht Club. Drain (infirmed) was created to divert onto Anchorage property northwest of tennis courts.

- Eliminate culvert from Yacht Club leading to Anchorage.
↳ Runoff should be managed on each individual property
- Consider a bio swale type system on Yacht Club lot on north side of existing concrete wall. Vegetation removal and replacement will be required. Boat storage will have have to be relocated slightly north.
- Install a bio retention area or constructed wetland type system on Anchorage property to manage and treat their site runoff prior to discharge at beach.
- Install a second constructed wetland system south of tennis courts on Anchorage site to treat runoff from the southern half of the property.
