## STX EE WATERSHEDS

## RETROFITS

Site Name/ID: TB-R-1 (Eastend Beach Parking) Watershed: League  
 Date: 1/24/2011 Assessed by: RAC ALG

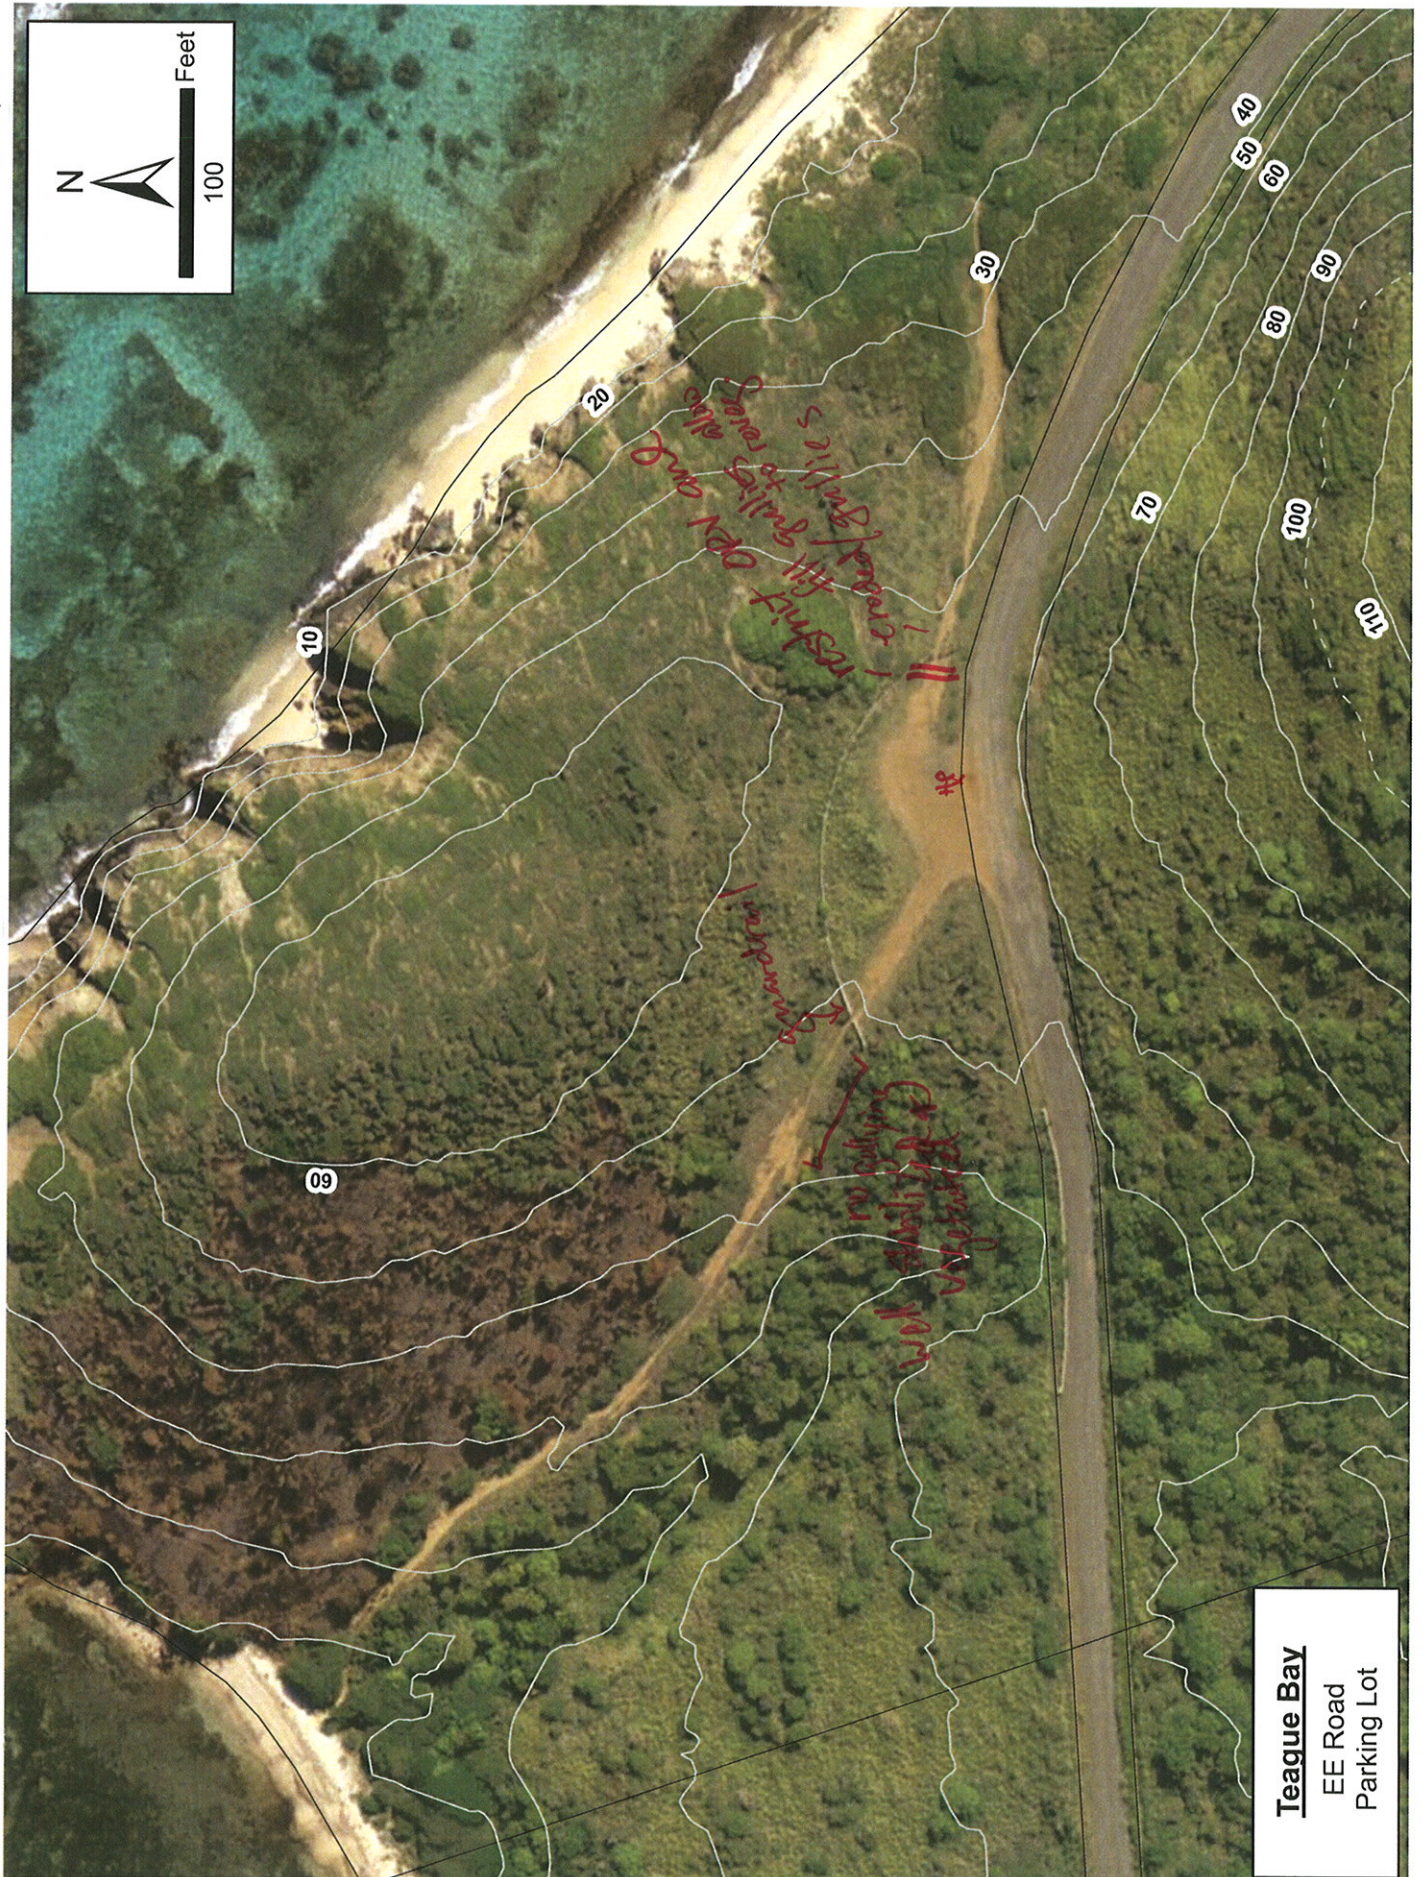
TB-R-1

Informal parking w/rusted guardrails - gravel/dirt parking w/erosion gullies leading to beach

☐ island bio/rain garden ☐ swale ☐ planter ☐ tree pits ☐ infiltration ☐ permeable paver ☐ sand filter ☐ pond  
☐ constructed wetland ☐ proprietary practice ☐ soil amendments ☐ reforestation ☐ impervious cover removal  
☐ rainwater harvesting ☐ disconnection ☒ Other (describe): restrict vehicle access to allow vegetation regrowth

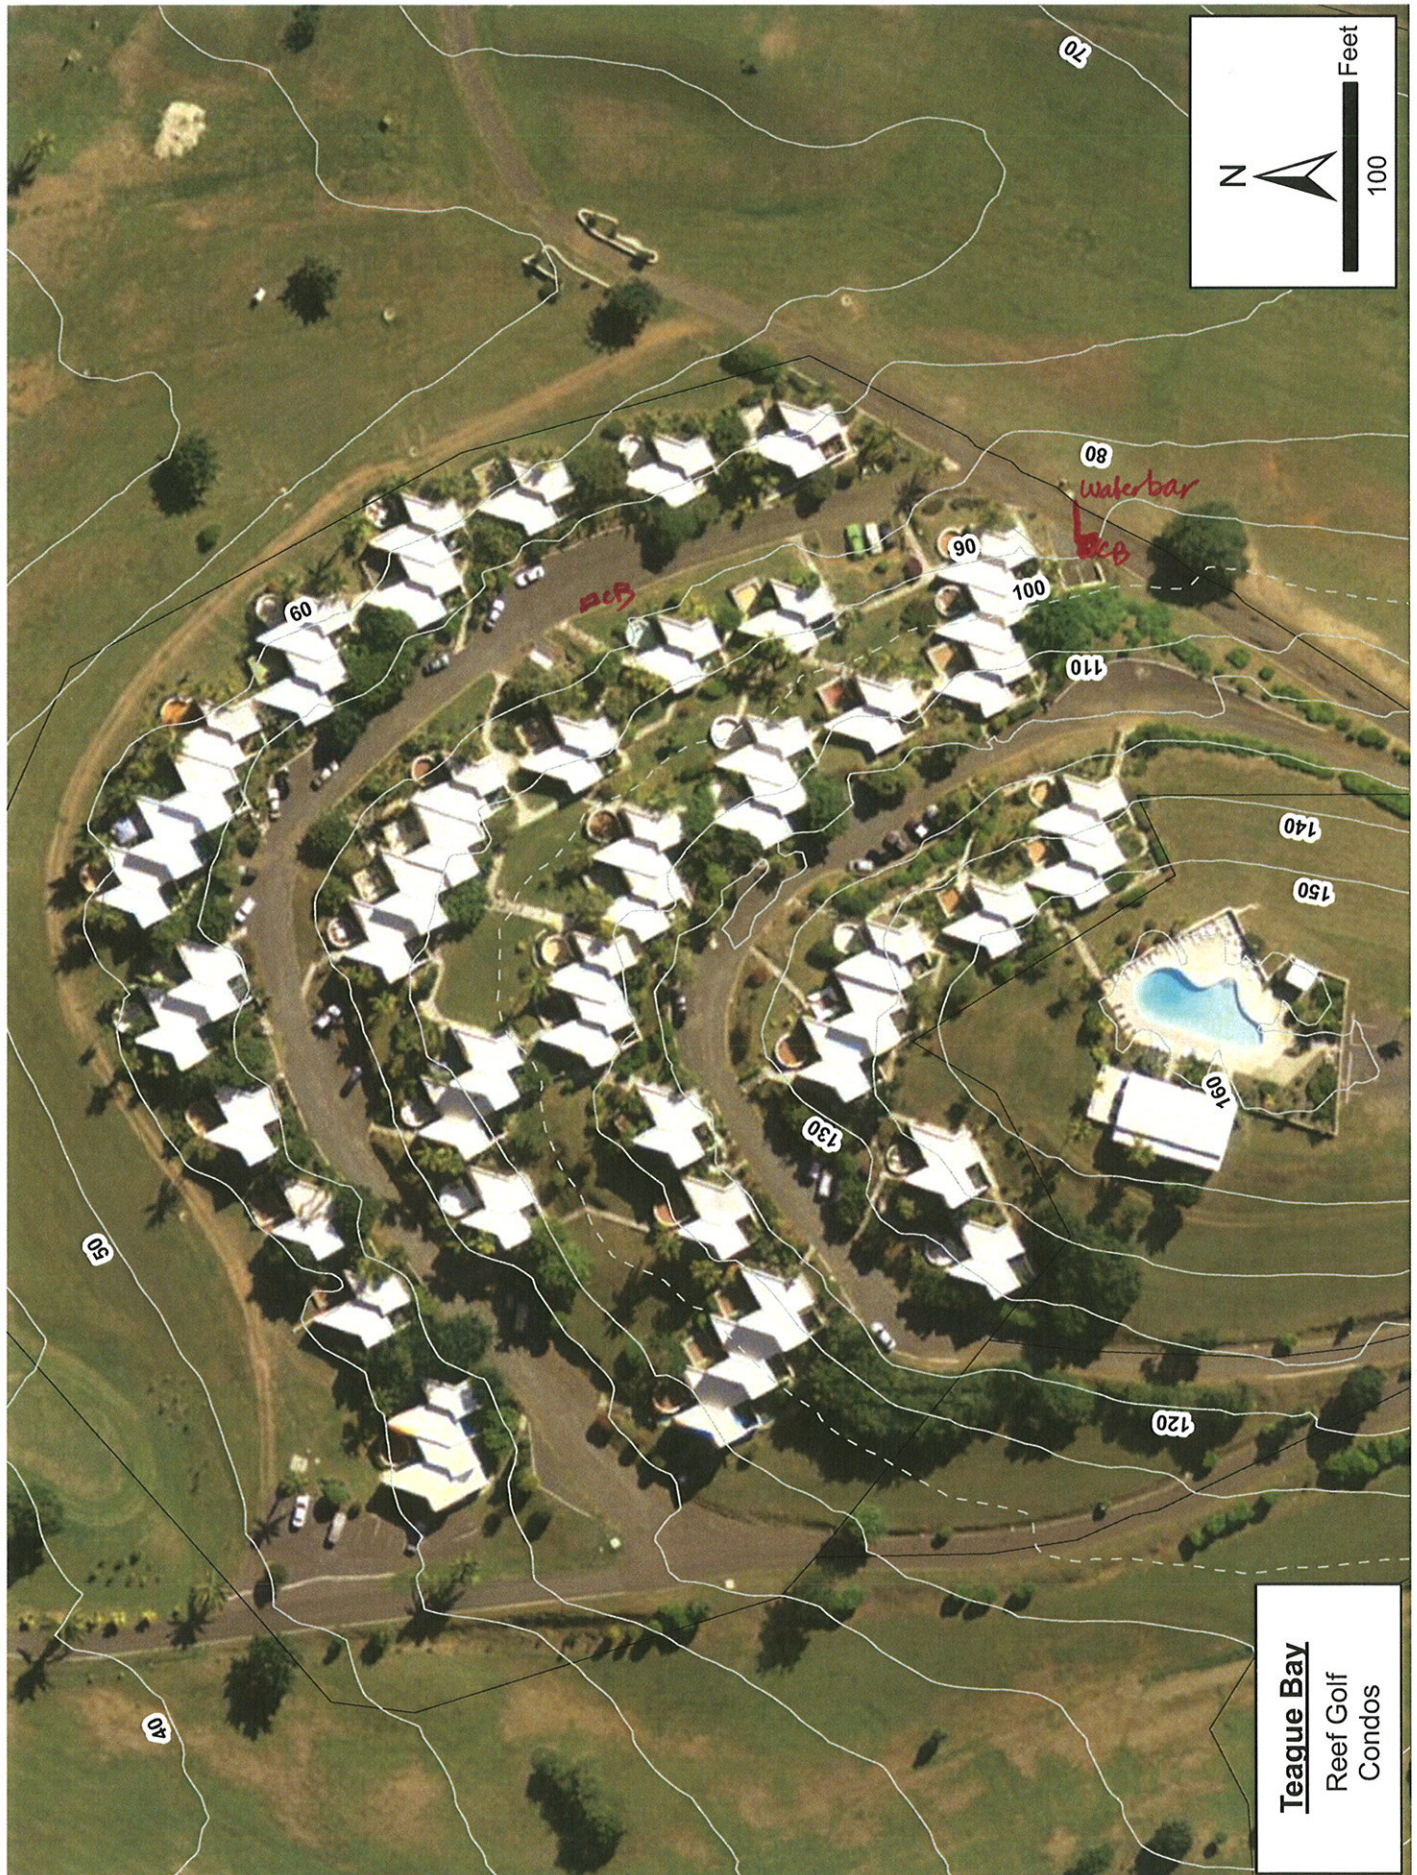
TB-GR-1 / TB-RL-1

Ponds finally had conc/plastic liners ~~to~~ installed in 70s  
↳ feed into each other
