Response to Physical Impacts on Coral Reefs in Puerto Rico and the USVI

2022 Report

Post Hurricane Fiona Coral Restoration Final Report

March 2023

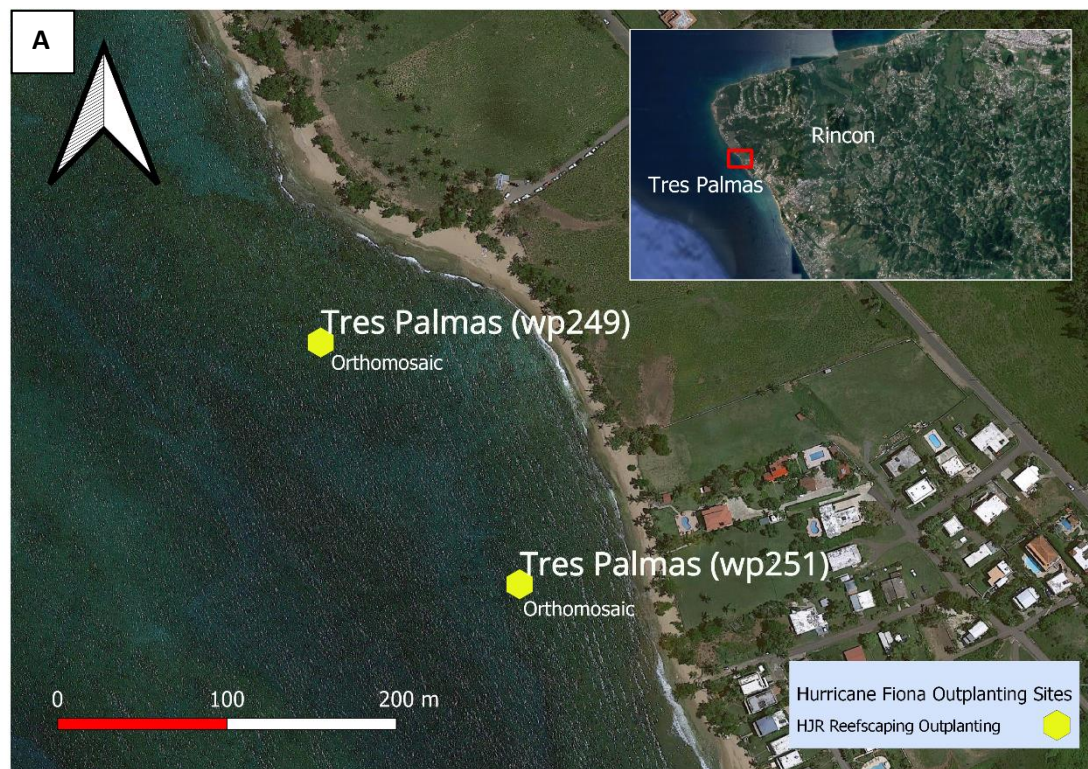
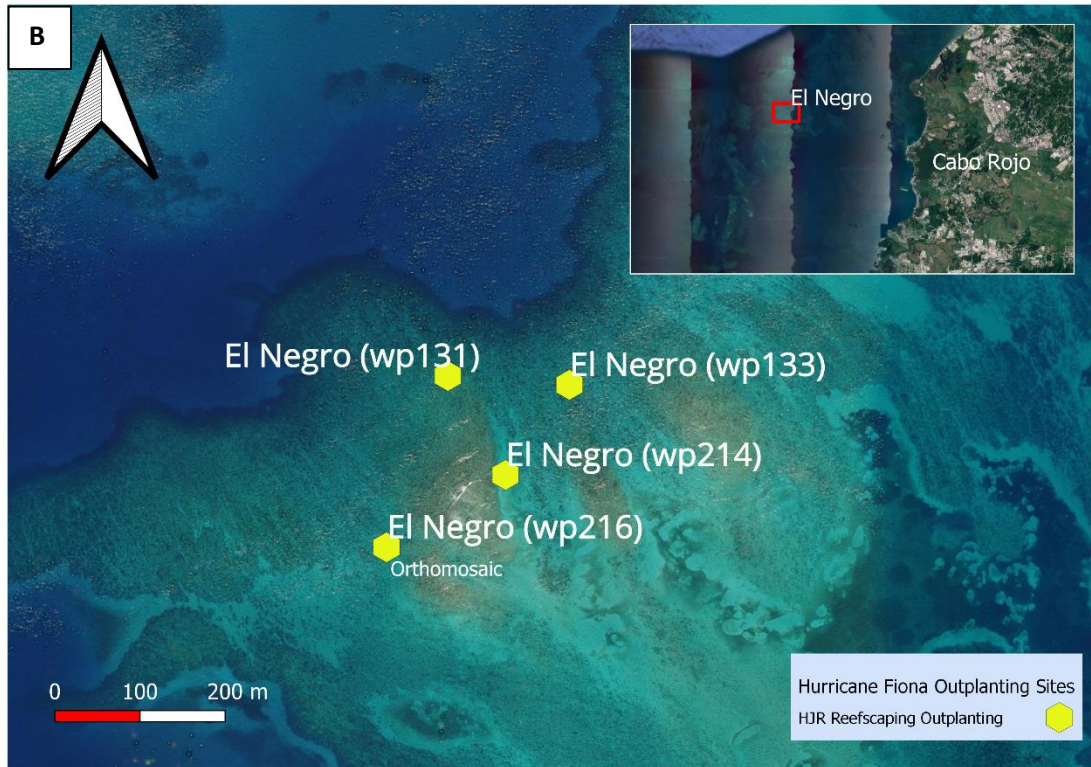
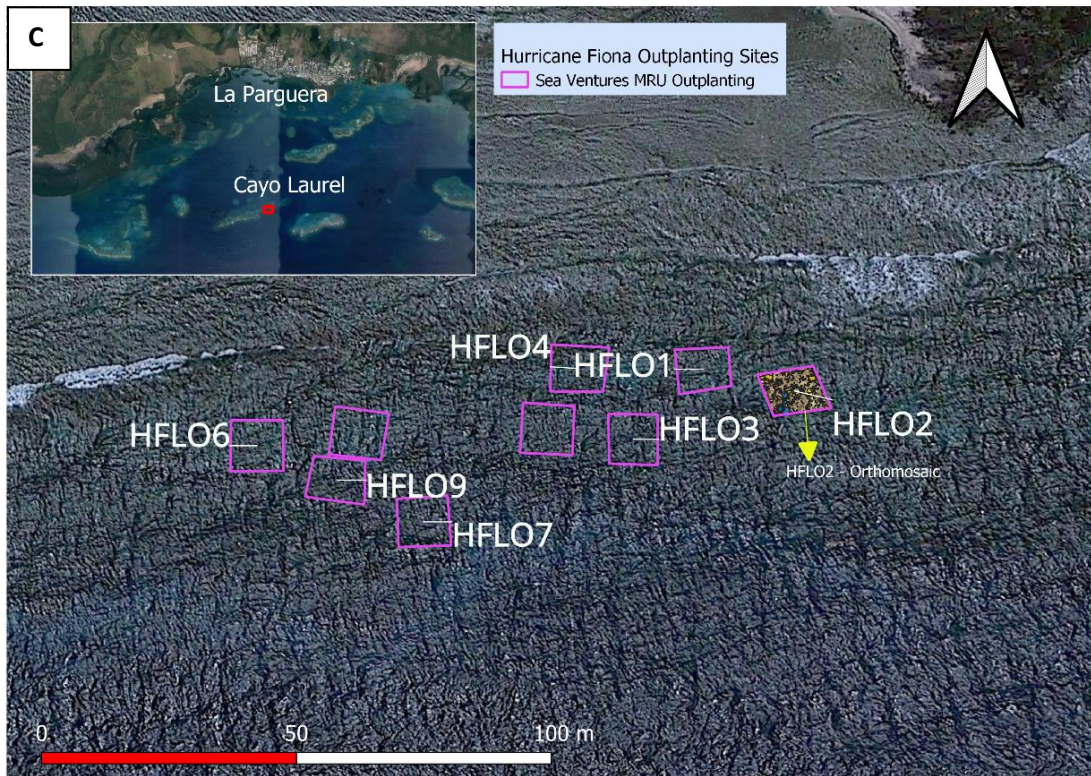
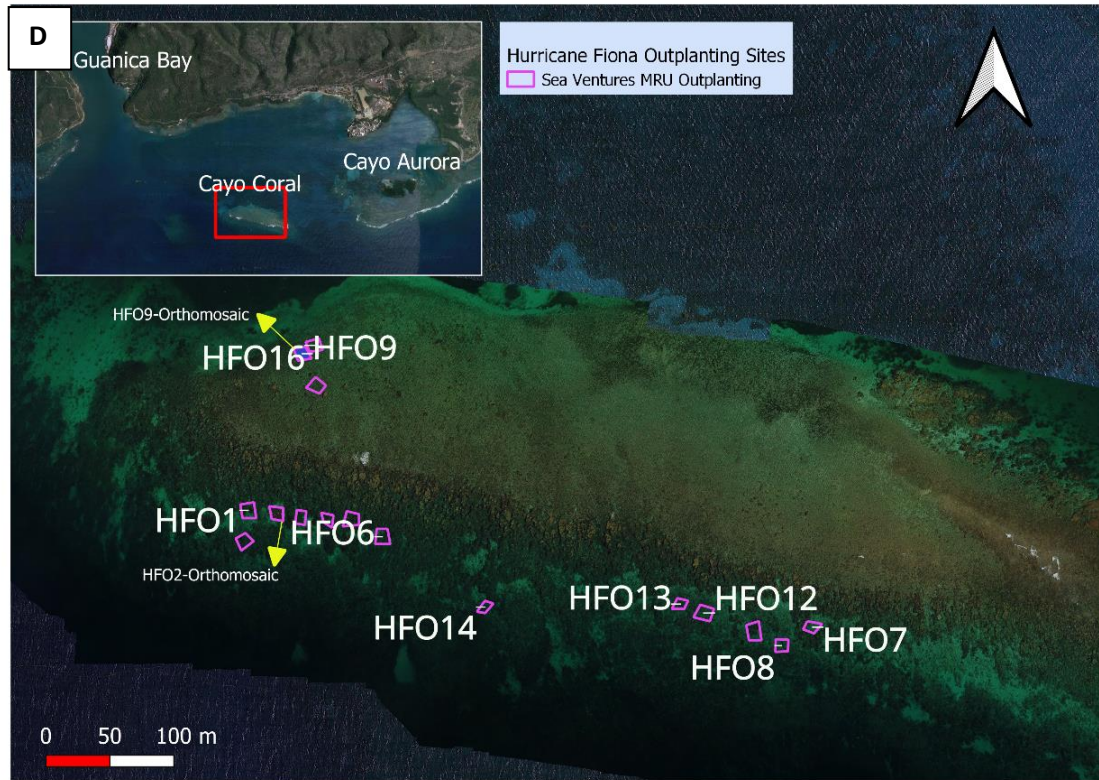
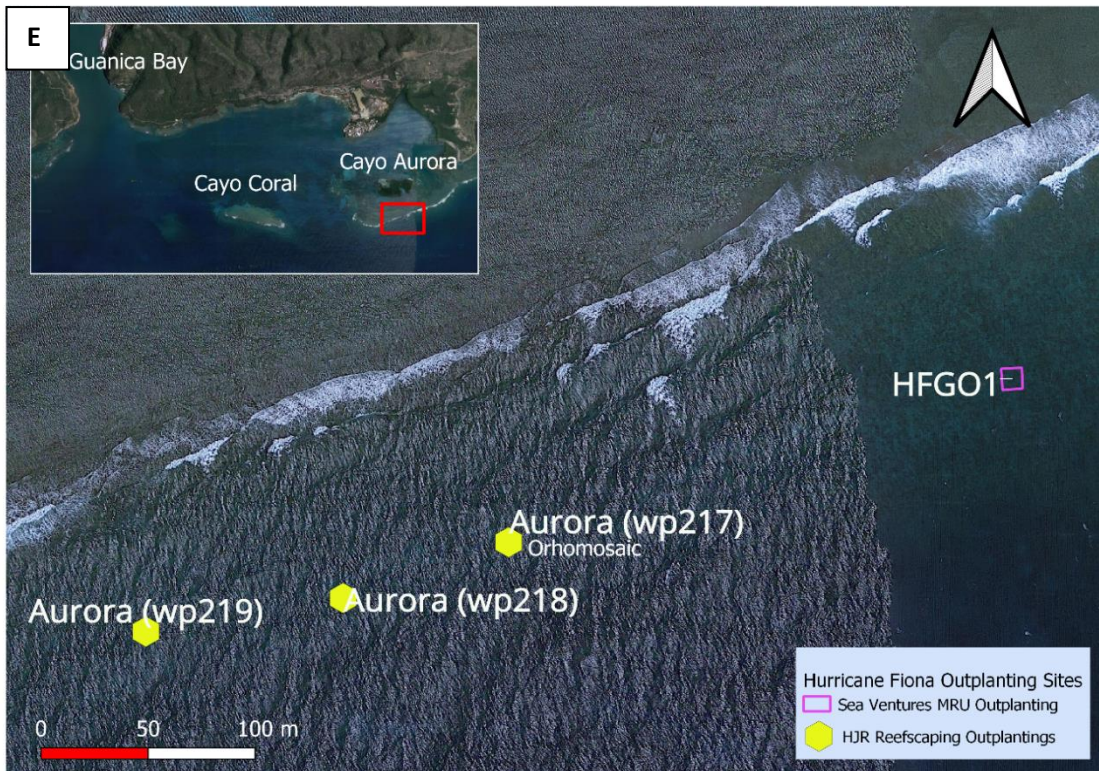
Figure 4. Triage site maps and plot areas for Tres Palmas (A), El Negro (B), Cayo Laurel (C), Cayo Coral (D) and Cayo Aurora (E). HFO= Hurricane Fiona Outplanting, HFLO= Hurricane Fiona Laurel Outplanting, HFGO= Hurricane Fiona Guilligan Outplanting

To estimate the restoration footprint and facilitate future monitoring, corals were attached in 10 x 10m plots when possible at Cayo Coral, Cayo Aurora, Laurel, and El Negro, and 5 x 5m plots at Tres Palmas. No plots were established in triage sites where triage was conducted over a broad area. For all plots a GPS central coordinate is taken and 4 additional coordinates for each corner. For plots selected for future monitoring fiberglass rebars are permanently installed. A numeric tag is installed in the center or at one of the corners of the plots. These GPS points are used to update site maps (Figure 4 A,B,C,D,E) and develop a georeferenced database of the project. The number of

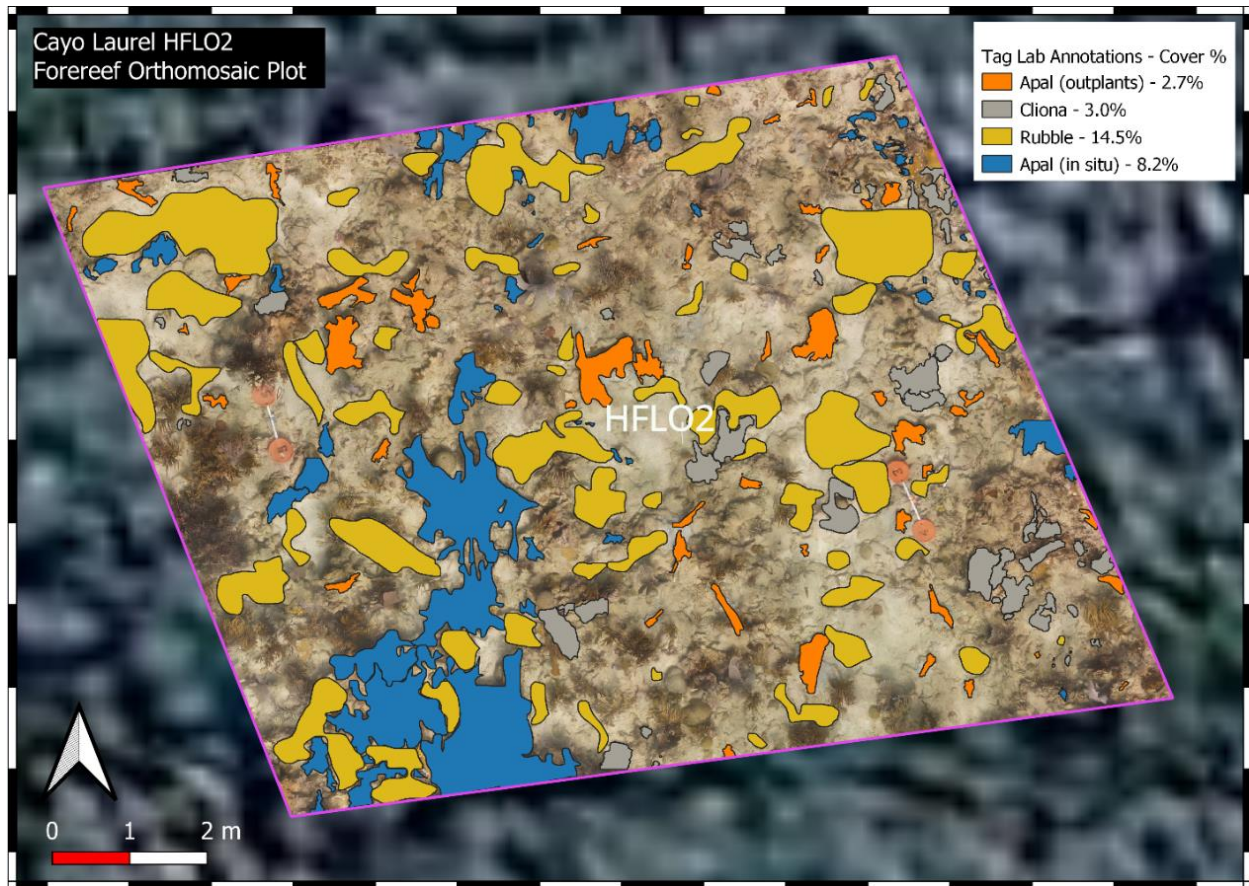
Figure 5. Example of annotated and georeferenced orthomosaic from plot HFLO2 (Hurricane Fiona Laurel Outplanting, plot 2) at Cayo Laurel in-situ triage site by Sea Ventures.

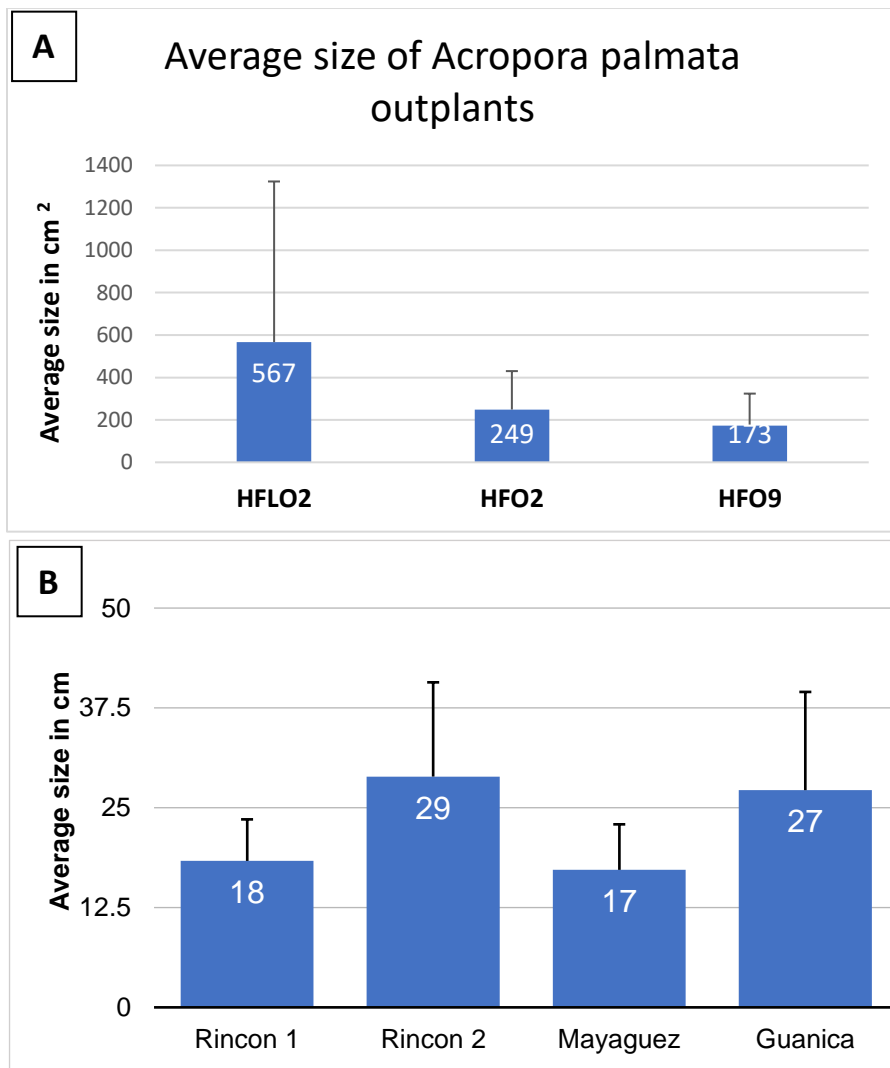
Photogrammetry analyses revealed that the size of outplants varied considerably between plots. For example, based on average planar area, at the forereef plot at Cayo Laurel (HFLO2) fragments measured 567 cm², while fragments at the backreef plot at Cayo Coral (HFO9) measured 173 cm² (Figure 10A). Despite large variability in size within each plot, differences among the plots was evident when compared to Cayo Laurel, where large colonies were overturned and stabilized using lift-bags. Less variability in outplants sizes, estimated as maximum linear distance, was documented by HJR Reefscaping at Rincon, El Negro and Cayo Aurora (Figure 10B).

Figure 10. Average size, estimated as planar area, of outplants at three plots where orthomosaics were produced by Sea Ventures MRU and (B) Average size, estimated as linear distance, of outplants in sites by HJR Reefscaping.

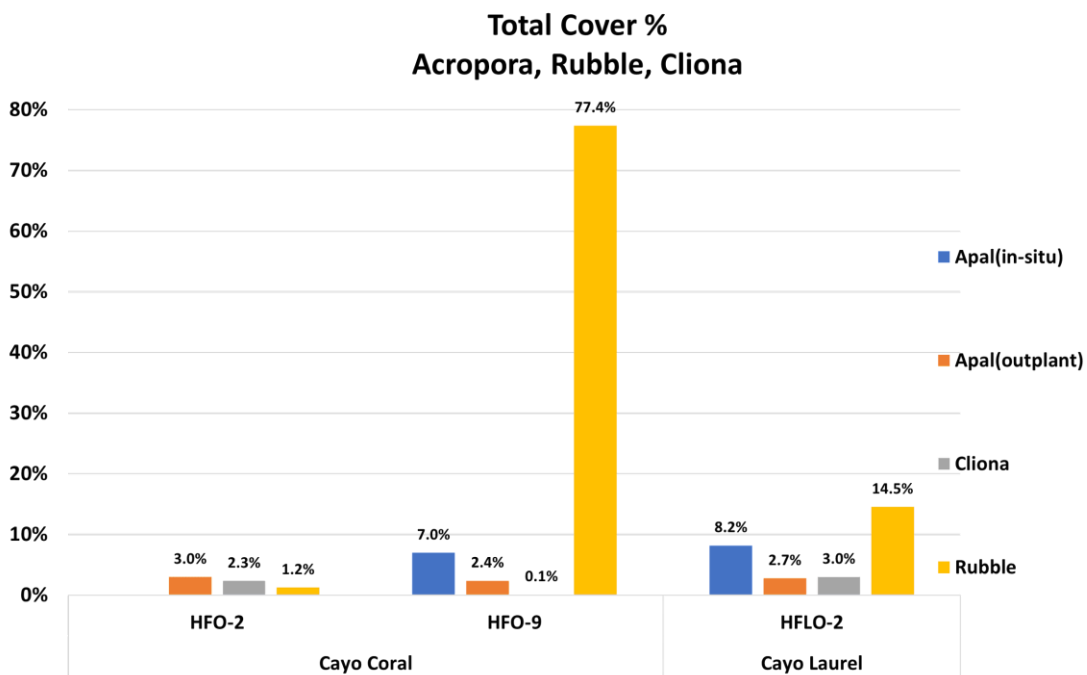
Photogrammetry analyses showed that, on average, outplanted *A. palmata* fragments covered 2.7 % of the benthic cover in three plots where orthomosaics were produced by Sea Ventures MRU, while *Cliona* covered 1.8 %, and Rubble covered 31 %. The cover % of outplanted fragments was consistent across plots (Figure 11). *Cliona* spp. cover was relatively low as expected based on the plot-selection criteria. The benthic category of interest with the greater variability was rubble, increasing dramatically in backreef areas, as evidenced by the plot in Cayo Coral Backreef (HFO9). This area was selected for outplanting given the completion of rubble stabilization, an intervention which provides clean additional stable substrate for the outplants to overgrow in areas of optimum growth but which are structurally compromised. In Cayo Coral, backreef areas seemed to provide key benefits to outplants such as good water circulation and relatively low breaking wave exposure compared to forereef areas, increasing the likelihood of fragment attachment in the short and long-term.

Figure 11. Cover % of benthic categories of interest estimated from photogrammetry analysis in TagLab at three plots where orthomosaics were produced by Sea Ventures MRU.

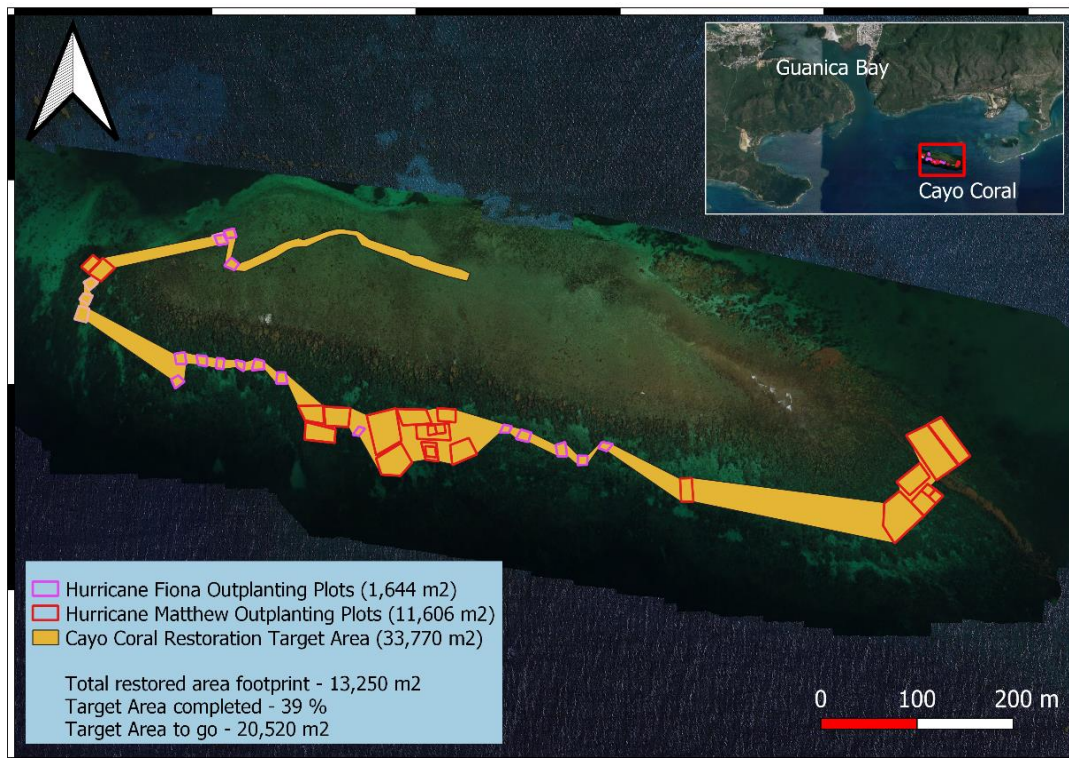
Figure 12. Map of Cayo Coral Restoration Target Area and outplanting plots completed since emergency response efforts in 2016.
