AUA WATERSHED MANAGEMENT PLAN 2023-2028

February 2024

Horsley Witten Group, Inc.

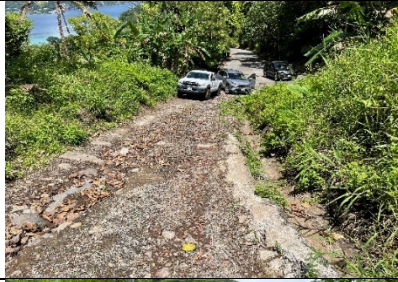
7. Unpaved Access Road	Unpaved Road	M	Steep road to uppermost house on hill where spring is, highly eroded, got messed up during sewer extension. False ditch blocking ditch and gully down surface and clogging inlet on main road. Repave or grade to insloped pitch to ditch. This should be fixed by Fletcher.

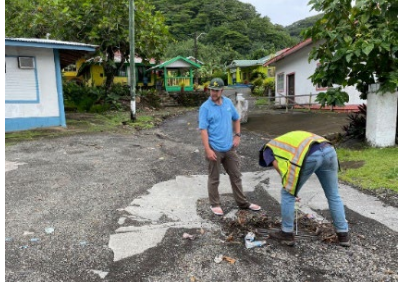
8. Unpaved Driveway and I-73	Unpaved Road	L	Eroding driveway (another site located across from culvert with Eel). Contributes sediment to main road and clogged drain. Good demonstration project. Two track design with berm at entrance

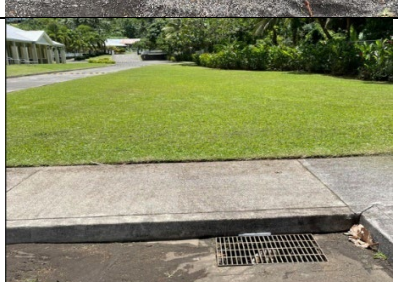
9. Mormon Church Parking	Stormwater Retrofit	L	Large amount of impervious cover, grass, and network of inlets, manholes, trench drains, outfalls. Runoff is piped to stream(s). Landscaping is raised curb. Few trees. Parking in back also serves as basketball court. Clean trench drains. Use grassed areas to create bio/add trees and tap into existing drainage system. Solar panel cover in rear for shade.

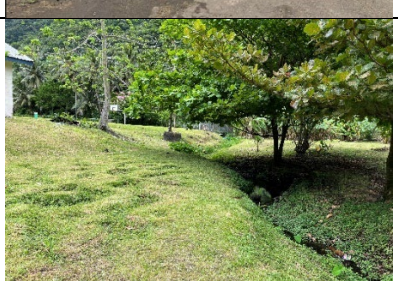
10. Wetland Restoration at Mormon Church	Stream Wetland Restoration	H	Open grassed area in back of church; some stream bank erosion observed. Mowed turf. Upstream of red mangroves. Re-establish/expand floodplain and restore mangrove wetlands. Maybe the site of new residential construction. Eel in stream. Just downstream the water turned color, looked like laundry discharge. Look for illicit discharges.

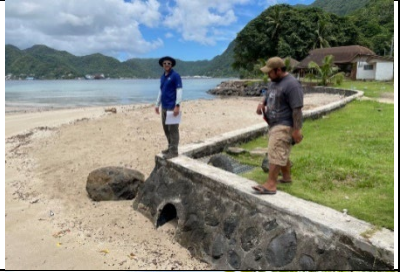
Site ID	Type	Initial Rank	Description	Photo
11. Main Stream Outlet (Lalolamauta)	Stormwater Retrofit	M	Grass roadside near beach with existing infrastructure. Shoreline to the east has minor erosion. Install a bioswale with sand filter to improve treatment. Install living shoreline/low revetment (half wall) with coir and veg above along eastern edge and protect remaining trees.

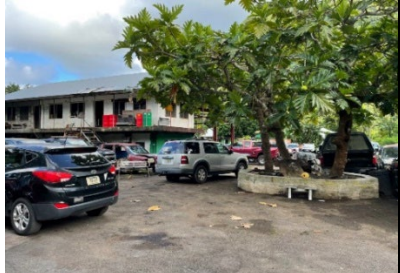
12. Auto Yard	Hotspot Pollution Prevention	H	Auto yard, organized but backs up to stream, car washing observed, staining on gravel, excessive trash and junk in stream and buffer. Develop pollution prevention plan. Proper outdoor material storage. Target area for stream cleanup. Remove junk cars

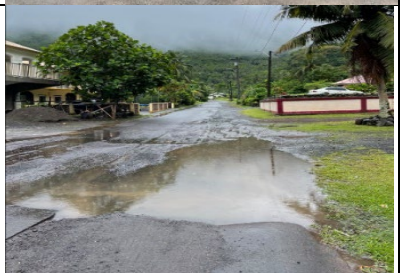
13. Main Road	Stormwater Retrofit	H	Ponding on road, road needs repaving by ASPA, infrastructure needs cleaning. Repave with road crown, add swale or turnouts in one section, enhance vegetation in ditches. Utility poles in ROW south of Catholic Church.

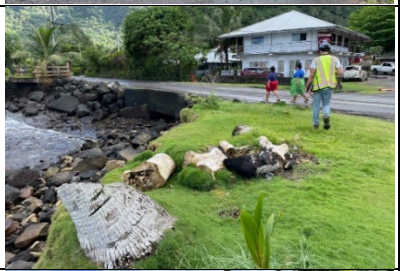
14. Shoreline at Coral Transect	Shoreline Stabilization	L	Small area of green shoreline with large undercut (40 inches of under cut 28 inches into slope). Needs stone toe protection, beach nourishment, coir logs, and appropriate coastal plantings. This is a small area, but high visibility and is location of coral transect marker. Replant coconut trees.

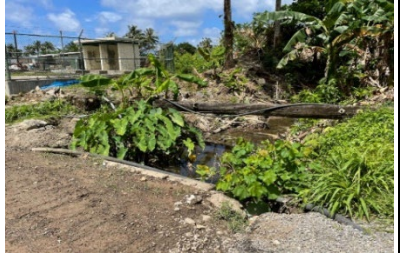
15. Stream Restoration	Stream/ Wetland Restoration	H	Stream channel impacted by sewer construction full of sediment. Buffer used for bananas, stone berm at mouth, excavation at new lift station. Stabilize banks with veg, stone protection at culvert, buffer plantings

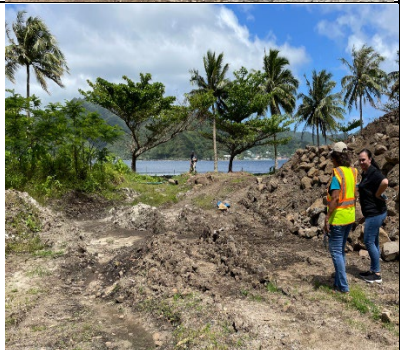
16. Onesosopo Park	Construction Site ESC & Park Masterplan	H	Terrible ESC on display--little effort except for dust control; major stockpiling for sewer project; construction entrance needs replacement. Conduct inspection and implement proper ESC practices. Remaining park includes grass field, fales, and a bathroom. Masterplan for park to avoid what happened at Lyons. Design for tree planting, formalized fields, rain garden, and permeable parking. Other park uses mentioned (a health clinic, fast food restaurant, and a splash pad).

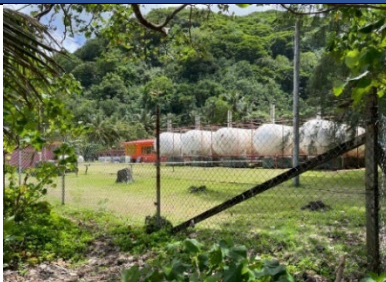
Site ID	Type	Initial Rank	Description	Photo
17. Origin Gas	Other	L	Gas tanks/storage in residential area. Ensure compliance with all required safety provisions for being located in residential area; work with Mayor on stream and shoreline buffer enhancement

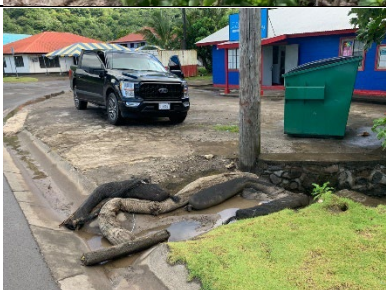
18. PT Mart and Laundry Mat	Other	L	Remove accumulated sediment and debris from upstream side of culvert. Consider replacing culvert with bridge to reduce capacity issues and sedimentation. Remove wall downstream of road and install backflow preventer (if bridge is not installed). Road may need to be raised if a bridge is constructed.

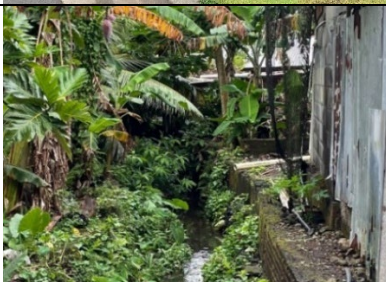
Village-wide	Wastewater & graywater management	H	Connect laundry and outdoor toilets to sewer system. Currently, only the house toilet (or what was connected to septic system) is now connected to sewer. Need an inventory of greywater and illicit discharge pipes and a subsidy program for hookups.

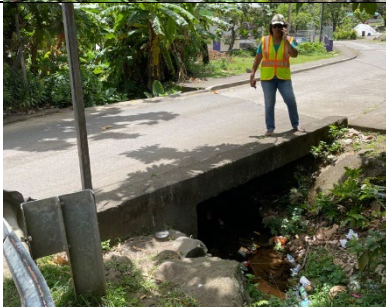
Village wide	Trash cleanup	L	Trash cleanup locations for community volunteer program run by mayor's office: Suaia stream and Rt 6 intersection, channel by auto shop down to wetland, Matagimalie stream (behind chief's new home)

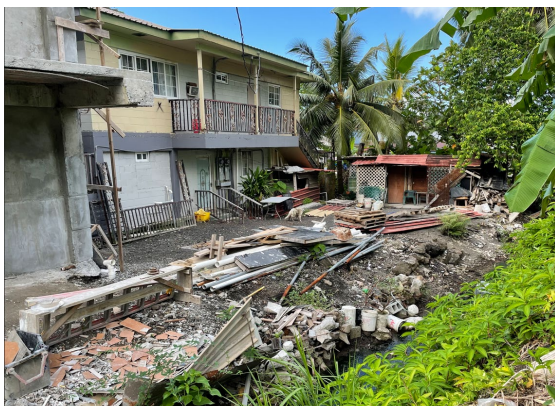
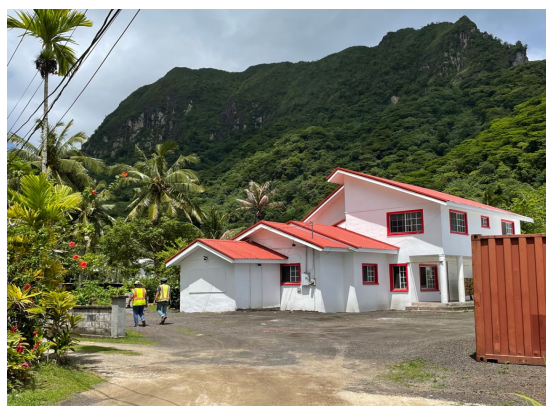
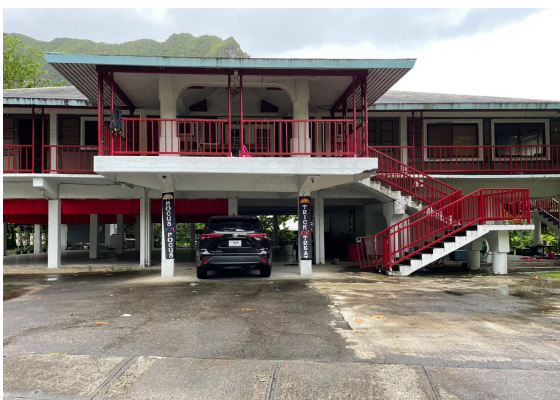
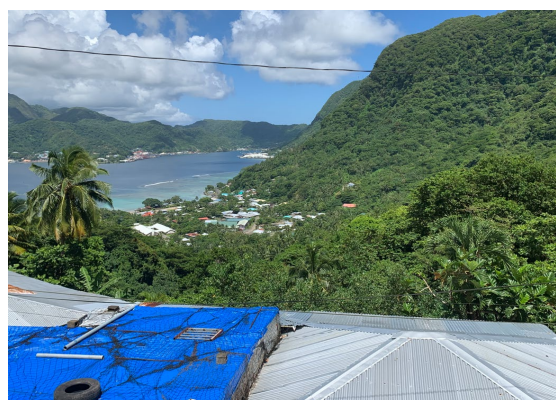
Although the Village population is not growing significantly – and may in fact be decreasing – there has been increasing development over the past few decades. Increasing impervious cover have led to increased surface runoff, flooding, water quality degradation, urban heating, and aquatic habitat loss. Development projects are required to undergo permitting through the Project Notification and Review System (PNRS), in which several agencies including ASEPA, DMWR, and DOC review proposed development. A lack of zoning, floodplain restrictions, and development standards, make it difficult to manage urban growth and maintain important watershed services, especially with no requirements for onsite stormwater management. Property boundaries and setbacks are not visibly demarcated, and stream/wetland buffer protections are not enforced. Residential construction frequently includes alterations to the stream corridor including clearing, filling in the floodplain, channelization, and dumping. Development patterns in the Village include new home construction or renovations adding an additional story. Some new construction appears to be elevated and some includes the conversion of former foundations to a family fale. Erosion and sediment control is not required for small residential construction and does not appear to be enforced for larger capital projects (i.e., sewer line upgrades). Due to limitations on available space in the Village, development moving forward will be either redevelopment and infill, or new construction moving up into the hillside.

(TOP LEFT) No erosion controls or stream protection next to residential infill construction site. (TOP RIGHT). New construction in the floodplain. (BOTTOM LEFT) Elevated first floor. (BOTTOM RIGHT) Development on the steep slopes.

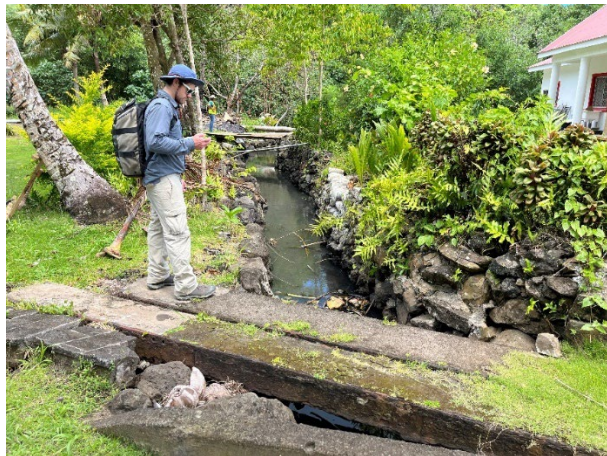
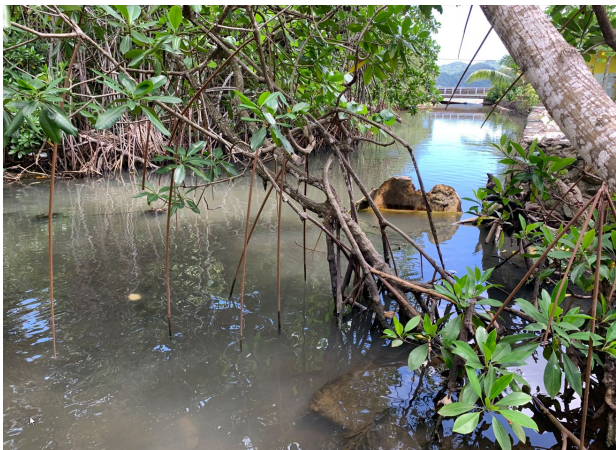
Streams throughout the Village are narrow (wider in the headwaters and narrower as you get into the Village), highly channelized (vertical walls or piped), and rerouted around buildings. Stormwater is discharged directly to streams with no pretreatment. Channels are frequently filled with trash and debris, and development encroaches all the way to the top of bank. Lack of vegetation along the banks of most streams and loss of floodplain connectivity results in reduced stream shading, habitat loss, and flood storage. Villagers tend to perform maintenance on streams by removing vegetation from within the banks. In a few instances, culverts with elevated drops created barriers to fish, eel, and other aquatic species passage. The Leasi and Lalolamauta streams have baseflow; other streams are reported to flow intermittently. Most streams were flowing during our assessment and eel, shrimp, tadpoles, and small fish were observed in lower reaches. There is little space for stream/floodplain restoration without impacting homes or roads. Historic accounts of a 9-acre central wetland in the Aua Village are hard to envision. Most of this wetland has been filled for development. A small red mangrove system remains extending from the beach up to Mormon Church.

(LEFT) Matamigalie Stream near its confluence with Lalolamauta Stream. Water in Matamigalie is turbid, and stream banks are confined by vertical stone walls. (RIGHT) Remaining mangrove system looking downstream.

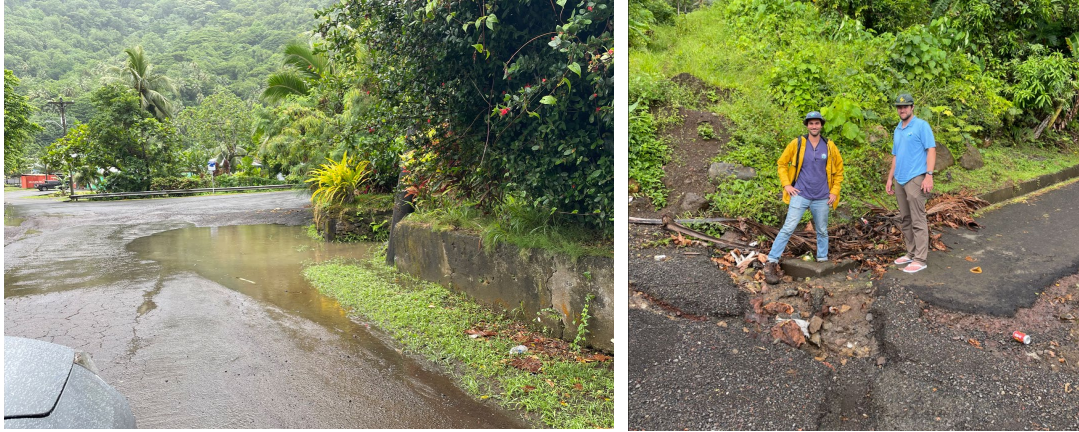
Aua is not alone in its poor maintenance practices. Most of the inlets and culverts we saw were clogged and could use regular cleaning. There were several locations where clogged pipes were causing flooding or leading to additional infrastructure damage.

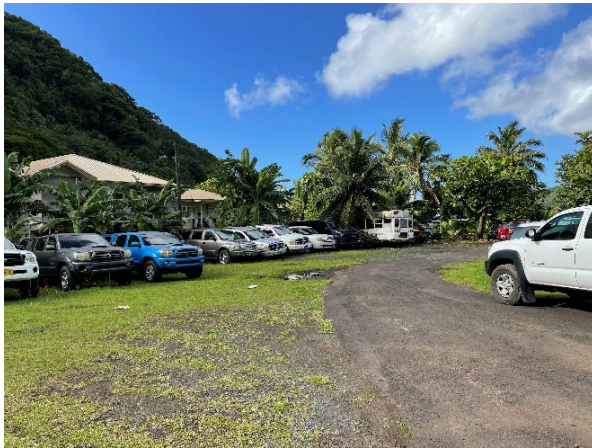
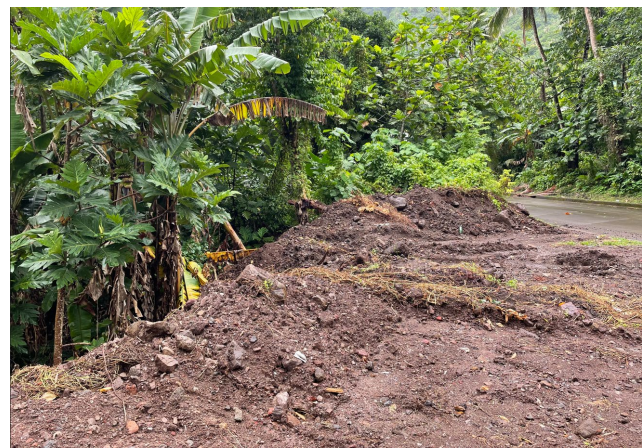
Some land uses have the potential to generate higher pollutant loads than typical urban areas, such as the construction sites (sewer project staging area, current and pending drinking water system upgrades); the auto yard in northeast section of the Village; and the Laundromat adjacent to Skyview Store and Tent Rental. According to ASEPA, there is currently no system for tracking or specifically regulating land uses with higher potential pollutant loads. ASPA has multiple large scale projects in the watershed that need to inspect/enforce approved pollution prevention plans (sewer expansion and Water Tank and pending 8" distribution line Village bypass). In fact, the excavation behind the Water Tank should be inspected to ensure the cut will not impact the stability of the upper road and to develop a plan for stabilizing cut material that was cast downslope. Animal operations are also considered high pollution generators. Waste from piggeries can have an impact on water quality. ASEPA is tracking three piggeries in the Village. This signifies a reduction in piggeries over the past few decades. We did not see any active piggeries and were unable to evaluate management condition or opportunities for improvement.

(LEFT) Automobile shop and lot. (RIGHT) Excavated material cast downslope at Water Tank construction site.
