Surveys of Abandoned Vessels: U.S. Caribbean Region

**SURVEYS OF ABANDONED VESSELS:
U.S. CARIBBEAN REGION**

Jacqueline Michel, Scott Zengel, Christine Lord, and Zach Nixon
Research Planning, Inc.
Columbia, South Carolina 29202

September 2002

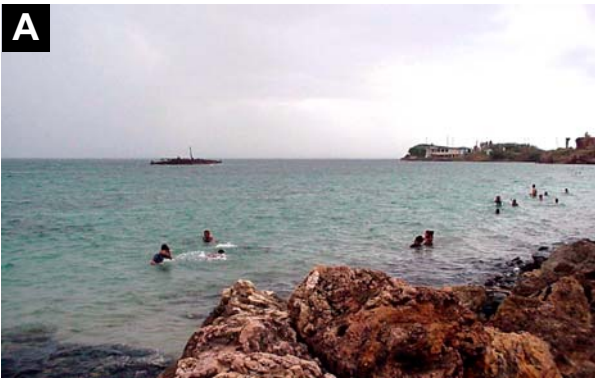
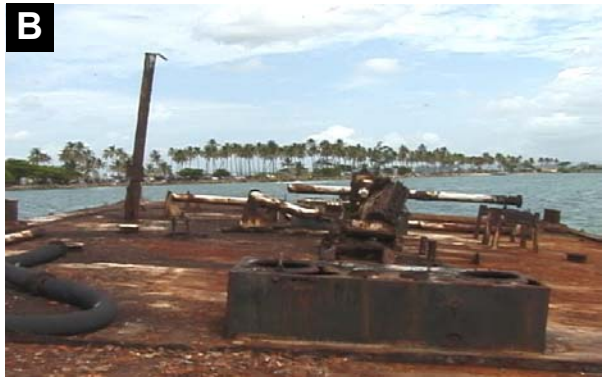
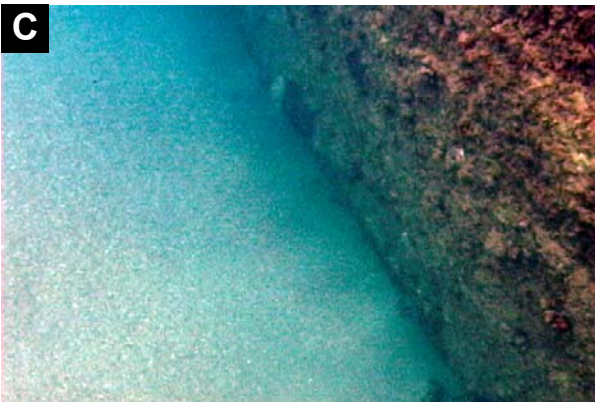
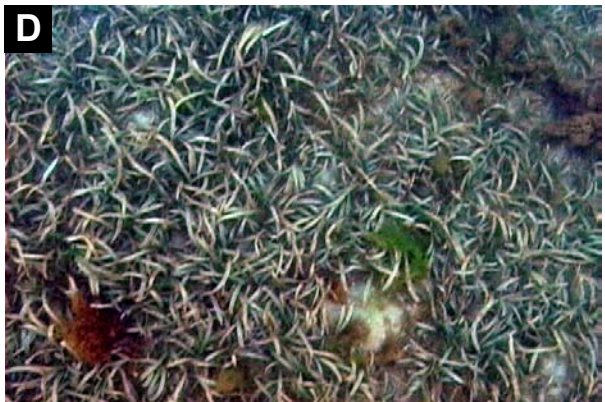
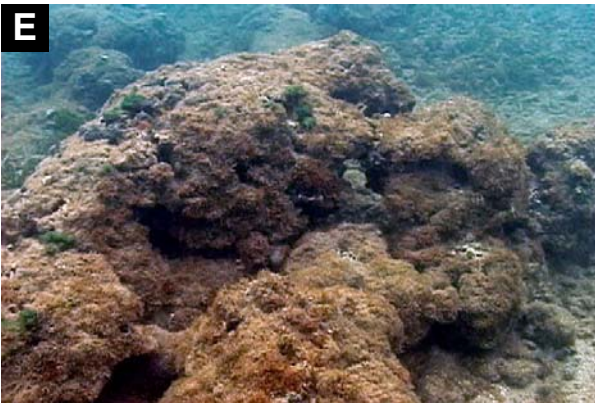
Photographs of *El Canuelo* (2 June 02):

Vessel Information: The *El Canuelo* is a 200 ft liquid fuel oil barge that has been hard aground since at least 1976. The steel deck plates are starting to break up and there are many holes in the side plates. The cargo area is open to the sea. No information is known about the previous owners.

Environmental Characterization: Seagrasses (shoal and turtle grass) were sparse and patchy surrounding much of the vessel scour area, but denser and mixed with fleshy macroalgae away from the vessel. There was a patch of hardbottom colonized mainly by macroalgae, (live hard coral cover was <1% and colonies were small) within 35 ft.

- A. View to the NW from the municipal park to the barge offshore. Note the swimmers.
- B. Barge deck condition.
- C. Unvegetated scour area that extends 15-30 ft around the vessel.
- D. Seagrass habitat.
- E. Hardbottom habitat 35 ft NE of barge with about 1% live coral present.

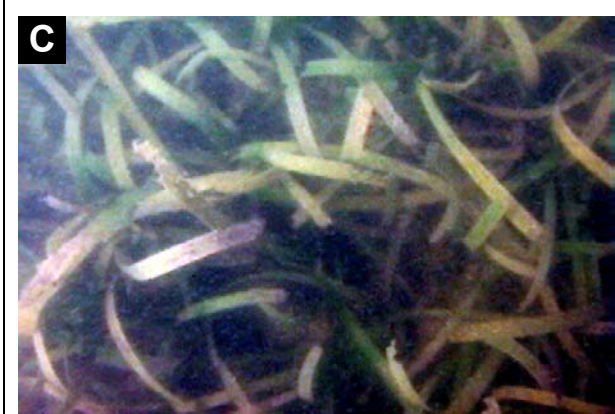
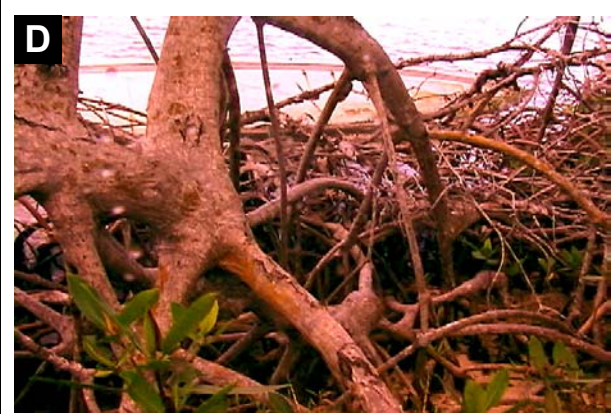
Photographs of *Be??trix* (3 June 2002):

Vessel Information: The *Be??trix* is a 30 ft fiberglass sailboat that is reported to have grounded during Hurricane Georges in September 1998. Only the fiberglass hull remains; it has been completely stripped. The mast and most of the cabin are gone. It is partially submerged and lodged against the outer mangrove fringe.

Environmental Characterization: A red mangrove stand, including some black mangroves landward, fringes the shore. The stand is large and mature but shows evidence of storm damage, as well as possible damage caused by the vessel. The nearshore benthic habitat around the vessel is composed of sparse shoal and turtle grass that becomes denser with increasing distance offshore. The vessel could move during future storms, causing more damage to adjacent seagrass and mangrove habitats.

- A. View looking north of the vessel lodged against the mangrove fringe.
- B. View looking west showing the vessel position relative to the mangroves.
- C. Seagrass habitat.
- D. Inside mangrove stand.
- E. Mangrove habitat.

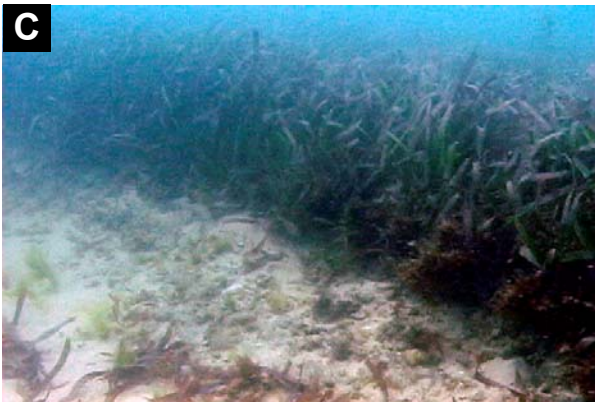
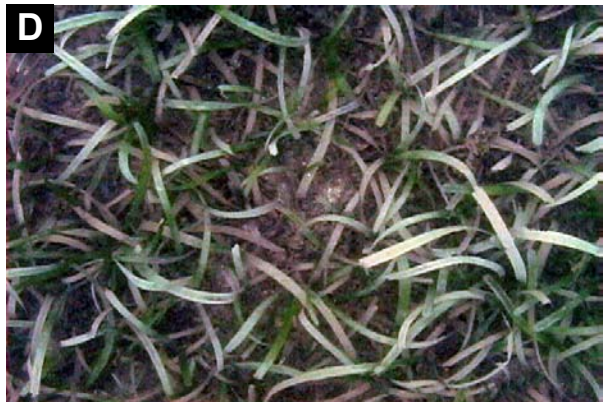
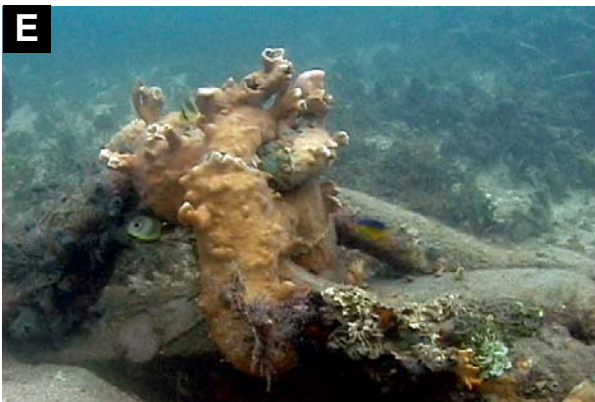
Photographs of the *Pawnee* and *Princess I* (4 June 02):

Vessel Information: The *Princess I* grounded when it was being moved to a shoreline site to be used as a restaurant. The salvage tug *Pawnee* grounded nearby during salvage efforts. Both vessels grounded in the early 1990s. The *Pawnee* has holes in its sides and the USCG thinks that there may be fuel in the deeper tanks. The *Princess I* burned to the waterline and only the steel hull remains. The USCG removed oily bilge water, and they believe there may be some fuel in deep tanks.

Environmental Characterization: Both vessels are grounded in seagrass habitat composed of dense turtle grass mixed with manatee grass and *Halimeda* macroalgae in places. The substrate is carbonate sand. Large areas around each vessel are now devoid of seagrass and signs of active scour are apparent. The edge of the grass bed around each vessel also has a 1-2 ft high eroding scarp where seagrass rhizomes are exposed and the root mat is undercut to 2 ft or more in places. Further loss of seagrass around each vessel is likely, particularly during hurricanes.

- A. The *Pawnee*.
- B. The *Princess I*.
- C. 1-ft high eroding scarp at edge of seagrass bed around the *Pawnee*.
- D. Seagrass habitat.
- E. Fire coral growing on vessel debris.

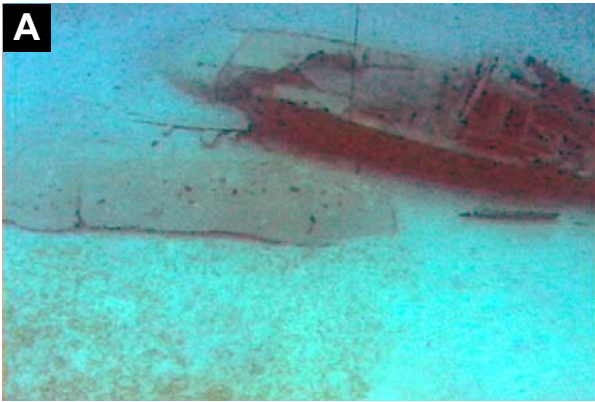
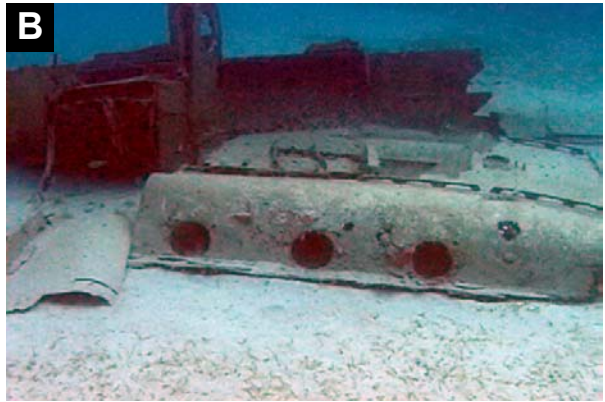
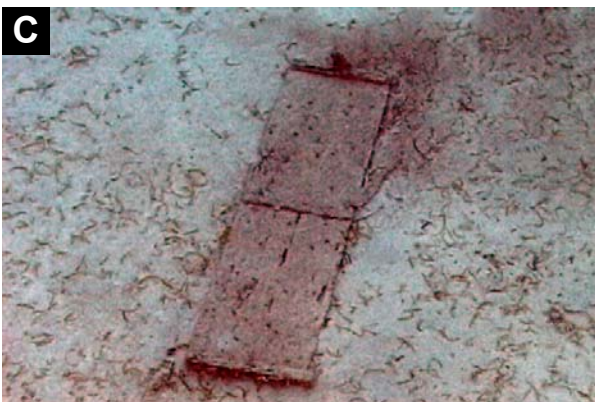
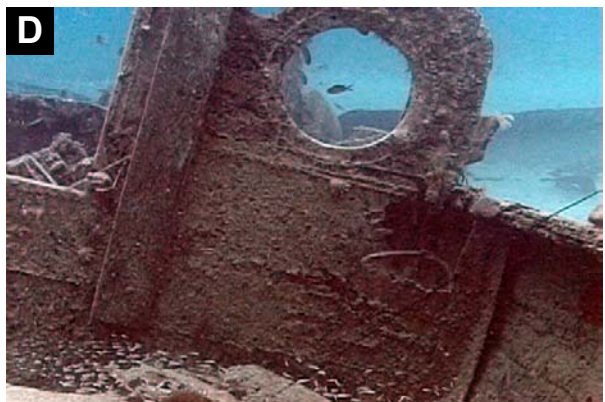
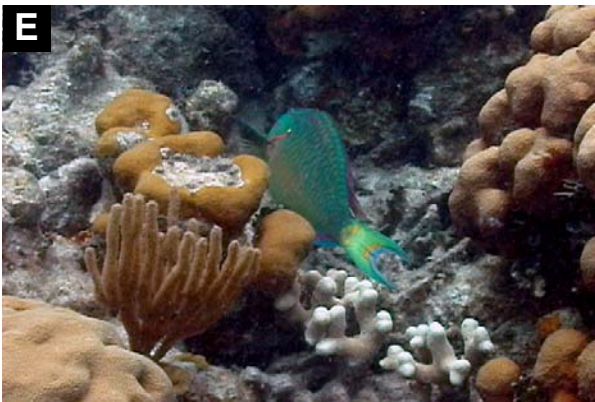
Photographs of the *Karma* (5 June 02):
A. Overview of vessel.
B. Horizontal view of vessel.
C. Vessel debris in sparse seagrass habitat.
D. Detail of remaining vessel structure.
E. Nearby coral reef habitat.

Vessel Information: The *Karma* is a wood and fiberglass sailboat that was intentionally sunk in April 2001 by the owner to create a diving site/artificial reef in a bay that is a popular diving and boating site. The vessel has already broken into two main pieces, and several small pieces have moved towards shore.

Environmental Characterization: The vessel is sunk in an area with dense turtle grass. Coral patch reef and a narrow fringing reef occur roughly 50-75 ft from the vessel. A large area around the vessel is now devoid of seagrass. Seagrass cover is sparse surrounding the bare area, with lower shoot density and shorter blades than in the surrounding grass bed. The site falls within Designated Critical Habitat for the federally threatened green sea turtle, which includes seagrass habitat damaged by the vessel.

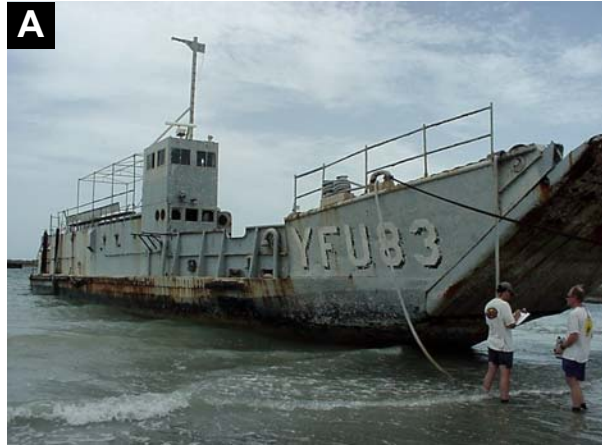
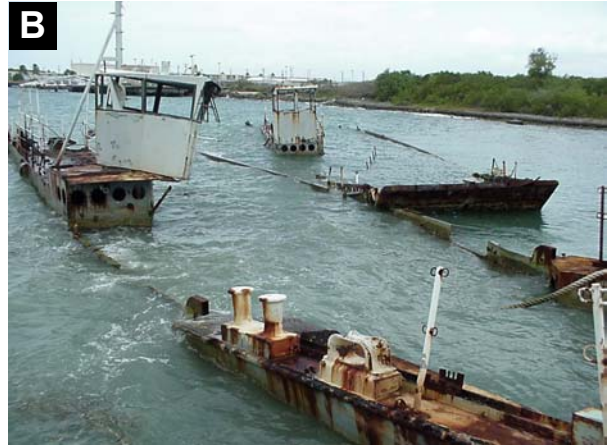
Photographs of the LCUs at Roosevelt Roads Naval Station (6 June 02):

Vessel Information: There are three LCUs partially sunk in the intertidal zone. Two vessels are awash up to the top deck. The other vessel (YFU83) had apparently sunk for a while and been re-floated; it had barnacles on the deck and housing. The bow of this vessel is resting on the sand and gravel beach at low water.

Environmental Characterization: Dense to patchy turtle grass mixed with calcareous macroalgae extend around all vessels. There is a scour at least 140 ft x 30 ft around YSU83, the only vessel that could be safely surveyed during the site visit because of moderate wave energy and high water turbidity. A steep scarp in the seagrass bed, indicating active erosion, occurs near the two partially submerged vessels. The adjacent mangrove forest is designated critical habitat for the federally endangered yellow-shouldered blackbird, which uses mangroves and coastal fringe habitats. Mangroves could be damaged if the vessels moved onshore during a major storm.

- A. This LCU was covered with barnacles, indicating that it had previously sunk and then was re-floated and grounded. There is extensive scouring of the adjacent seagrass beds.
- B. The two partially submerged LCUs; photo taken from the YFU83.

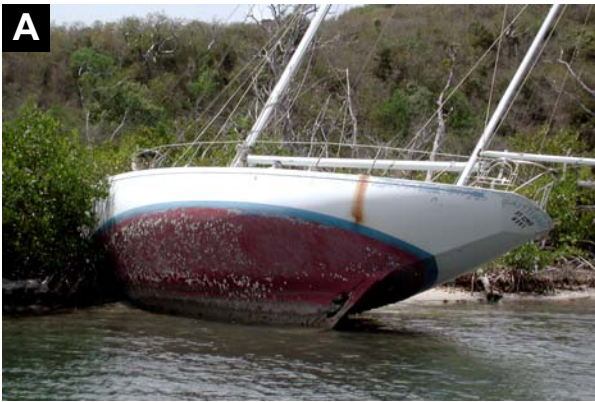
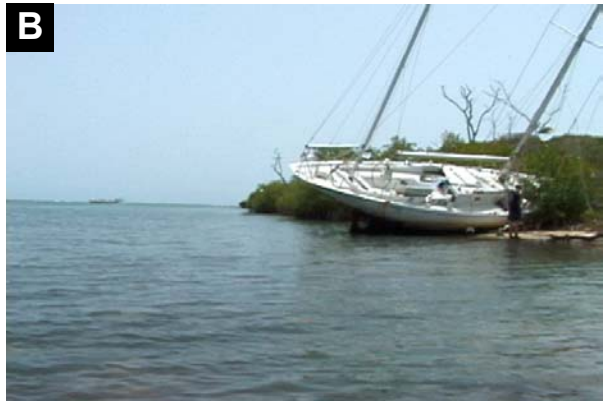
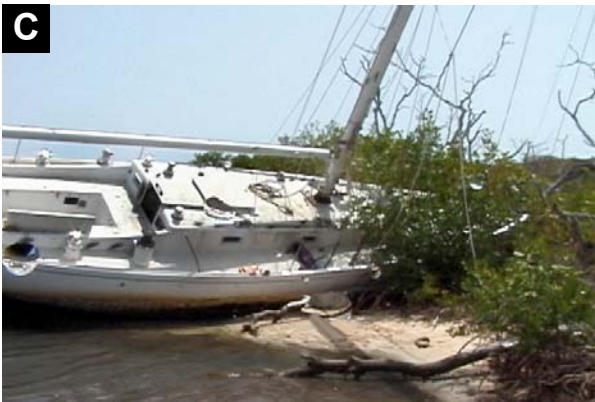
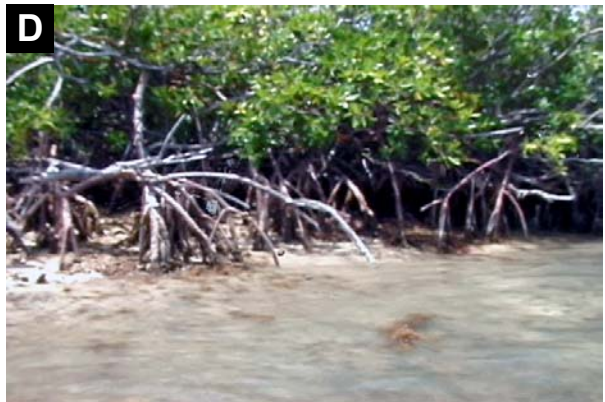
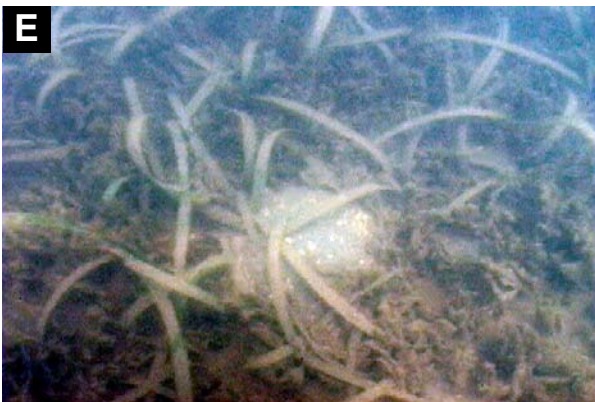
Photographs of the *Kittiwake* (25 June 02):

Vessel Information: The *Kittiwake* is a 48 ft sailboat that most likely grounded during a hurricane. It is aground and ashore. The vessel is in good condition with no obvious hull damage. The cost estimate for removal was reported to be \$4,800.

Environmental Characterization: The vessel is aground on mangroves, sand beach, and seagrasses (proceeding from bow to stern, landward to seaward). The red mangrove forest is 30+ ft wide, and the sand beach is about 7 ft wide. A patch of dense turtle grass with infauna burrows roughly 10 feet wide runs adjacent and parallel to the beach. Dense cover of *Halimeda* macroalgae with infauna burrows occurs seaward of the seagrasses and extends into deeper water. Intertidal sediments are sandy. Muddier sediments occur in the subtidal area with increasing depth. Physical mangrove damage was observed extending roughly 15-20 ft into the forest, and was caused at least in part by this vessel. Unrelated hurricane damage was also present. Seagrasses were damaged directly under the vessel and along a 3 ft-wide unvegetated strip along the port side of vessel. Additional mangrove and seagrass damage is possible if the vessel moved during major storms or hurricanes.

- A. View of vessel from port side.
- B. View of vessel from starboard side.
- C. Vessel deck; beach and mangrove habitat.
- D. Mangrove habitat.
- E. Seagrass and macroalgae habitat.

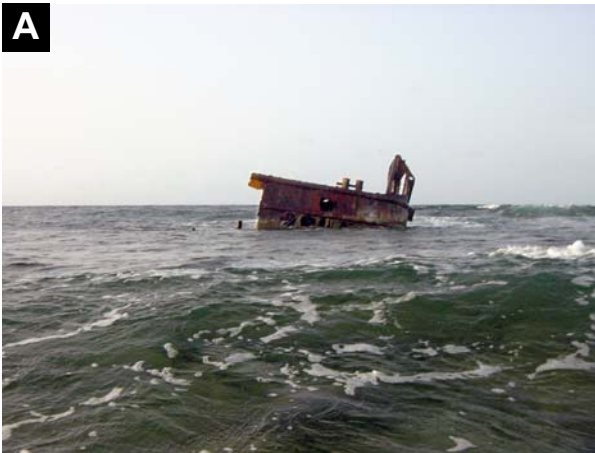
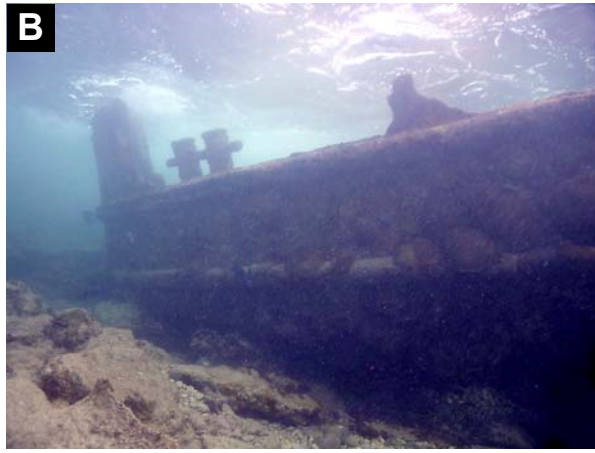
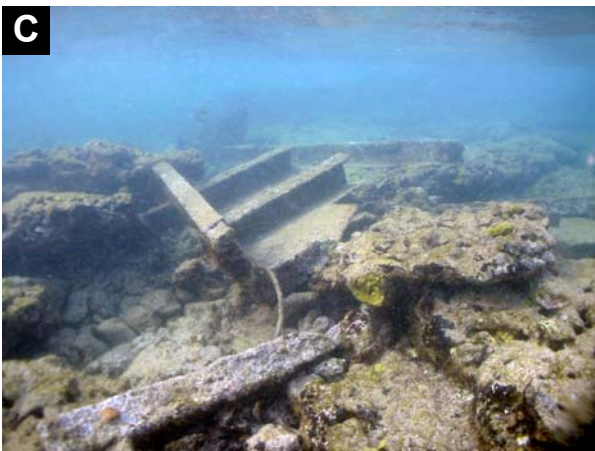
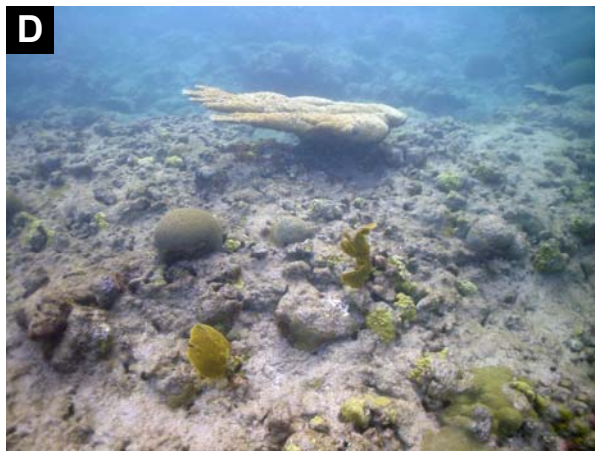
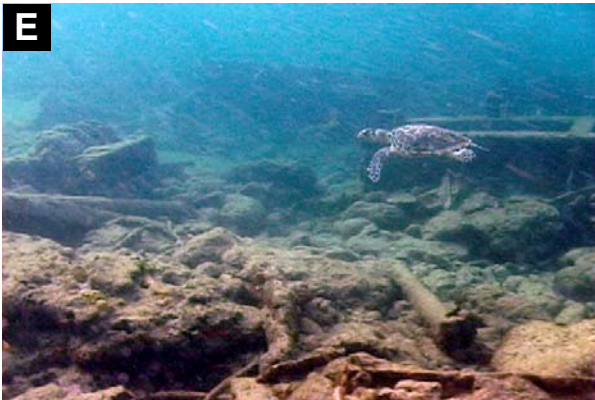
Photographs of Unk2431 barge (25 June 02):

Vessel Information: Unknown 2431 is a steel barge surrounded by a large debris field. The vessel and debris are very rusted. No information is known about the previous owners.

Environmental Characterization: The vessel is grounded on hardbottom and coral reef habitat near Whitehorse Reef. Limited live coral was observed. An extensive debris field extends over 100 ft around the barge. *Diadema* and fish were relatively abundant, and lobster and a juvenile hawksbill sea turtle were observed.

- A. View of barge from shore.
- B. View of barge underwater.
- C. Debris field.
- D. Soft coral on hardbottom.
- E. Juvenile hawksbill sea turtle swimming around debris field.

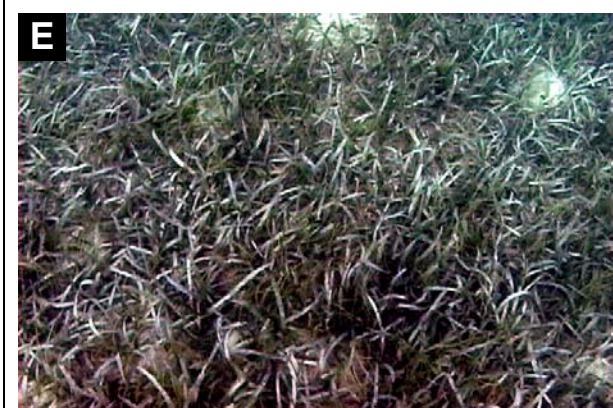
Photographs of Unk1949 sailboat (26 June 02):

Vessel Information: Unknown 1949 is a 50 ft ferro-cement sailboat that sunk at its mooring. The hull is mostly intact, and two masts, several booms, rigging, wiring, and other debris are present. It is completely submerged in ~ 8 ft of water. An estimate of \$7,000 has been quoted for removal.

Environmental Characterization: A large area under and around the vessel is devoid of seagrass and signs of active scour are apparent. Several blowout areas were observed around the port side near the bow and stern. Small eroding scarps were observed at the edge of the seagrass beds along the entire port and stern sides. Dense turtle grass and large infauna burrow mounds surround the vessel scour, and dense coverage of a mixture of turtle and manatee grass occur off of the stern. Sparser coverage occurs adjacent to sand blowout area between 6-10 ft off of the port side. Approximately 90 feet beyond the starboard side of vessel is a 10-12 ft deep unvegetated channel. Some fire coral and soft coral are growing on the vessel. The substrate is coarse-grained sand of calcareous origin with some shell material. Debris remains within the vessel, and two masts extend well beyond the hull into seagrass habitat.

- A. View of vessel as navigation hazard.
- B. Scour in seagrass habitat.
- C. Wheelhouse and debris.
- D. Vessel as artificial reef habitat.
- E. Seagrass habitat.

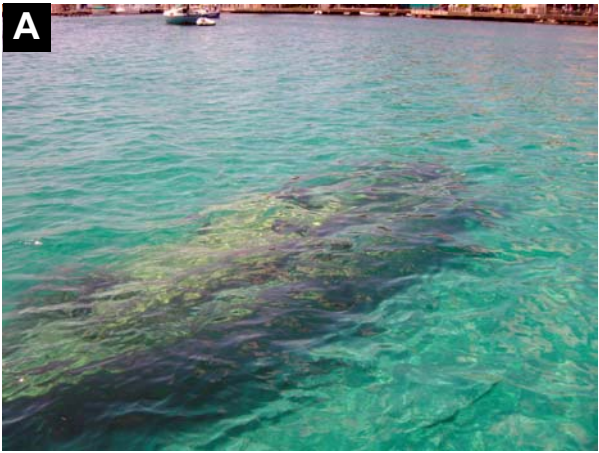
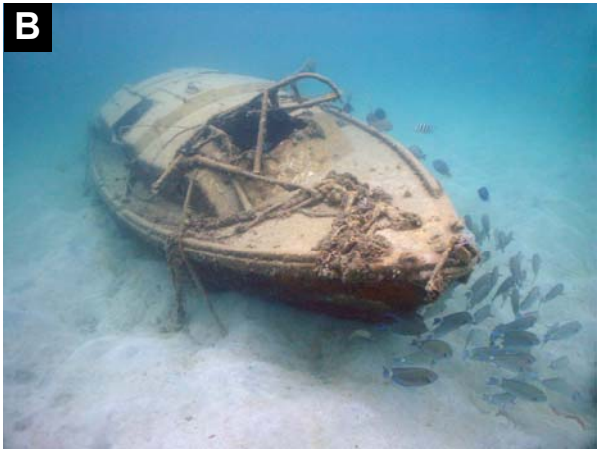
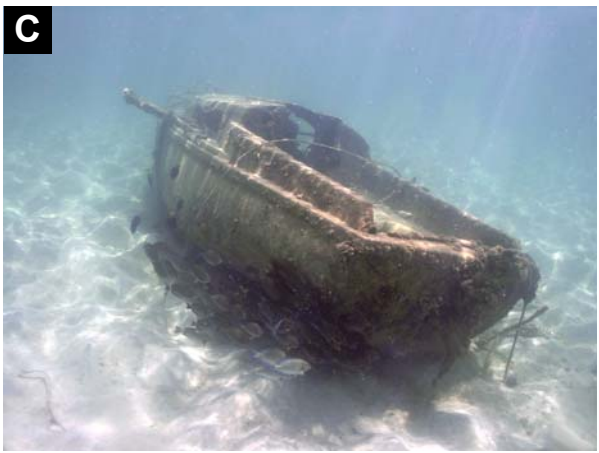
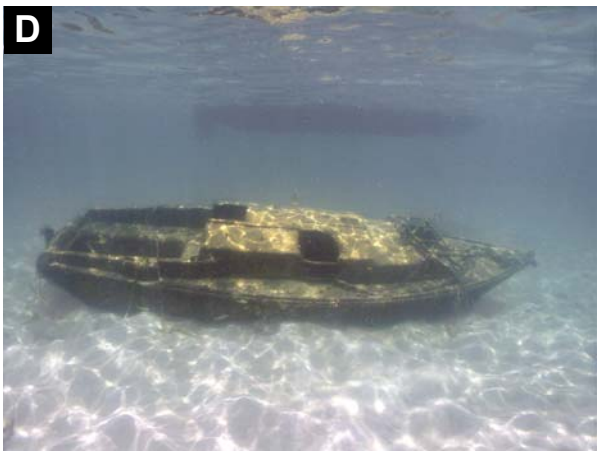
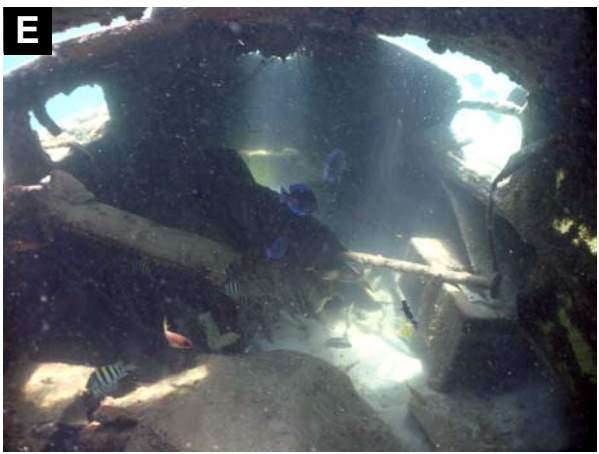
Photographs of Unk2435, sailboat (26 June 02):

Vessel Information: Unknown 2435 is a 25-28 ft fiberglass sailboat. This vessel sank at its mooring during Hurricane Hugo in 1989. The vessel hull is fairly intact, but there are no masts and it is beginning to deteriorate. No information is known about the previous owners.

Environmental Characterization: The vessel is grounded on unconsolidated sediment (sand bottom) in a harbor. If the vessel moved during a large storm or hurricane, it is possible that nearby benthic habitats, most likely seagrass or macroalgae, could be impacted.

- A. Aerial view of vessel.
- B. View of vessel from bow.
- C. View of vessel from stern.
- D. Sand bottom habitat.
- E. Vessel interior.

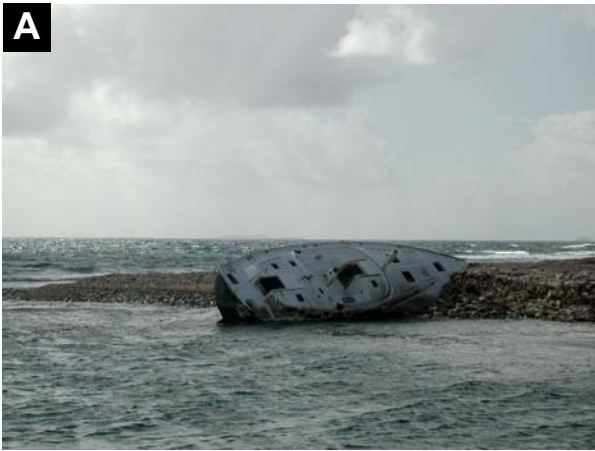
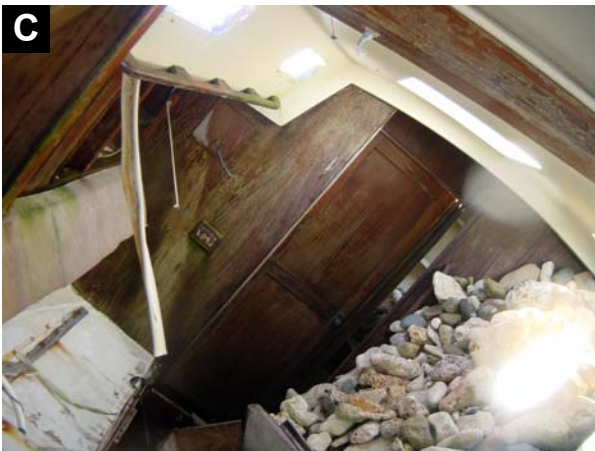
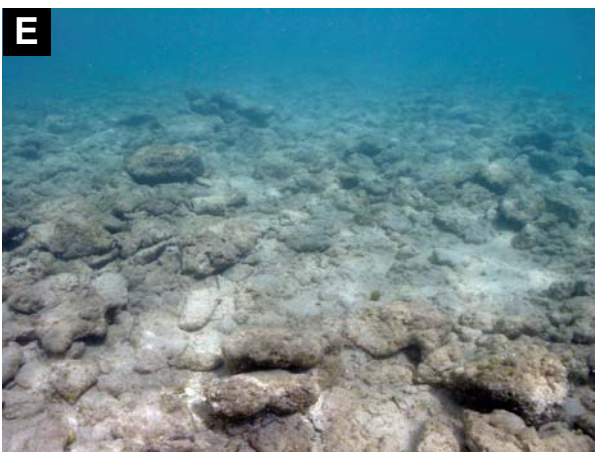
Photographs of *Munro* (27 June 02):

Vessel Information: The *Munro* is a 46 ft fiberglass sailboat aground and ashore. The vessel's mooring broke in Honeymoon Bay on Water Island and it drifted to Saba Island in 2000. The hull is intact, but is approximately one-quarter filled with rubble and there is no mast. No information is known about the owners.

Environmental Characterization: The stern is grounded on hardbottom habitat and coral rubble with calcareous sand, and the bow is ashore on a mixed sand gravel beach with some cobble to boulder-sized sediments. Sparse macroalgae occurs on the substrate, and very little live coral was observed. The vessel is located in a high-energy environment, and its presence onshore is causing a high gravel berm (3-6 ft) to form on the starboard side, and erosion to occur on the port side. Damage to benthic habitats is not evident, but is possible if the vessel was to move during a storm event.

- A. Gravel beach habitat.
- B. View of vessel and beach from port side.
- C. Cabin interior.
- D. View of stern.
- E. Hardbottom habitat.

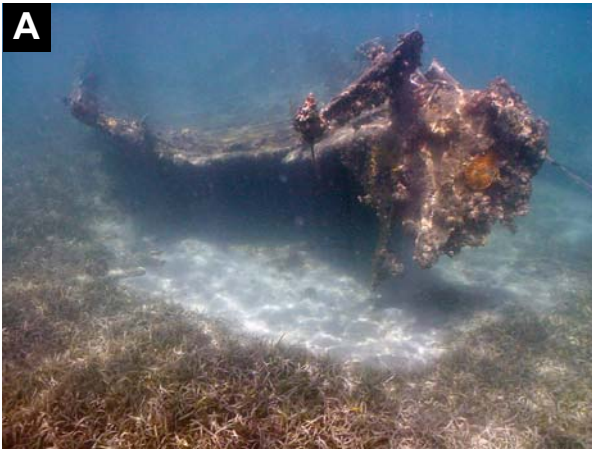
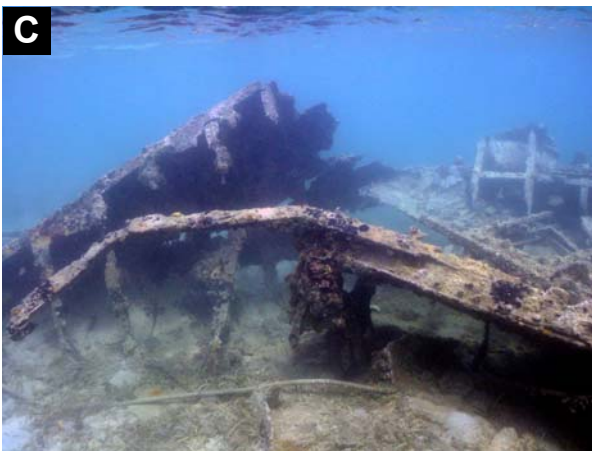
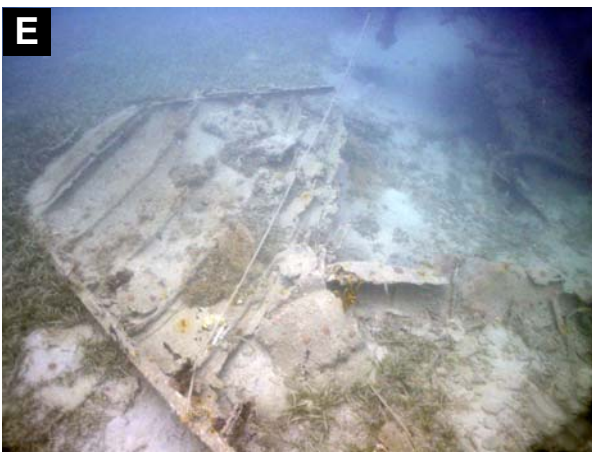
Photographs of Unk2443, sailboat (27 June 02):

Vessel Information: Unknown 2443 is a 66 ft, steel-framed sailboat with wood planking. The vessel caught fire and burned at its mooring sometime between 1983-1985. The steel hull remains, but the vessel is mostly burned. No information is known about the owners.

Environmental Characterization: A large area under and around the vessel is devoid of seagrass, and signs of active scour are present. The scour area is wider around the bow and on the starboard side. Dense turtle grass occurs surrounding the vessel scour on all sides. Approximately 30 feet to the port side of the bow is an area of sand and gravel bottom with some soft coral. The vessel could cause additional seagrass damage, and/or possibly soft coral damage, if it moved during major storms or hurricanes.

- A. Scour area in seagrass habitat.
- B. Vessel on seagrass.
- C. Burned hull.
- D. Live coral growing on hull.
- E. Overview of hull.

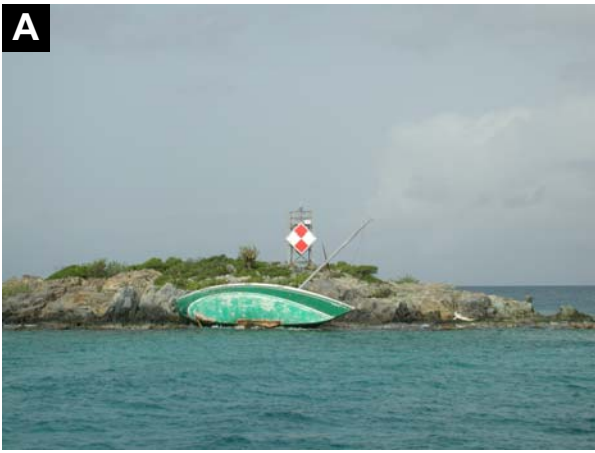
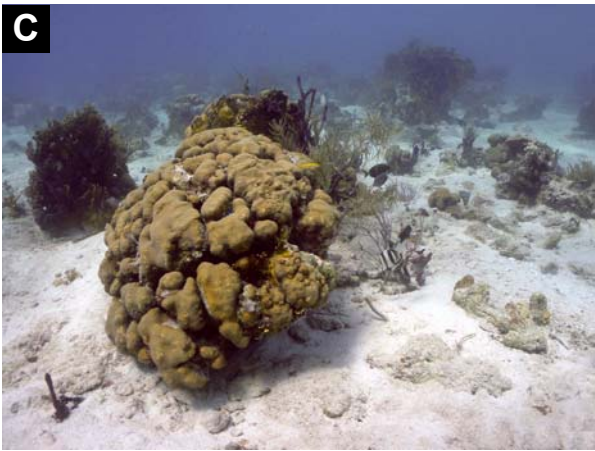
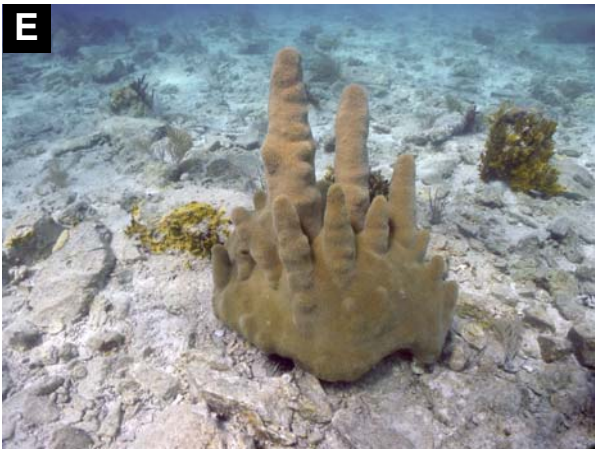
Vessel Information: The *Serendipity* is a 46 ft fiberglass sailboat, aground since 2001. The vessel lost its anchorage during a storm and was grounded on Current Hole Rock. The vessel is mostly intact, except the keel is broken. No information is known about the owners.

Environmental Characterization: The vessel is aground on a rock platform. The adjacent benthic habitat is hardbottom and coral reef. From the shoreline to approximately 65 feet offshore, the habitat is fire coral, some hard coral (brain coral, elkhorn), and soft coral on bedrock and large boulders. *Diadema* are abundant. Further offshore are higher density patch reefs on coarse-grained sand and coral rubble with abundant soft corals, sponges, massive corals, fire coral, *Diadema*, and small colonies of staghorn and pillar coral. Damage to live coral, invertebrates, coral reef, and hardbottom habitat is likely if the vessel moved during a large storm or hurricane.

Photographs of *Serendipity* (28 June 02):
 A. View of vessel from starboard side.
 B. View of deck.
 C. Reef habitat.
 D. Staghorn coral.
 E. Pillar coral.

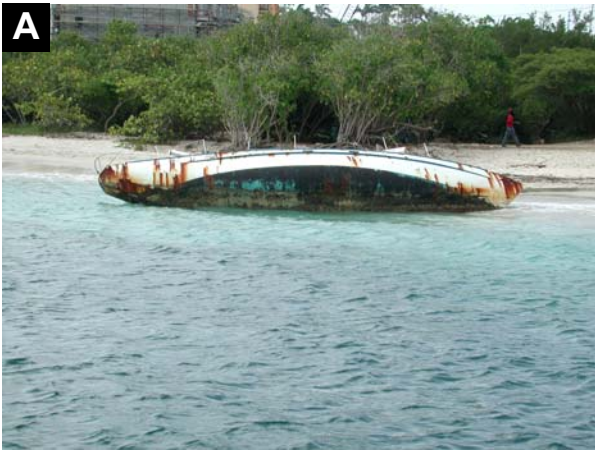
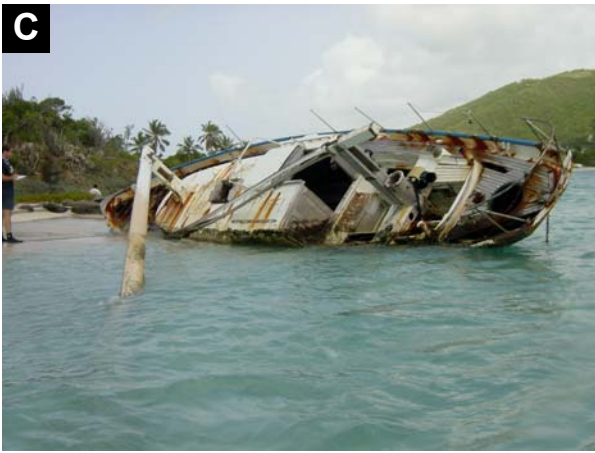
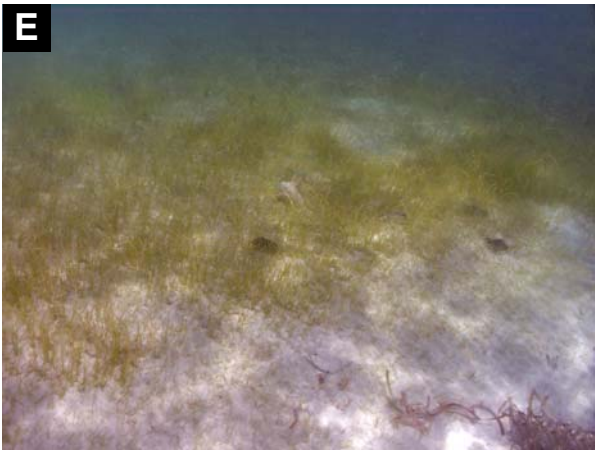
Photographs of ORCA (28 June 02):

Vessel Information: The *Orca* is a 41 ft steel sailboat aground and ashore since 1995. The vessel was likely grounded during Hurricane Marilyn. The vessel is rusting and the mast is broken, but the hull is mostly intact. No information is known about the owners.

Environmental Characterization: The vessel is aground in the intertidal zone on seagrass and sand. Approximately 15 ft from the starboard side of the vessel is a 30 cm seagrass scarp, and a roughly 15 ft wide manatee grass bed of moderate coverage extends along the starboard and stern sides of the vessel. Offshore from the manatee grass bed is dense coverage of mixed turtle and manatee grass and macroalgae. There is an unvegetated intertidal and subtidal sandy zone surrounding the vessel. The vessel could cause seagrass damage if it moved during major storms or hurricanes.

- A. View of vessel from starboard side.
- B. Sand beach habitat.
- C. Vessel deck.
- D. Sandy intertidal zone.
- E. Seagrass habitat.

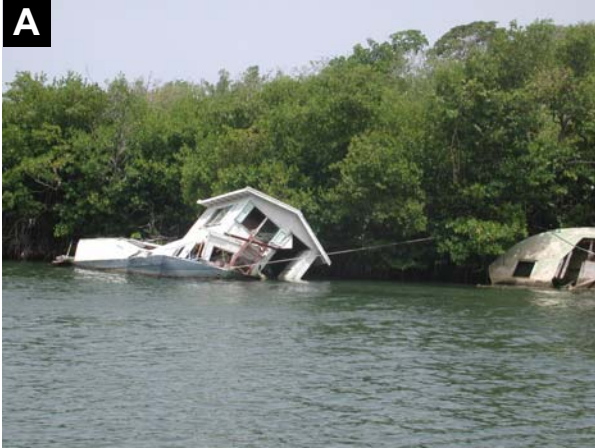
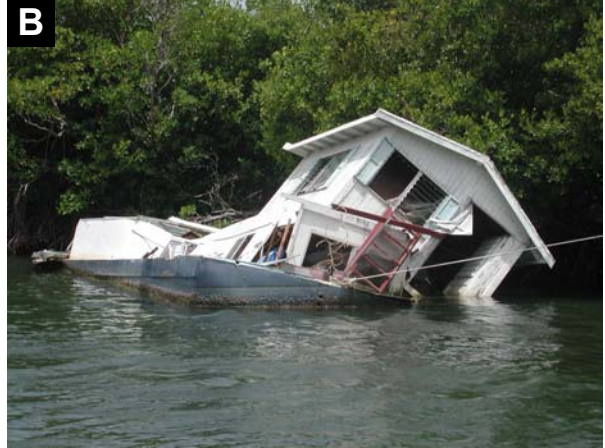
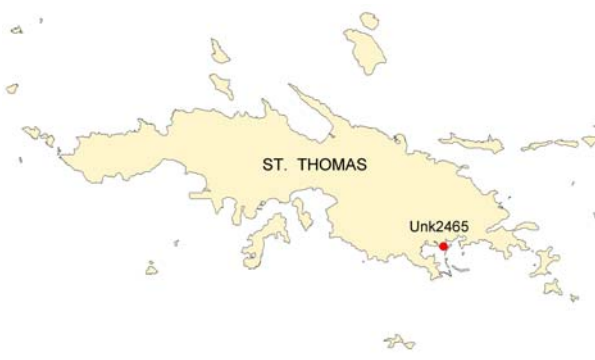
Photographs Unk2465, houseboat in Benner Bay (26 June 02):

- A. View of two houseboats tied to mangroves.
- B. View of dilapidated vessel.

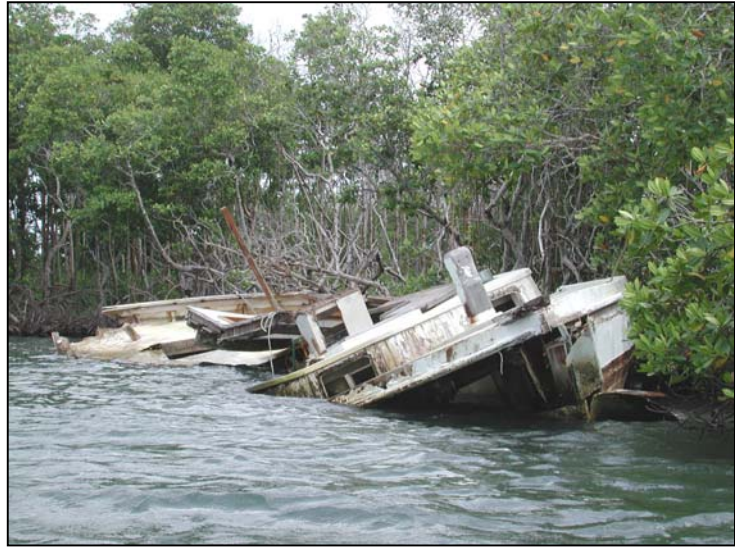
- a) **General status of vessel:** Partially submerged.
- b) **Nature of casualty (preliminary cause if known):** Grounded during Hurricane Georges.
- c) **What were the circumstances of the grounding or abandonment?** Abandoned after the hurricane.
- d) **Date of grounding/length of time the vessel has been "abandoned":** September 1998.
- e) **General description of vessel damage:** Only the fiberglass hull remains; most of cabin is gone. What appears to be the wooden deck cover is floating on the seaward side of the vessel, partially trapped under the hull.
- f) **Vessel Cargo:** None.

- a) **Dimensions of vessel grounding footprint:** Un-vegetated benthic area and vessel intrusion into edge of mangrove forest covers roughly 50 ft x 30 ft in maximum length and width. These dimensions do not include possible mangrove damage in nearby area.

- e) **Substrate:** Sand mixed with some finer material.
- f) **Damage Observations:** Roughly 15 ft-wide area of un-vegetated substrate occurs on starboard side of vessel where seagrasses were likely present. Two smaller un-vegetated areas near the

vessel, roughly 5 ft in diameter each, may be seagrass blowout areas. Substantial physical mangrove damage observed, along port side of vessel, as well as in larger area roughly 20-30+ ft in diameter, occurring several feet off the stern of the vessel and extending inside the forest interior (dead trees, open canopy, and understory mangrove regeneration observed). Mangrove damage may have been caused by this vessel, at least in part, although unrelated hurricane damage also a possibility. Vessel could cause additional mangrove and seagrass injury if it moved or broke up during a major a storm or hurricane.

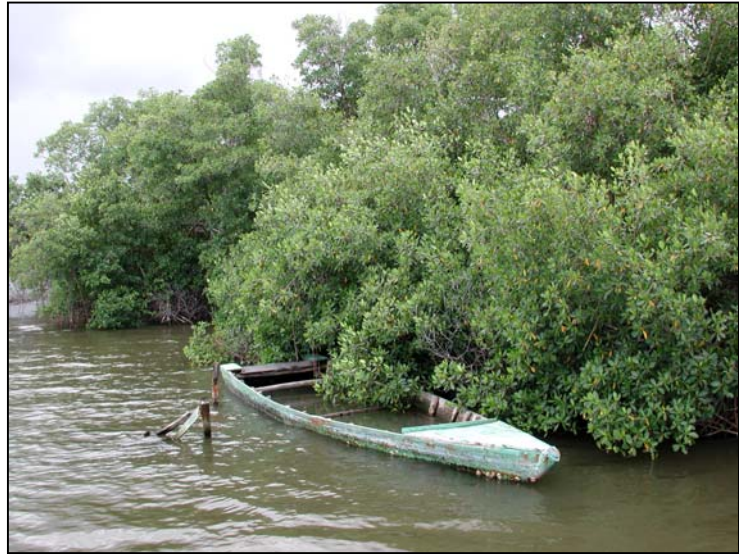
Vessel is on un-vegetated mud bottom at edge of mangrove forest. Area is designated critical habitat for the federally endangered yellow-shouldered blackbird, which uses mangroves and coastal fringe habitats. See Code of Federal Regulations, Title 50, Chapter I, Part 17.95, 1 October 2001, <http://www.access.gpo.gov/>. Mangroves are the primary nesting habitat for this species. Mangroves could be damaged if the vessel moved during a major storm or hurricane, although the damage would likely be minor.

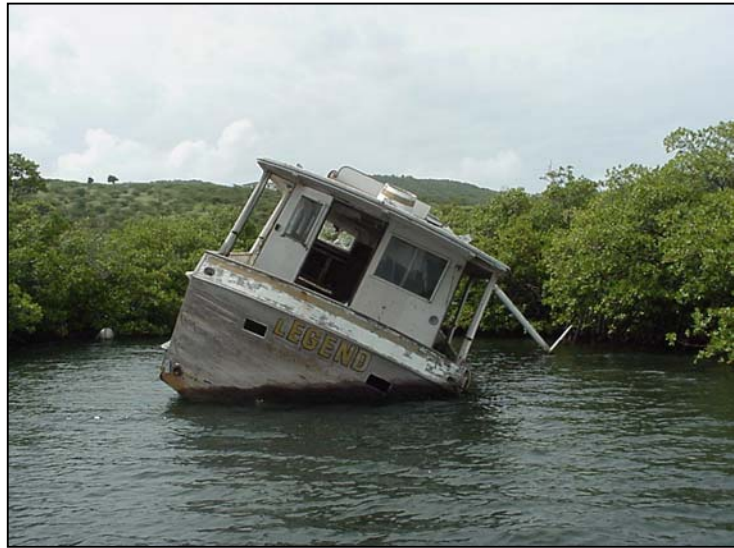
- a) **General status of vessel:** Aground and tilted to starboard by about 30 degrees.
- b) **Nature of casualty:** Sank at its mooring.
- c) **What were the circumstances of the grounding or abandonment?** Due to negligence by the owner, who lives out of the country, the vessel sank at its mooring, several times.
- d) **Date of grounding/length of time the vessel has been "abandoned":** Last sinking was in 1998.
- e) **General description of vessel damage:** The wood is starting to deteriorate. The hull is flooded. The vessel is grounded at a steep (30 degrees) angle on starboard side.
- f) **Vessel Cargo:** None.

- a) **Public uses in the area:** Recreational boating area.
- b) **Evidence of people boarding the vessel?** Some (trash).
- c) **Entrapment or slip/fall hazards?** Yes, there are open hatches and rotting wood.

- a) **Dimensions of vessel grounding footprint:** Not measured.
- b) **Dimensions of debris field:** Not examined.
- c) **Primary Habitat(s):** Mangrove. Vessel bow against red mangroves at head of small bay.
- d) **Secondary Habitat(s):** N/A.
- e) **Substrate:** Mud.
- f) **Damage Observations:** None directly observed. Vessel could cause mangrove damage if it moved during future hurricanes.

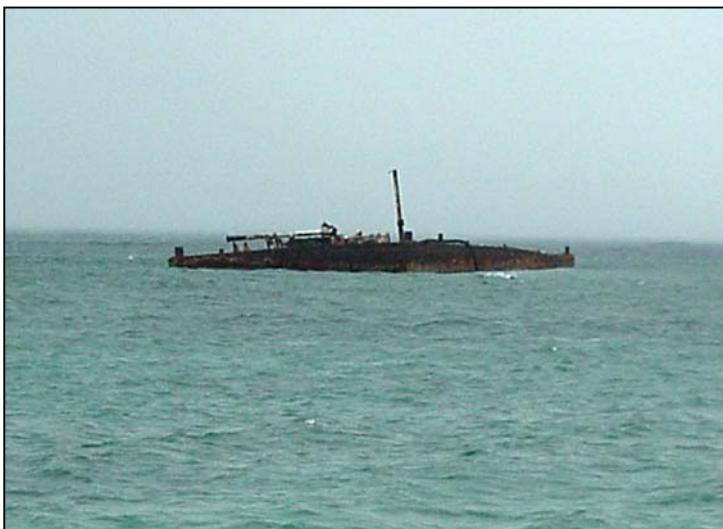
- a) **General status of vessel:** Aground.
- b) **Nature of casualty (preliminary cause if known):** Unknown.
- c) **What were the circumstances of the grounding or abandonment?** Unknown.
- d) **Date of grounding/length of time the vessel has been "abandoned":** Unknown. First mention in history section of USCG database in 1976.
- e) **General description of vessel damage:** Deck plates are starting to break up; many holes in sides and open to the sea.
- f) **Vessel Cargo:** None at this time; was used for liquid petroleum.

- a) **Public uses in the area:** Heavy use of water area for swimming, diving, snorkeling, jet skis.
- b) **Evidence of people boarding the vessel?** During the survey on Sunday, several groups of swimmers boarded the vessel. It is a destination point for swimmers.
- c) **Entrapment or slip/fall hazards?** Yes, the deck surface is rusting; some areas are already broken through. Expect continued degradation that will pose greater future public hazard.

- e) **Substrate:** Sand with some finer materials and pebble-sized coral rubble.
- f) **Damage Observations:** Large area around vessel devoid of seagrass (bare sand). Active scour observed. No eroding scarp observed at edge of bare area. In most places only sparse seagrass coverage occurs around the bare area. Seagrasses will not likely colonize the bare and sparse areas around the vessel with any permanence due to continuing scour. Additional seagrass damage could occur during major storms or hurricanes.

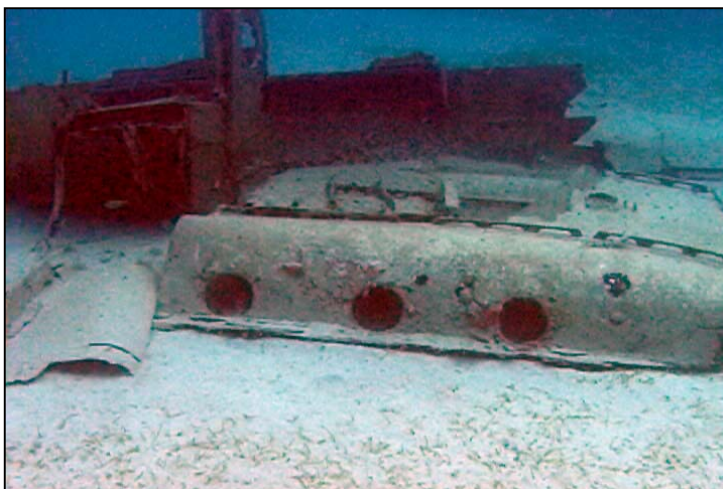
- a) **General status of vessel:** Completely submerged.
- b) **Nature of casualty:** Intentional sinking as a diving site/artificial reef.
- c) **What were the circumstances of the grounding or abandonment?** Intentional sinking.
- d) **Date of grounding/length of time the vessel has been "abandoned":** April 2001.
- e) **General description of vessel damage:** Vessel has broken into main pieces and several smaller pieces. The sides of the main stern section are collapsing.
- f) **Vessel Cargo:** None.

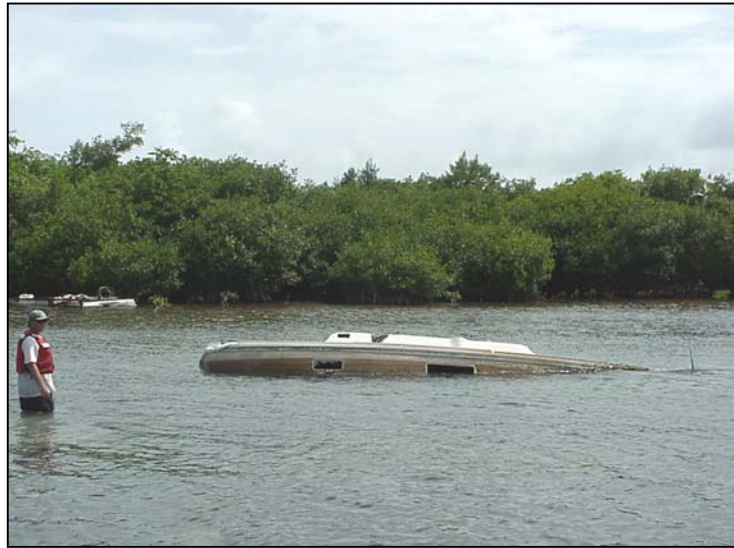
Sailboat, 35 ft x 8 ft fiberglass hull, with two (broken) masts and part of the sails present. Submerged and tilting by 15 degrees to port in 3 ft of water and 100 ft from a mangrove-fringed shoreline. Scour pit 5 ft deep and 6 ft wide all around vessel.

Vessel occurs in shallow seagrass habitat with dense turtle grass. Seagrass has been damaged by vessel and scour in an area roughly 50 ft x 20 ft in maximum length and width. Additional seagrass damage could occur from scour or if the vessel moved during a major storm or hurricane. Vessel occurs adjacent to designated critical habitat for the federally endangered yellow-shouldered blackbird, which uses mangroves and coastal fringe habitats. See Code of Federal Regulations, Title 50, Chapter I, Part 17.95, 1 October 2001, <http://www.access.gpo.gov/>. Mangroves are the primary nesting habitat for this species. Mangroves could be damaged if the vessel moved onshore during a major storm or hurricane.

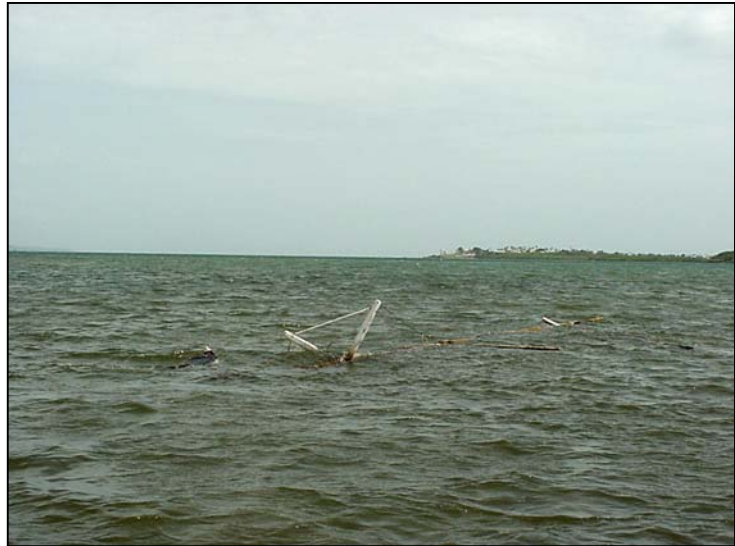
Vessel occurs in shallow seagrass habitat, dense turtle grass mixed with manatee grass. Seagrass has been damaged by vessel and scour. Scour around vessel is about 3 ft wide. Additional seagrass damage could occur from scour or if the vessel moved during a major storm or hurricane. Vessel occurs adjacent to designated critical habitat for the federally endangered yellow-shouldered blackbird, which uses mangroves and coastal fringe habitats. See Code of Federal Regulations, Title 50, Chapter I, Part 17.95, 1 October 2001, <http://www.access.gpo.gov/>. Mangroves are the primary nesting habitat for this species. Mangroves could be damaged if the vessel or parts of the vessel moved ashore during a major storm or hurricane.

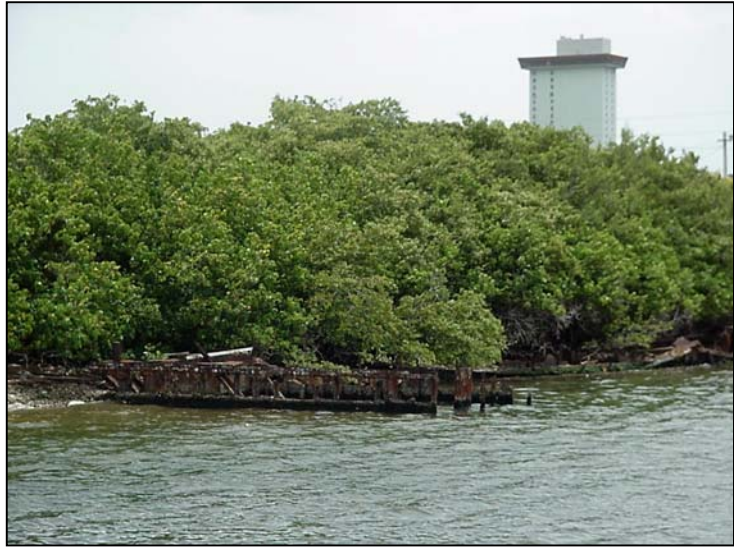
Rusted metal remnants of 3 vessels.
Unable to identify vessel types.

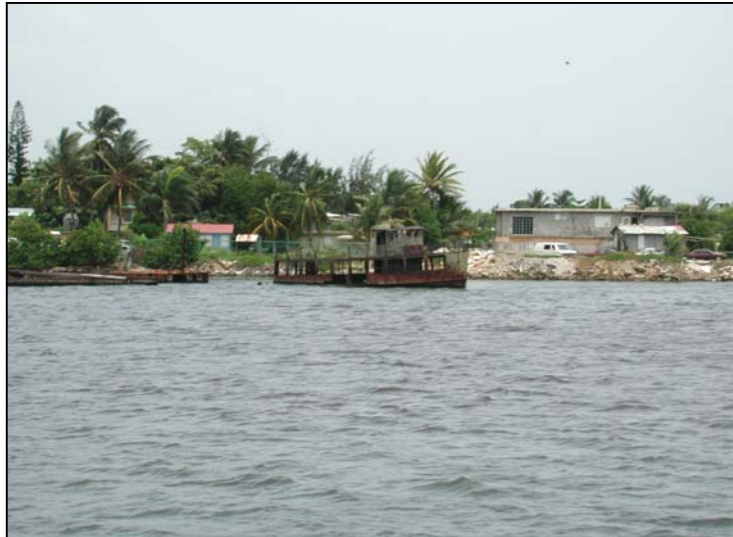
Rusted metal party boat or small
fishing vessel. Grounded and
partially submerged.

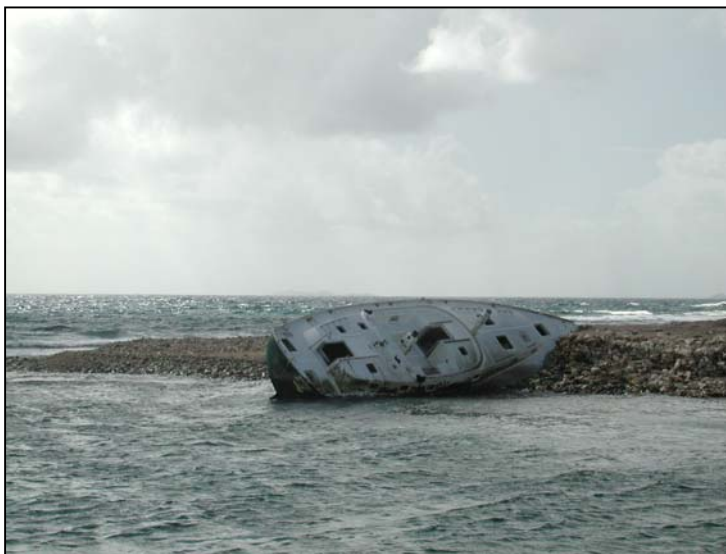
- a) **General status of vessel:** Aground and ashore.
- b) **Nature of casualty:** Mooring broke in Honeymoon Bay (Water Island) and drifted to Saba Island.
- c) **What were the circumstances of the grounding or abandonment?** Grounded after mooring broke.
- d) **Date of grounding/length of time the vessel has been "abandoned":** 2000.
- e) **General description of vessel damage:** The hull is intact, but is approximately $\frac{1}{4}$ filled with gravel.
- f) **Vessel Cargo:** None.

- a) **Dimensions of vessel grounding footprint:** Similar to principal vessel dimensions.
- b) **Dimensions of debris field:** N/A.
- c) **Primary Habitat(s):** Hardground and coral rubble. Some macroalgae occurs on substrate, but very little live coral.
- d) **Secondary Habitat(s):** The bow is grounded on a mixed sand gravel beach with some cobble to boulder sized sediments.
- e) **Substrate:** Hardground coral and rubble with some calcareous sand.
- f) **Damage Observations:** The vessel is located in a high energy environment, and its presence onshore is causing a high gravel berm (3-6 ft) to form on the starboard side, and erosion to occur on the port side. Damage to benthic habitats is not evident, but is possible if the vessel was to move during a storm event.
