Surveys of Abandoned Vessels: U.S. Caribbean Region

**SURVEYS OF ABANDONED VESSELS:
U.S. CARIBBEAN REGION**

Jacqueline Michel, Scott Zengel, Christine Lord, and Zach Nixon
Research Planning, Inc.
Columbia, South Carolina 29202

September 2002

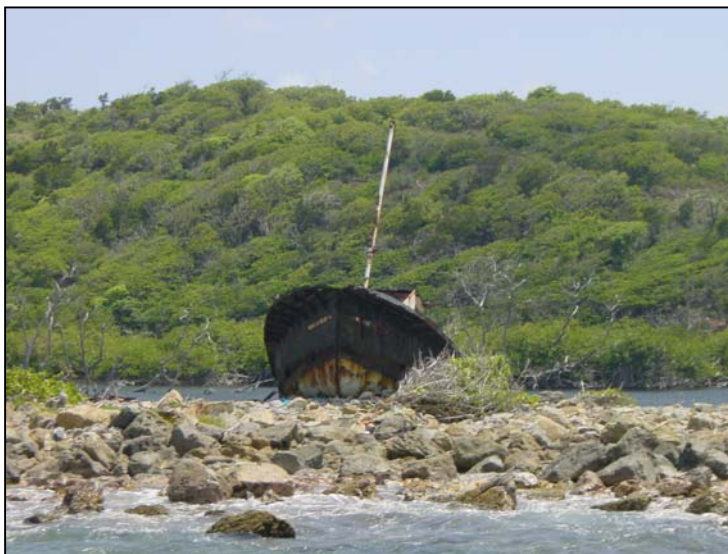
- a) **General status of vessel:** Ashore.
- b) **Nature of casualty:** Hurricane Hugo.
- c) **What were the circumstances of the grounding or abandonment?** Vessel moved across harbor entrance during hurricane.
- d) **Date of grounding/length of time the vessel has been "abandoned":** 1989.
- e) **General description of vessel damage:** Were unable to get close, seems fairly intact.
- f) **Vessel Cargo:** Unknown.

- a) Dimensions of vessel grounding footprint: Unknown, the vessel was inaccessible, but likely to be similar dimensions as the vessel.
- b) Dimensions of debris field: N/A.
- c) Primary Habitat(s): Gravel beach. The bow is located on the backshore of a gravel berm.
- d) Secondary Habitat(s): The stern is located in a salt pond, and the landward side of the pond is mangrove habitat.
- e) Substrate: Gravel beach with boulder sized sediment.
- f) Damage Observations: Damage to the habitat is unknown because of inaccessibility. It is possible that the beach, salt pond, or mangroves could be damaged if the vessel moved during a major storm or hurricane.

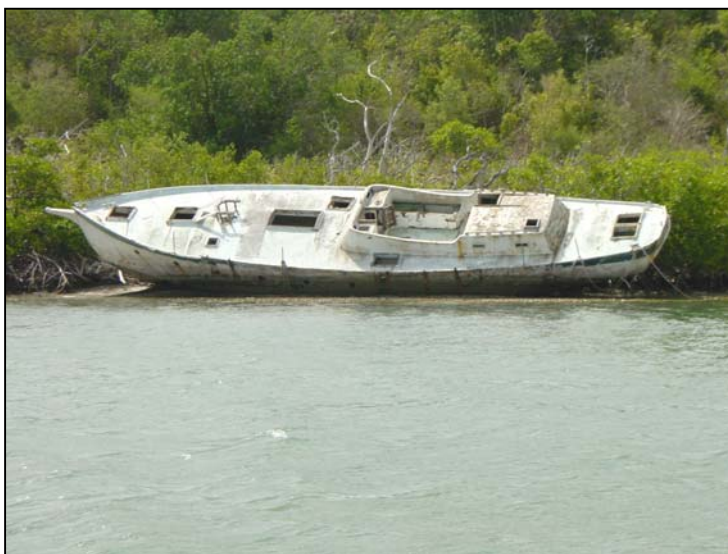
- a) **General status of vessel:** Ashore.
- b) **Nature of casualty:** Unknown.
- c) **What were the circumstances of grounding or abandonment?** Hurricane Georges.
- d) **Date of grounding/length of time the vessel has been "abandoned":** 9/21/98.
- e) **General description of vessel damage:** Large hole on starboard side below water line, several smaller holes, keel buried.
- f) **Vessel Cargo:** None.

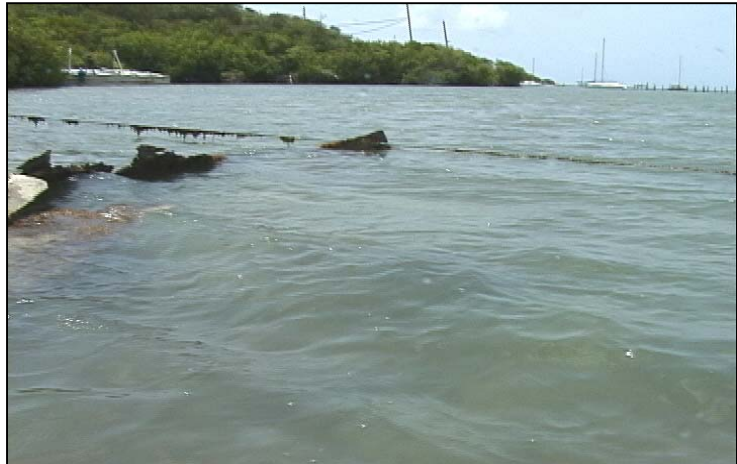
Badly deteriorated wooden vessel, 36 ft x 6 ft.

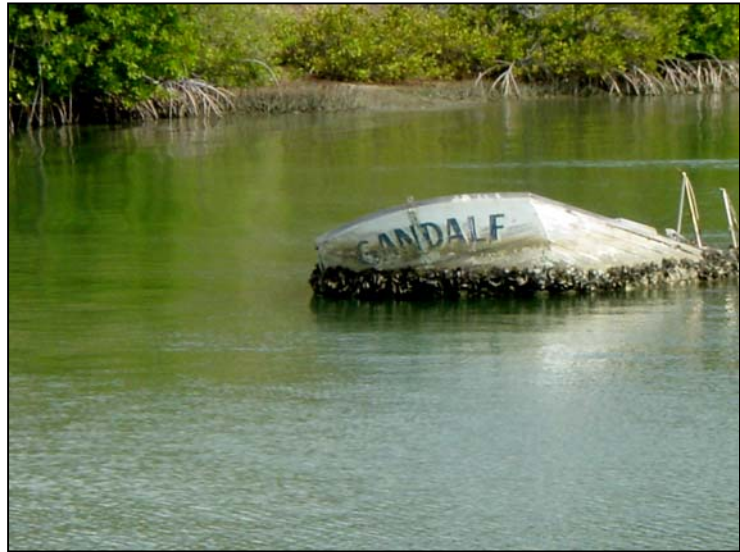
The vessel is grounded in a sheltered bay on the east side of Salt River.

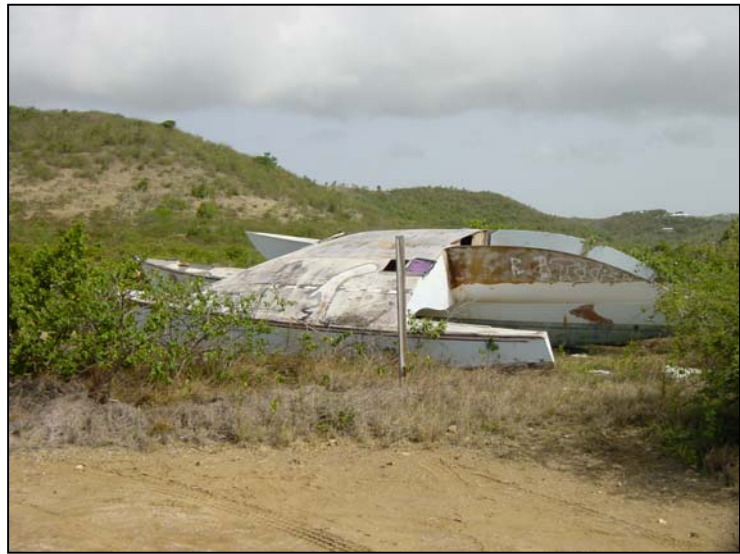
The vessel is ashore in upland habitat.

Slip/fall hazard.

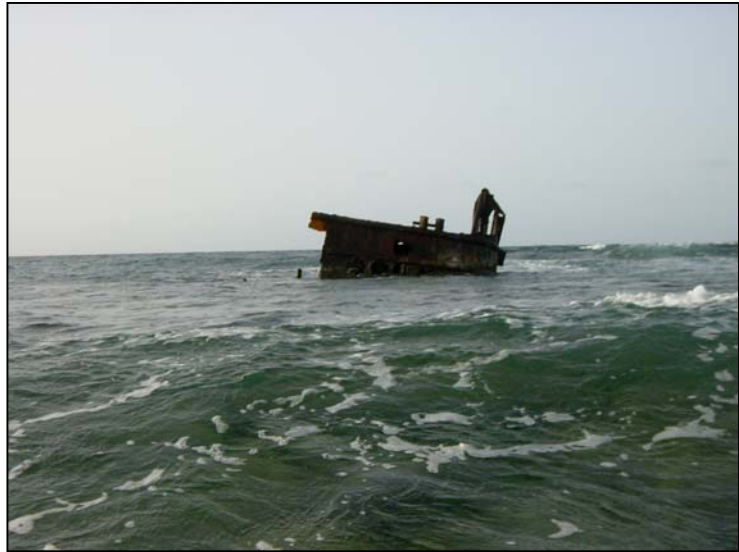
The vessel is aground near the Salt
River Lagoon entrance and
Whitehorse Reef ~ 100 m offshore.

Slip/fall hazard and rusty debris.

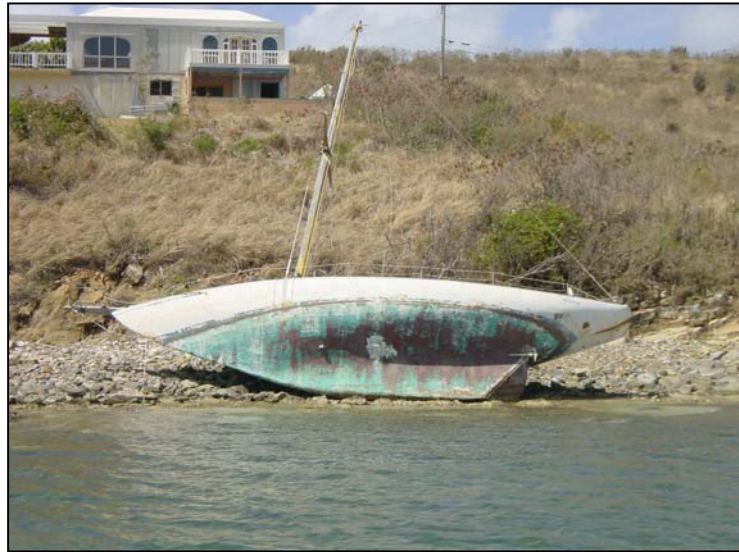
Slip/fall hazard.

The vessel occurs on a gravel beach adjacent to a sheltered rocky shore. Seagrass occurs in intertidal and subtidal areas adjacent to shore, and damage to this habitat could occur if the vessel moved during a major storm or hurricane.

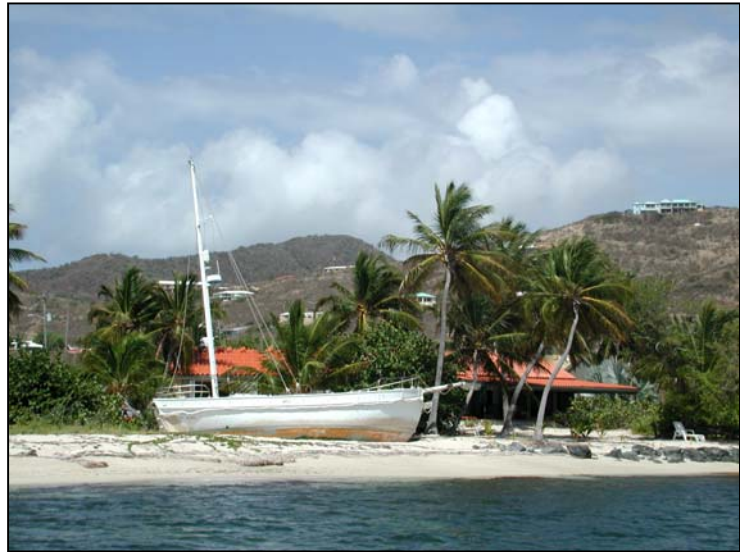
Fiberglass sailboat, sitting upright, fairly good condition, still has electrical equipment onboard.

The vessel is ashore on a sand beach. Seagrass occurs in adjacent subtidal areas. Damage to this habitat could occur if the vessel moved during a major storm or hurricane.

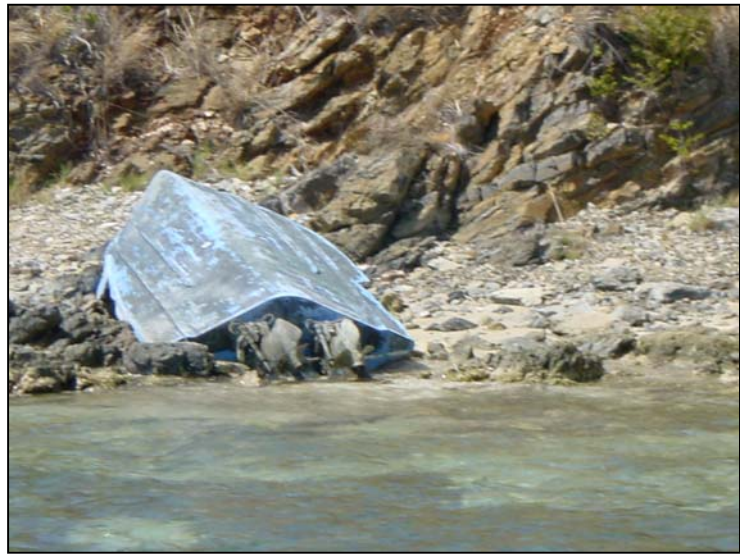
The vessel occurs on a gravel beach adjacent to a sheltered rocky shore. Seagrass occurs in intertidal and subtidal areas adjacent to shore, and damage to this habitat could occur if the vessel moved during a major storm or hurricane.

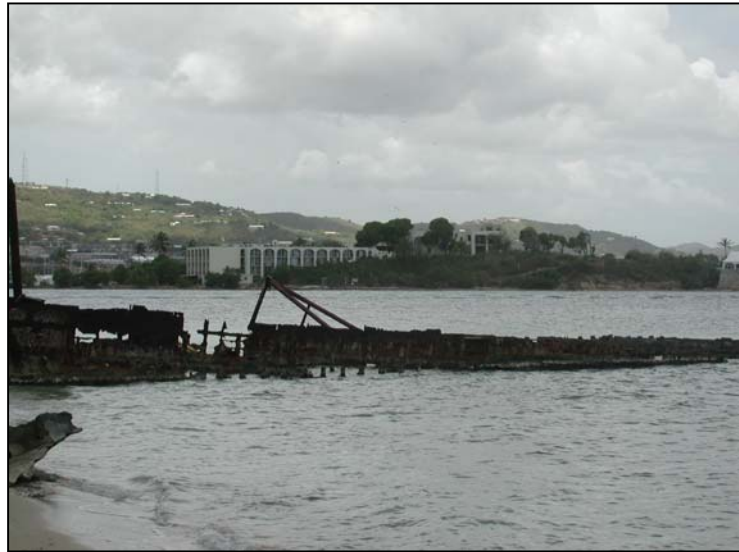
Slip/fall hazard, and a lot of rusty edges and debris onshore.

The bow of the vessel occurs on a mixed sand and gravel beach. The stern occurs on unconsolidated sediment with sparse seagrass and *Halimeda*. The vessel is currently serving as a breakwater to the adjacent marina. Pilings and pipes occur off of the starboard side. Seagrass and macroalgae has likely been damaged underneath and around the vessel. Additional damage could occur if the vessel moved during a major storm or hurricane.

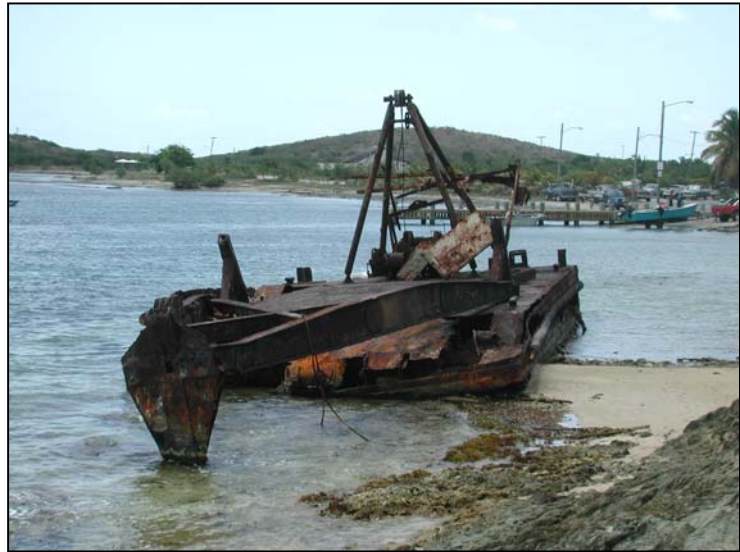
Slip/fall hazard and rusty parts.

The vessel occurs partially on a mixed sand and gravel beach and partially on unconsolidated sediment with sparse seagrass. The vessel may be interfering with circulation in and out of Altona Lagoon. Seagrass has likely been damaged underneath and around the vessel. Additional damage could occur if the vessel moved during a major storm or hurricane.

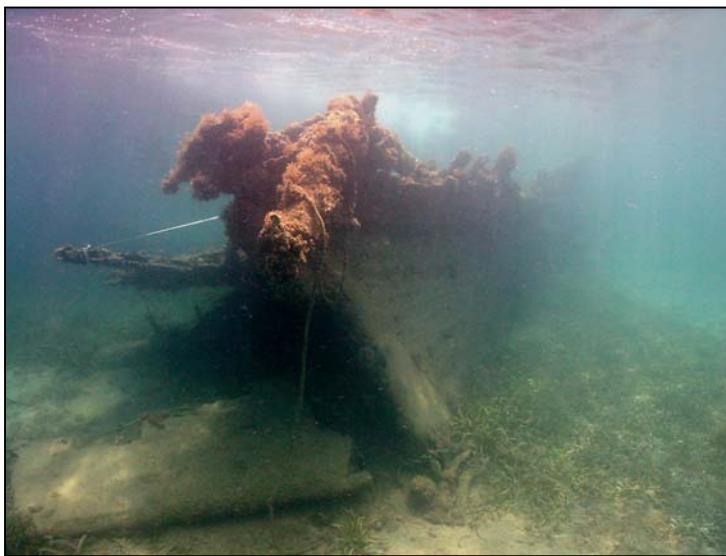
- a) **General status of vessel:** Submerged.
- b) **Nature of casualty:** Possibly Hurricane Marilyn.
- c) **What were the circumstances of the grounding or abandonment?** Unknown.
- d) **Date of grounding/length of time the vessel has been "abandoned":** Possibly 1995.
- e) **General description of vessel damage:** A lot of growth on vessel, hull fairly intact, but deteriorating in some places.
- f) **Vessel Cargo:** None.

- a) **Dimensions of vessel grounding footprint:** The area under and around the vessel devoid of seagrass was roughly 43 ft x 15 ft.
- b) **Dimensions of debris field:** N/A.
- c) **Primary Habitat(s):** Seagrass. Dense turtle grass occurs surrounding the vessel scour on all sides excluding approximately 2/3 of the starboard side.
- d) **Secondary Habitat(s):** The habitat off of the starboard side is mostly hardbottom with sand and boulders and some live coral on larger boulders.
- e) **Substrate:** Coarse-grained sand.
- f) **Damage Observations:** Un-vegetated area was present around entire vessel, and was larger on the port side of the bow and around the stern. Vessel could cause additional seagrass damage or damage to live coral if it moved during major storms or hurricanes.

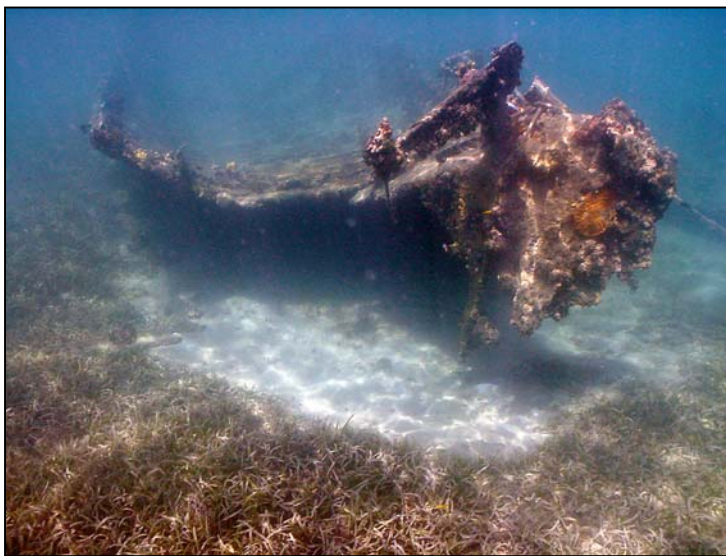
- a) **General status of vessel:** Submerged.
- b) **Nature of casualty:** Vessel caught on fire on mooring.
- c) **What were the circumstances of the grounding or abandonment?** Fire was extinguished, and vessel was not salvageable.
- d) **Date of grounding/length of time the vessel has been "abandoned":** Sometime between 1983-1985.
- e) **General description of vessel damage:** Vessel is burned, steel hull partially remaining.
- f) **Vessel Cargo:** None.

- a) **Dimensions of vessel grounding footprint:** The area under and around the vessel devoid of seagrass was roughly 72 ft x 33 ft.
- b) **Dimensions of debris field:** N/A.
- c) **Primary Habitat(s):** Seagrass. Dense turtle grass occurs surrounding the vessel scour on all sides.
- d) **Secondary Habitat(s):** Approximately 30 feet to the port side of the bow is an area of sand and gravel bottom with some soft coral.
- e) **Substrate:** Coarse-grained sand and gravel.
- f) **Damage Observations:** Un-vegetated area was present around entire vessel, but was wider around the bow and on the starboard side. Vessel could cause additional seagrass damage, or possibly soft coral damage, if it moved during major storms or hurricanes.

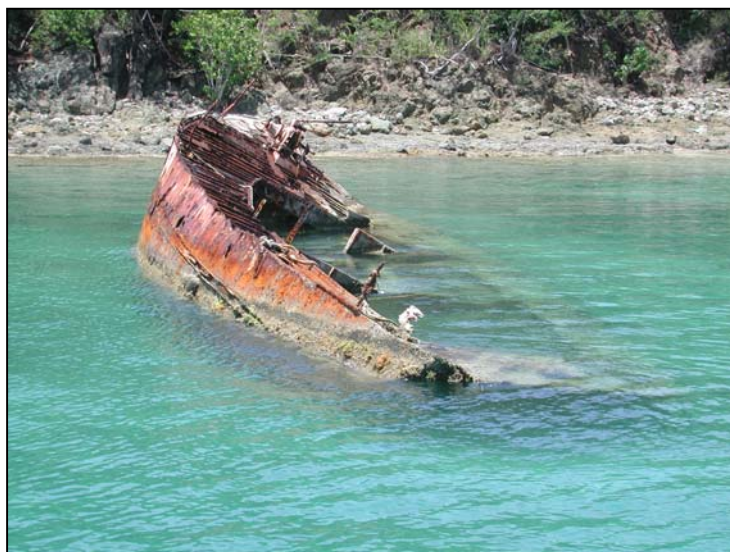
- a) **General status of vessel:** Aground.
- b) **Nature of casualty:** Went aground during a storm.
- c) **What were the circumstances of the grounding or abandonment?** Was moored in area prior to storm and was abandoned.
- d) **Date of grounding/length of time the vessel has been "abandoned":** Late 1970's.
- e) **General description of vessel damage:** Steel shell of hull remains.
- f) **Vessel Cargo:** None.

- a) **Public uses in the area:** Mooring area, recreational boating.
- b) **Evidence of people boarding the vessel?** No.
- c) **Entrapment or slip/fall hazards?** Slip/fall hazard.

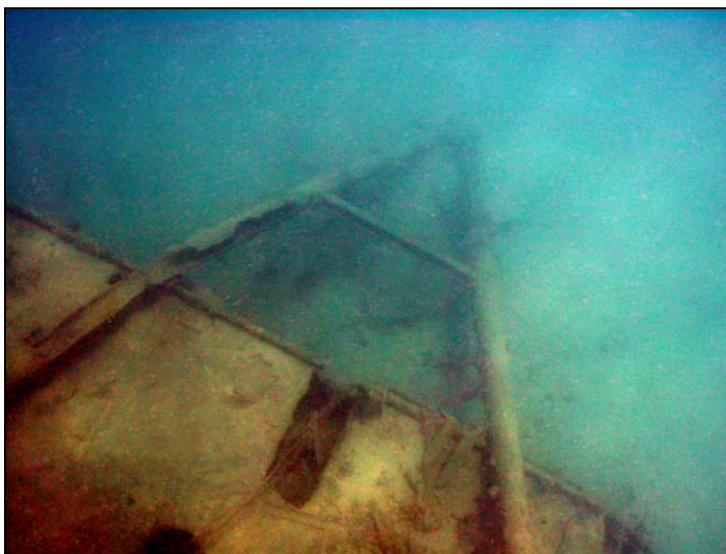
- a) **Public uses in the area:** Mooring area, recreational boating.
- b) **Evidence of people boarding the vessel?** No.
- c) **Entrapment or slip/fall hazards?** Yes, entrapment.

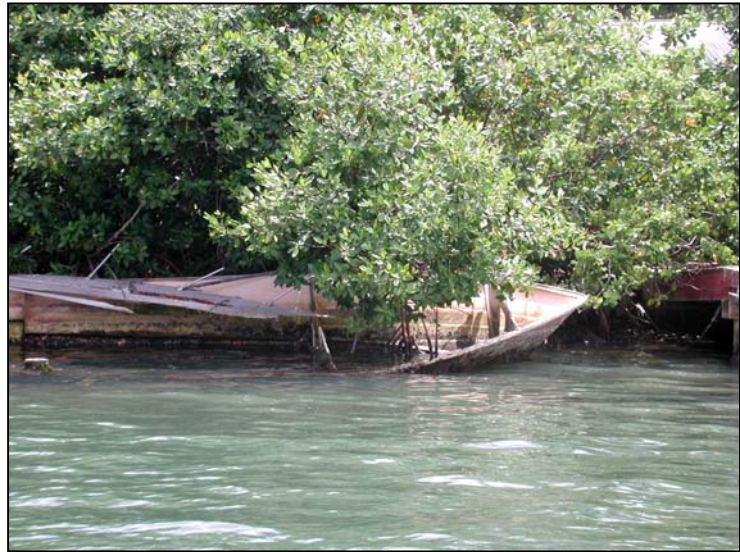
Fiberglass powerboat aground and damaged.

Vessel is in the mangroves, so damage is possible. Additional damage may occur if the vessel moved or was broken up during a major storm or hurricane.

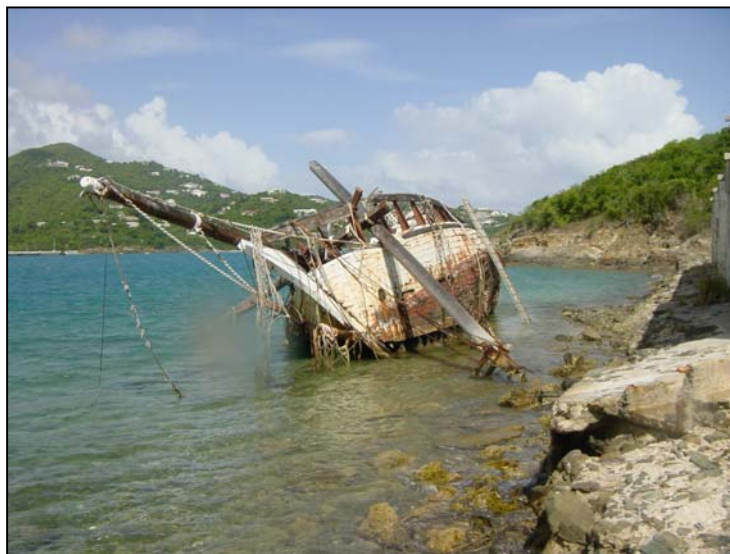
- a) **General status of vessel:** Aground
- b) **Nature of casualty:** Hurricane Marilyn.
- c) **What were the circumstances of the grounding or abandonment?** Hurricane.
- d) **Date of grounding/length of time the vessel has been "abandoned":** 1995.
- e) **General description of vessel damage:** Vessel is fairly intact, some deterioration.
- f) **Vessel Cargo:** Unknown.

- a) **Public uses in the area:** Adjacent land tenant, area used as workshop, sailboat moorings in entrance to cove.
- b) **Evidence of people boarding the vessel?** Yes, ladder on it, easily accessible.
- c) **Entrapment or slip/fall hazards?** Yes, slip/fall hazard.

- e) **Substrate:** The benthic substrate is mixed coarse-grained sand and gravel.
- f) **Damage Observations:** Seagrass density is lower adjacent to the vessel than further offshore. Additional damage to seagrass is possible if the vessel moved during a large storm or hurricane.
