NOAA ARRA USVI Watershed Stabilization Project

Coral Bay Watershed Management Project – Lower Bordeaux Drainage Improvements

Patricia Reed
Environmental Projects Manager
Coral Bay Community Council

March 31, 2012

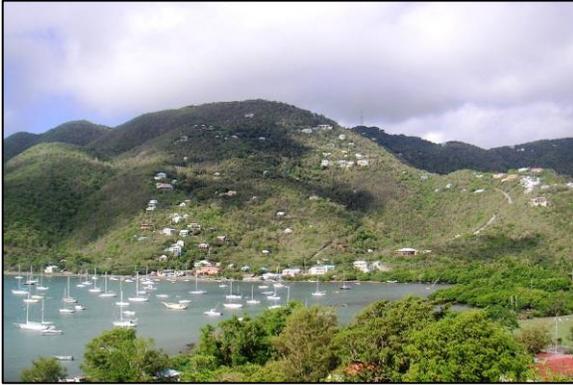
Photo 2: Lower Bordeaux Watershed.

Steep slopes with highly erodible soils characterize the Lower Bordeaux Watershed (Photo 2). This watershed includes the southeastern portion of Bordeaux Mountain bounded on the west by Picture Point and the north by Route 108 (Bordeaux Mountain Road), Coral Harbor to the east, and the ridgeline south of Little Plantation Ghut to the south. The lower portion of the watershed is characterized by a flat area called Spring Garden that includes numerous intermittent springs and the ghut outflow locally known as Voyages Ghut. Roughly 18 residences, 3

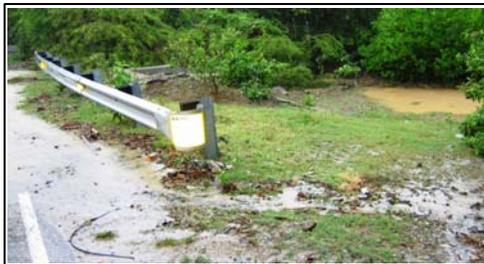
Photo 6: Stormwater runoff.

being sent down the paved road clogging the new devices (Photos 4-5), and entering into the mangroves fringing Coral Bay (Photo 6). In this circumstance, because mangroves filter much of this sediment before it enters the bay, the quantity of sediment filtered out will eventually take a toll on the health of this habitat. Additionally, the volume of runoff laden with rock debris and sediment often caused the roadside and culvert grates to become blocked; thereby, leaving rocks and debris on the road surface, causing road damage and unsafe driving conditions (Photo 7). The area downstream discharges directly into the mangroves and was designed as an energy dissipater and sediment area; however, it has fallen into a state of disrepair. The originally installed culvert outlet baffle box was not designed properly for cleanout because it had a concrete bar blocking machine “bucket” access.

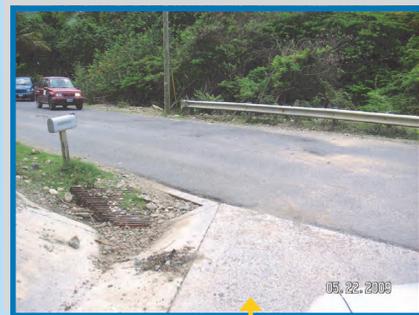
BEFORE

The intersection of Rt. 107 & Rt. 108 has numerous issues that contribute to the contamination of water entering the bay. On Rt. 108 uphill, there were a number of blocked inlets and swales from crumbling roadside cliffs and sediment from steep dirt roads at higher elevations. This led to debris-laden stormwater flowing down the newly paved roads, which clogged the pipe culvert under Rt. 107 with sediment and created roadway flooding. Cleaning the blocked culvert and inlet boxes, and redesigning the inlet & outlet boxes will allow cleaner water to filter through the mangroves. Regular clean out of the recessed outlet box from the culvert will remove accumulated sediment.

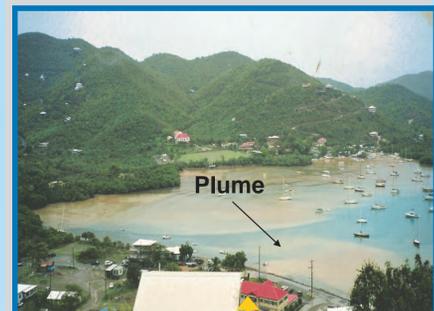
BEFORE

During development and Rt. 108 paving, runoff from two ghuts was redirected into a single ghut of the Lower Bordeaux watershed. This concentration of flow caused too much water flowing too quickly for that ghut. Significant erosion occurred, especially during large storms and sent large amounts of sediment into Coral Bay Harbor. Public works returned some excess water flow back into Little Plantation Ghut during their 2011 paving project on Rt. 108. We installed a trench drain across Rt. 108 to return the rest of the excess water into a different branch of the Lower Bordeaux watershed. Reducing the quantity of runoff that flows through the watershed reduced the velocity, which decreased the amount of erosion (see also Spring Garden Project). The result is less sediment and muddy water flowing into Coral Bay.

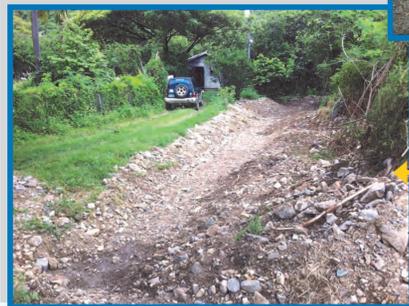
BEFORE

Several ghuts high on lower Bordeaux Mountain join into one flow before entering the ocean. The force of this flow generates significant erosion of ghut banks which results in sedimentation (see also Route 108 Trench Drain Project). When the ghut enters the flats in Spring Garden, sediment deposits have historically allowed the ghut to overflow its banks and run down a dirt road. The adjacent dirt road has also been a water channel. We cleaned the ghut and installed a berm, swale, waterbar, and used Geoweb™ road stabilization. Coupled with the reduced flows from the upper watershed, these features should reduce sedimentation potential of the waters flowing here.

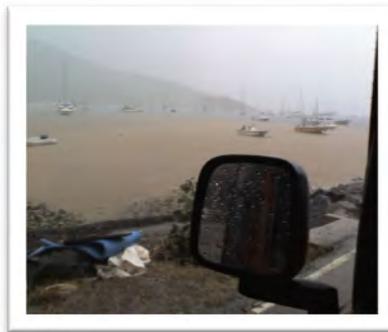
This plume is generated by three pipe culverts crossing under Rt. 107. The first culvert is located under the open area that serves as a parking lot for an apartment building and Island Blues. The second is located where the ghut adjacent to the Voyages building is piped under Rt. 107. The last is on the southeast side of Cocolobo where an existing road directs flows from a roadside channel into a pipe culvert under Rt. 107.

Combined Plume from all three pipes

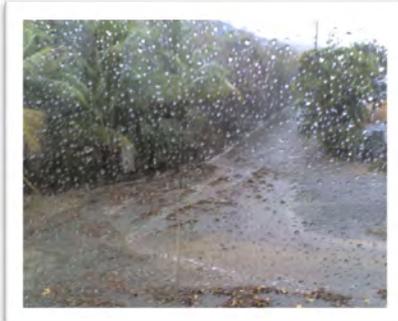
Road adjacent to Cocolobo

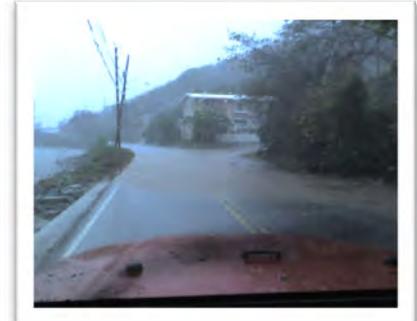
Runoff bypassing third pipe

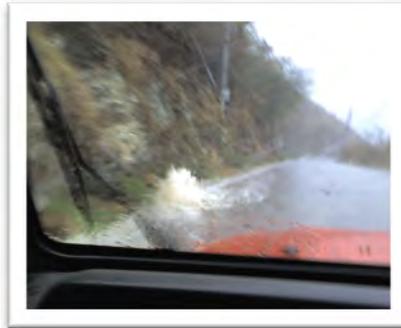
Blocked inlets uphill cause large flows to bypass inlets and
run over the road.

- Immediately clean out blocked pipe and remove debris from inlets along road. Flush entire system to ensure removal of existing sediment and debris. Once this action is taken, the system should operate since much of the initial causes of this blockage are remedied with the recent paving of Rt. 108.

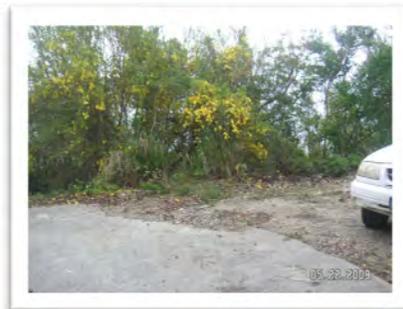
Upper Bend – Water does not make
It around the curve

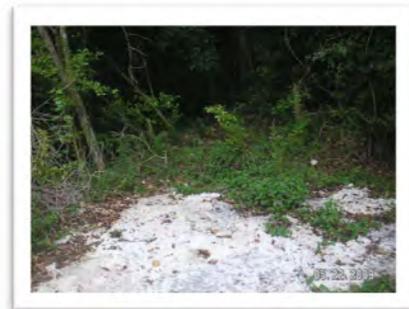
Area at edge of bend where water goes
Ideal area for installation of a BMP

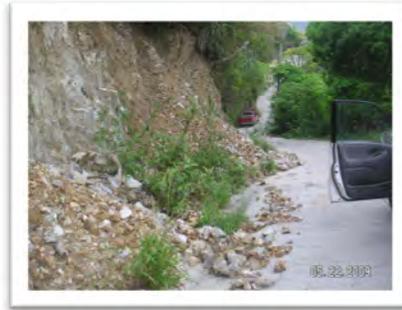
Roadside with undermining due to no backfilling after forms were removed
