## Response to Physical Impacts on Coral Reefs in Puerto Rico and the USVI

July 2014

## Minimizing Damage to Corals during the Salvage of the S/V “Arena”

December 2010

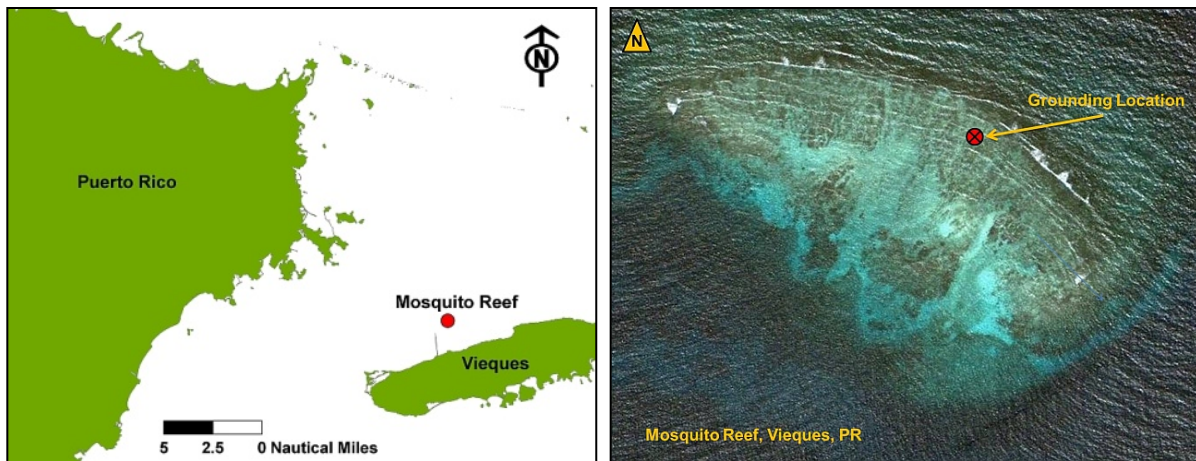
The sailing vessel “Arena” ran aground on Mosquito Reef north of Vieques, Puerto Rico (Lat N18.1615<sup>o</sup>, Lon W65.4956<sup>o</sup>, Figure 1) on November 2010 while adrift in rough sea conditions. The vessel grounded on the shallow fore-reef and was carried onto the reef crest by the breaking waves. A salvage effort was conducted by Sea Tow on December 8, 2010 to remove the vessel. Seaventures, a coral reef restoration contractor, initiated work to minimize impacts to vulnerable marine resources at the grounding site and related to the salvage operations. Priority attention was given to avoiding impacts the staghorn coral (*Acropora cervicornis*), a threatened species, as well as other coral species in the area. This report describes the methods and results from the work to avoid impacts to the coral reef from the salvage operation.

**Figure 1. Location of the vessel grounding on Mosquito Reef located approximately 1.5 nautical miles north of Vieques, Puerto Rico (left). The approximate location of where the vessel came to rest on the reef crest of Mosquito Reef, Vieques (right).**
