TABLE OF CONTENTS

## 2.0 Inlet History and Current Inlet Conditions

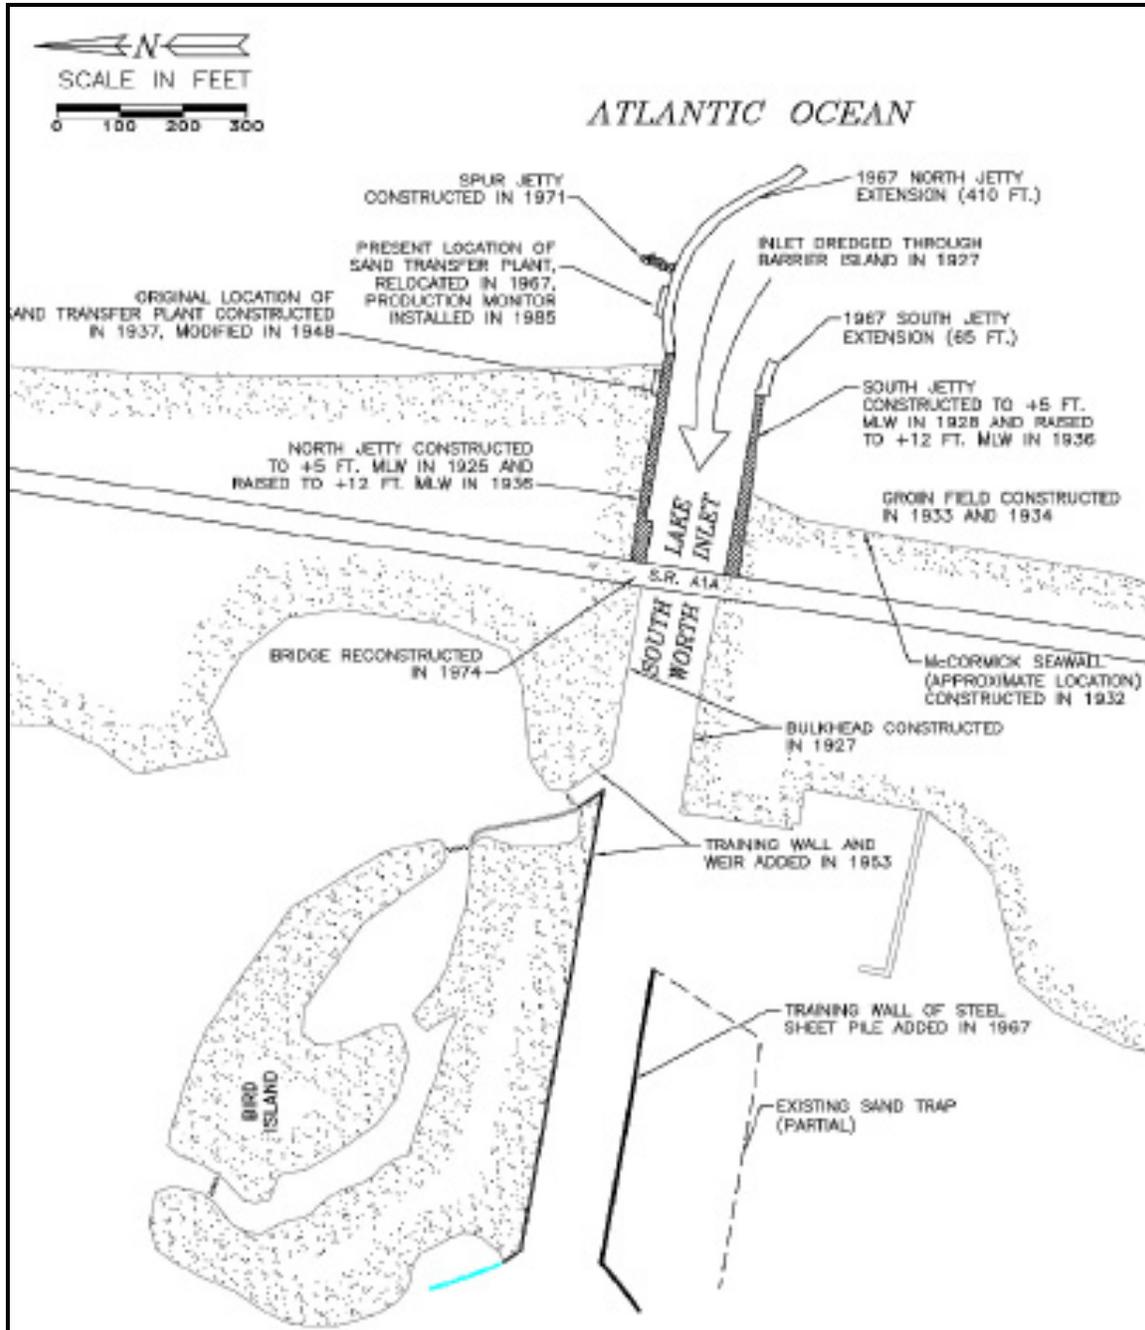
Figure 1 – Overview of Improvements to South Lake Worth Inlet (source: PBC ERM)

In 1996 the South Lake Worth Inlet District was abolished and the County now operates the sand transfer plant and manages the inlet. The latest inlet construction project occurred in 1998 when 8 "t-head" groins were installed south of the inlet to help retain a minimum beach section immediately downdrift of the inlet. The shoreline to the south of the inlet is maintained as a Federal Beach Nourishment project with the County serving as the local sponsor.

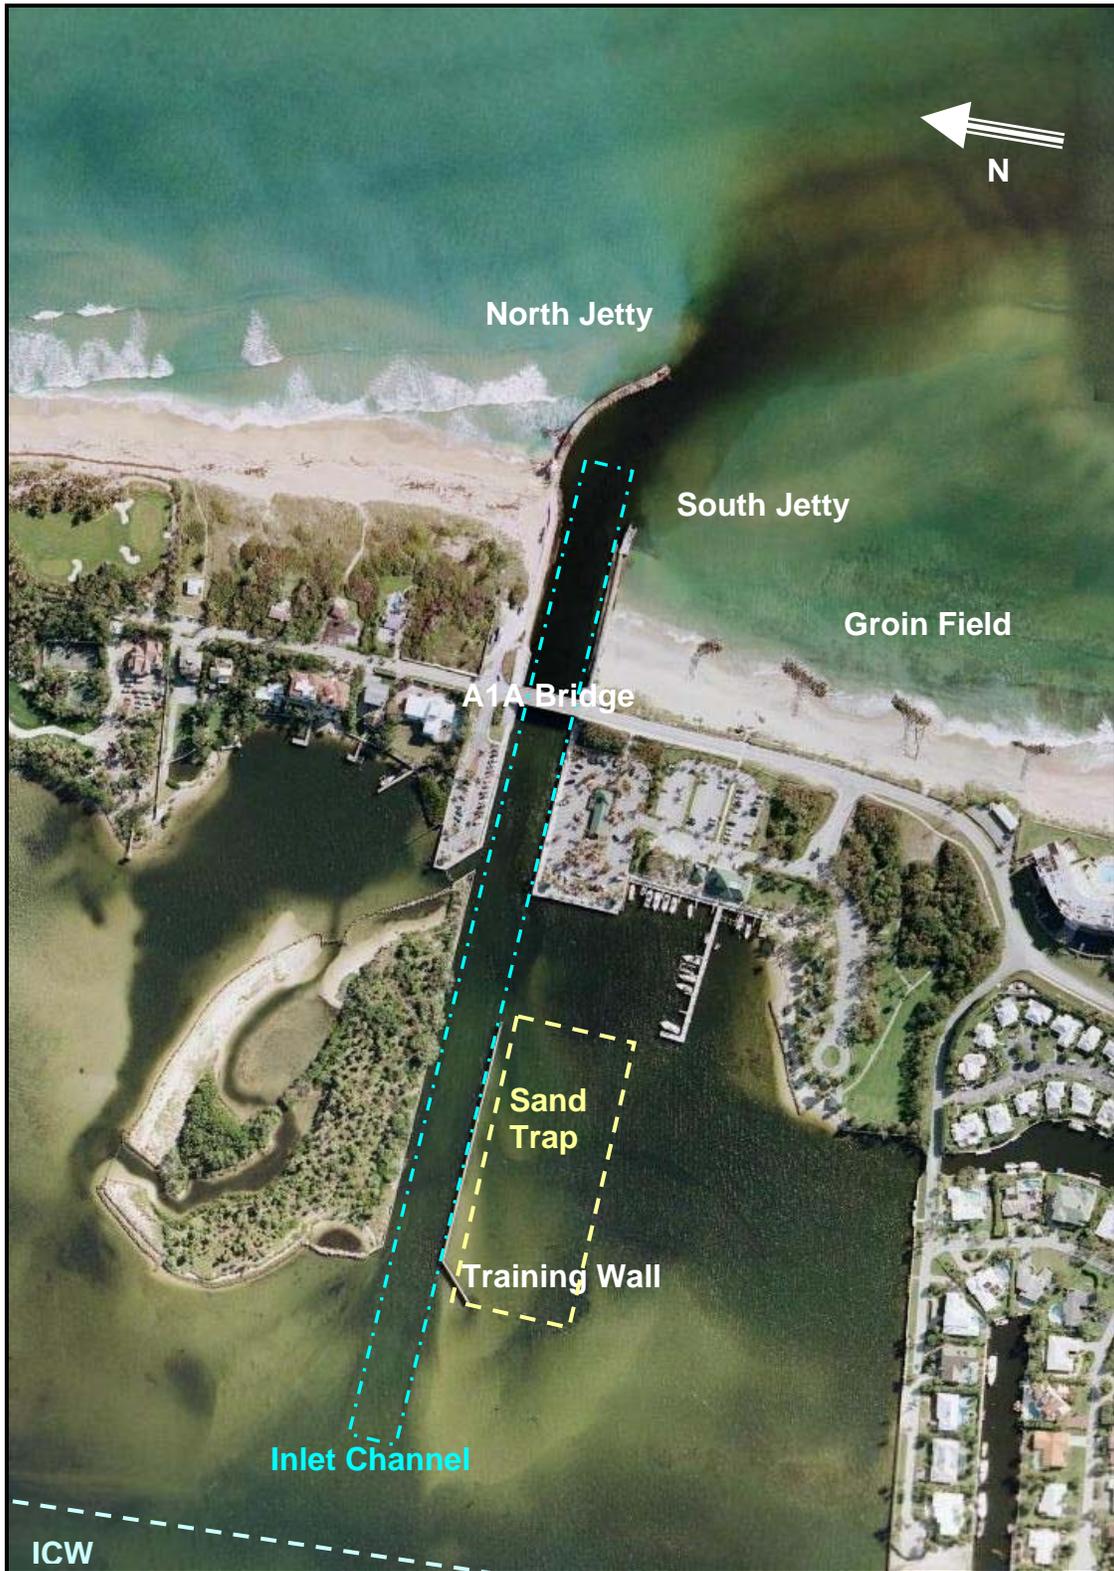
Figure 2 – Current Inlet Configuration

Today South Lake Worth Inlet remains close to its original configuration (Figure 2). The inlet is stabilized by two rock and rock-filled crib jetties. The south jetty was 370 feet long, but lost ~10 ft of the outer end after the hurricane season of 2004. The north jetty is around 770 feet long and also suffered damage and loss of around 10 ft of the outer end during the 2004 hurricane season.

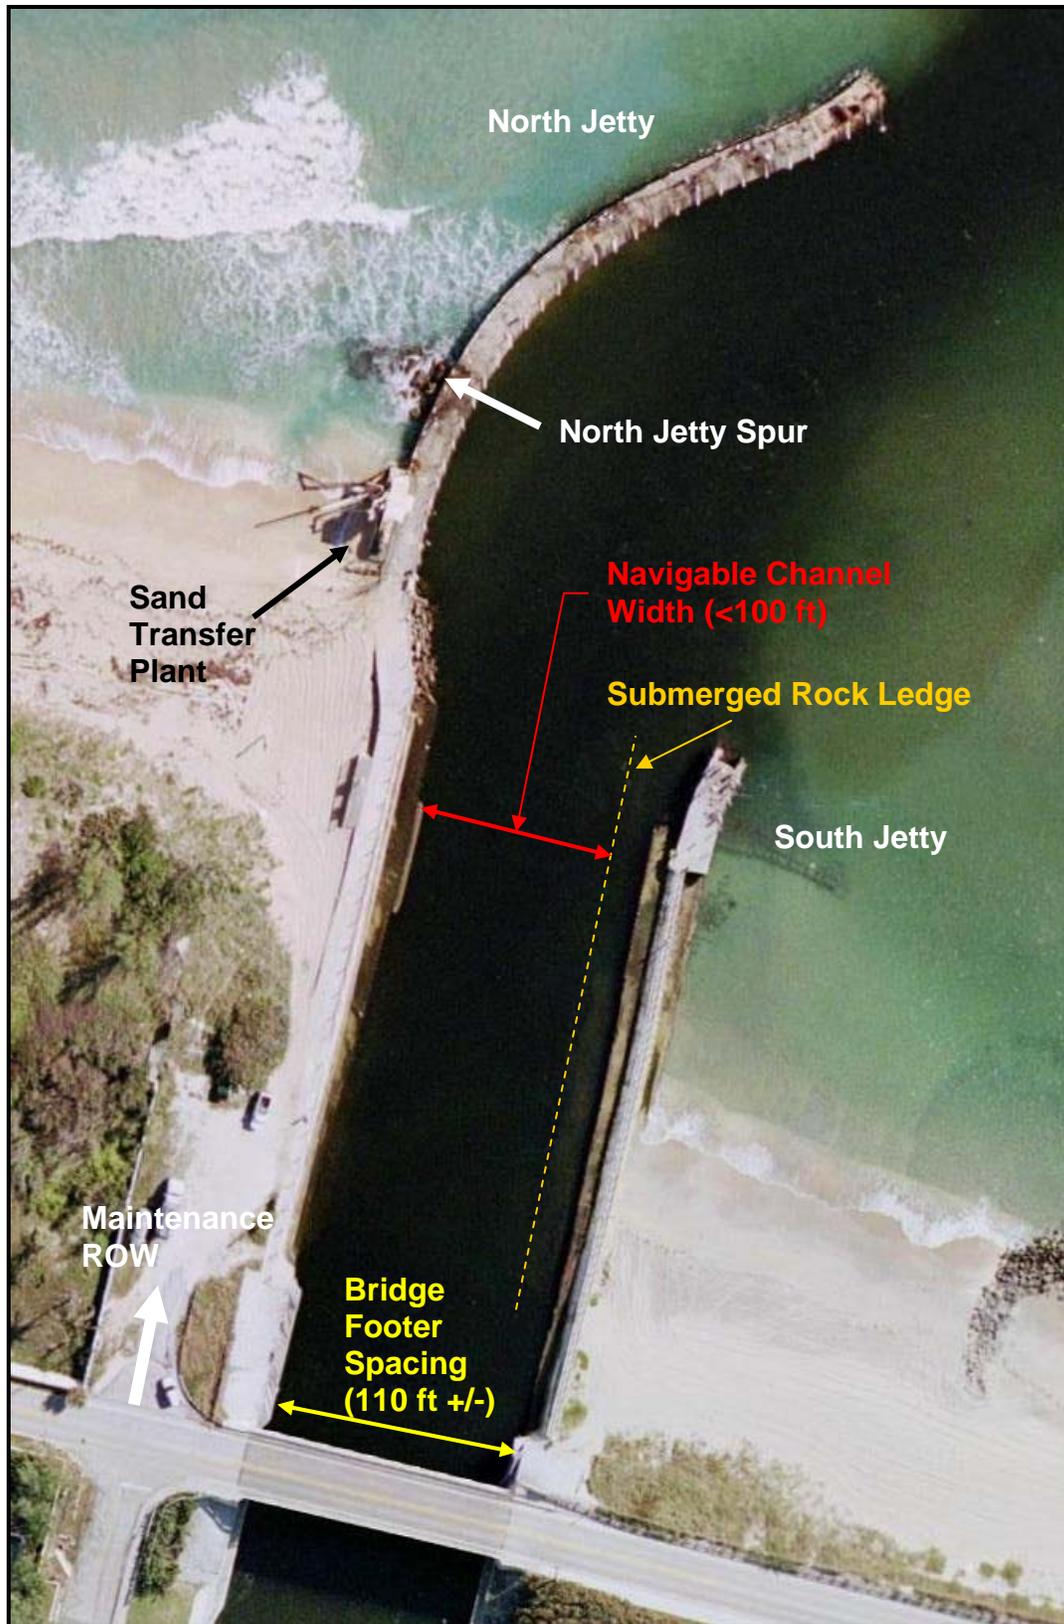
Figure 3 Inlet Mouth

The navigable channel width varies from 125 feet wide west of the bridge to around 110 feet wide at the bridge, then down to less than 100 feet wide near the mouth of the inlet east of the bridge (Figure 3). Both sides of the channel passing through the barrier island are protected by vertical sheetpile walls. Bird Island is located inside the Lake Worth Lagoon and immediately adjacent to the north side of the channel and is protected by 840 feet of vertical wall. Opposite Bird Island is the 615-foot long training wall (also a vertical structure).

The total length of the inlet’s constricted channel from its intersection with the ICW to the end of the north jetty is approximately 2,400 feet. As previously mentioned, the navigable channel width through South Lake Worth Inlet varies from 125 feet wide west of the S.R. A1A bridge to around 110 feet wide at the bridge, then down to less than 100 feet wide near the mouth of the inlet east of the bridge (refer back to Figure 3). The width of the eastern end of the channel is effectively reduced by a submerged rock ledge that was left after excavation along the south side of the inlet. The width of the ledge is around 15 feet and there is minimal water depth here.

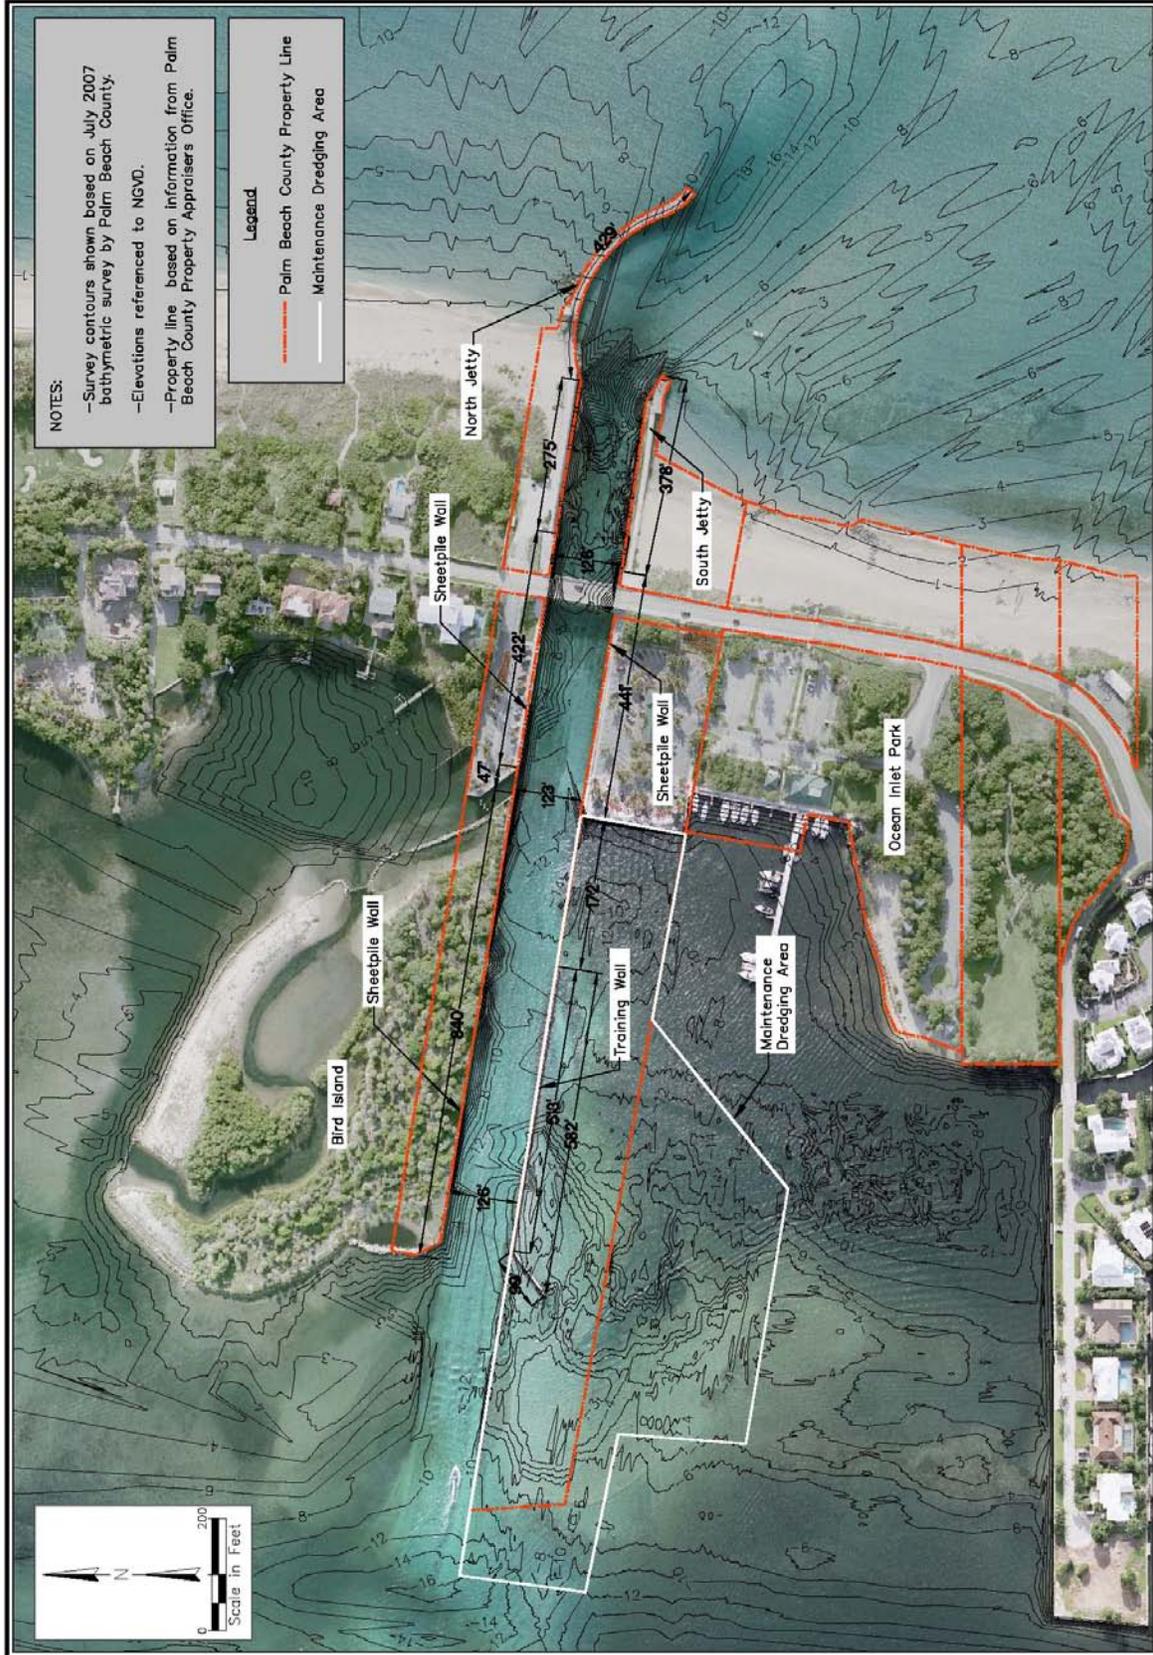
**Figure 4 – South Lake Worth Inlet Survey**

As can be seen in Figure 4, the depths within the channel also vary appreciably. The controlling water depth is between 8 and 10 feet. Average bottom elevations are around -11 feet NGVD west of the bridge. Near the mouth of the inlet there are deep pockets greater than 20 feet deep and remnant submerged ledges of -8 feet NGVD or less in the center of the channel. Along the south side of the inlet east of the bridge and roughly 15 feet from the north side of the south jetty structure, there is a near vertical ledge with less than 4 feet of water. This submerged ledge effectively reduces the navigable width of this section of the channel to less than 100 feet.

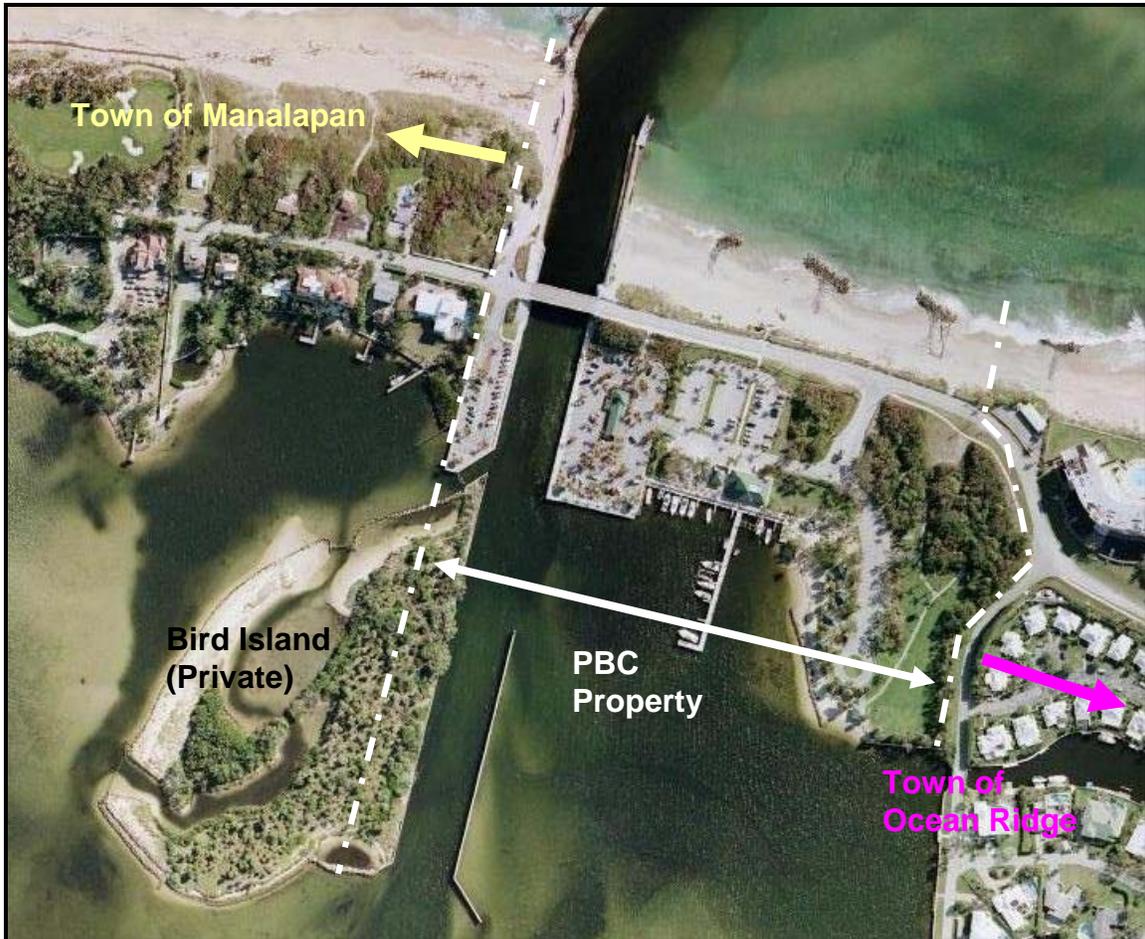
Figure 5 – Approximate Property Boundaries

Palm Beach County owns and maintains 11.4 acres surrounding the inlet roughly as shown in Figure 5 below. Ocean Inlet Park has 1,100 linear feet of Intracoastal Waterway frontage and 600 ft of guarded ocean beach. The park is open from sunrise to sunset and fishing on the jetties is permitted 24-hours. Additionally, the park has the following facilities:

Along the north side of the inlet, the County maintains an 80-ft right-of-way for access to the north jetty and fixed bypass plant. The 80-ft ROW continues west along the parking area and out onto Bird Island. The remainder of Bird Island is privately owned and was in the recent past an Audubon bird sanctuary. Public access is restricted to Bird Island.

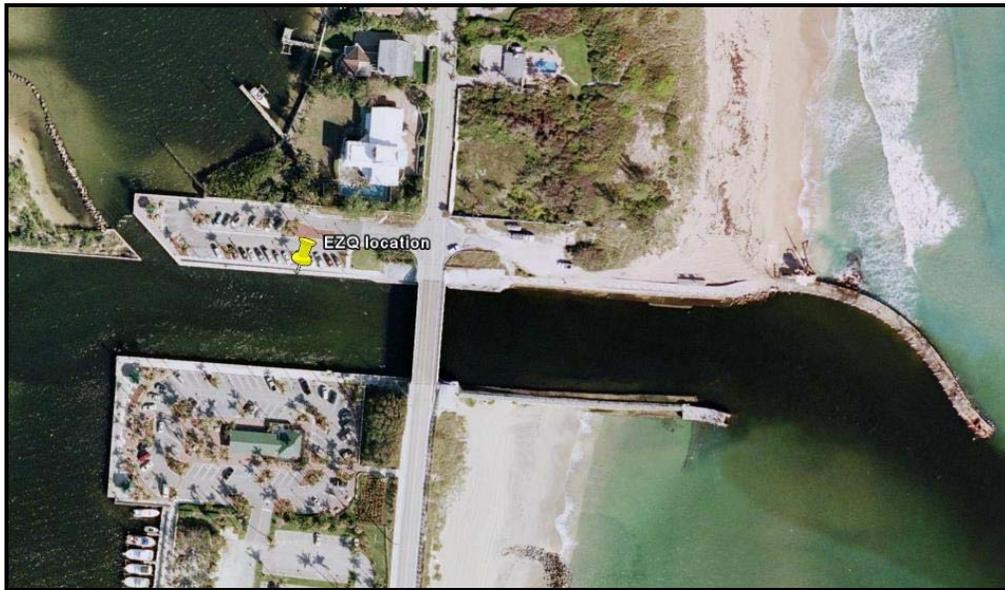
**Figure 9 – Instrument Location (Image from Google Earth)**

Tidal currents that pass through the inlet are based on hydraulic head differences between ocean and lagoon water surface elevations. ATM deployed an acoustic current meter (Nortek EZ-Q) for a period of nine days (August 28<sup>th</sup> to September 6<sup>th</sup>, 2007) to obtain time-series stage and current readings for use in calibrating a numerical flushing model. The meter was installed on an existing rail system located on the northern bulkhead approximately 150 feet west of the bridge and roughly 6 feet off of the bottom (Figure 5).

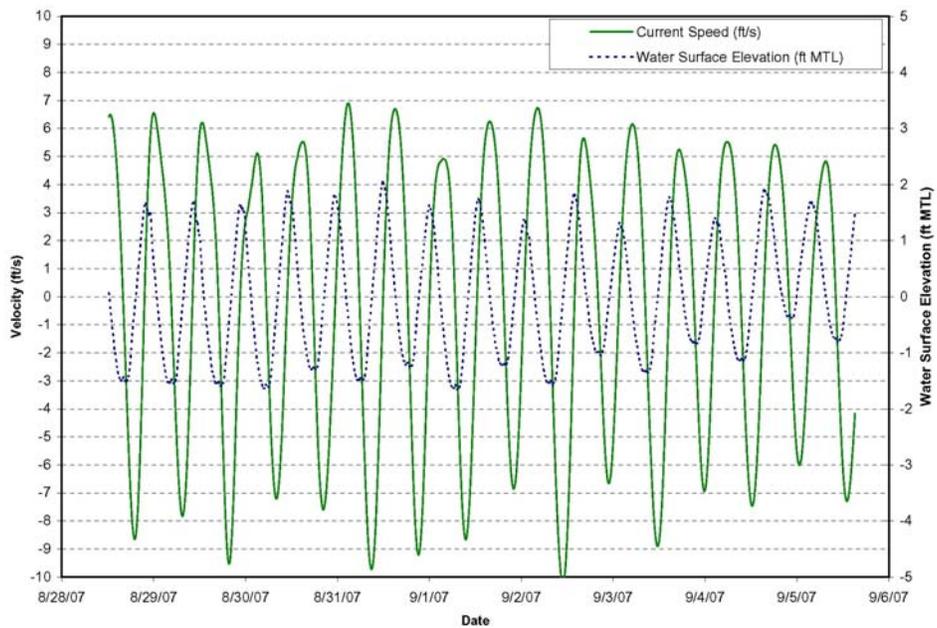
**Figure 10 – Recorded WSEL and Tidal Currents (South Lake Worth Inlet)**

Tidal current measurements obtained during the course of this study revealed current velocities that ranged near zero feet per second (fps) to a peak of around 10.2 fps (Figure 10) on the outgoing (ebb) tide. Measured tide ranges were between 2.08 and 3.54 feet.

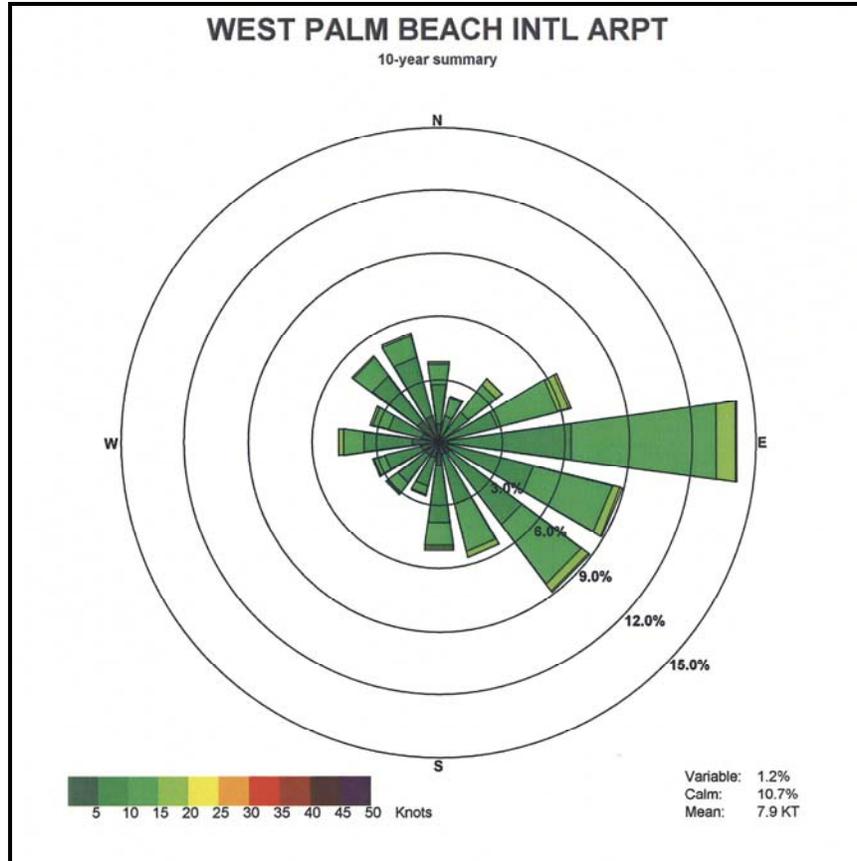
Figure 11 – Wind Rose for West Palm Beach (NCDL website)

A ten year record of hourly wind data from 1996 through 2005 was analyzed to determine the long-term, prevailing conditions. Figure 11 presents a wind rose of the data. The wind speeds are 15 knots or less 83% of the time and are primarily from the east, which accounts for approximately 14% of the time. The overall mean wind speed for the period of the 10-year record is 7.9 knots.

Although the wind rose shown in Figure 11 does not show seasonal data, the wind conditions are known to vary by season. During the summer season, the winds are typically from the southeast. Based on the data, winds are from the east-southeast through the south-southeast a total of 23.7% of the time, the mean wind speed is approximately 9.6 knots. During the winter season, the winds are generally from the northeast through the east, and these winds occur 24.6% of the time. The mean winds speed for winds from the northeast through the east is approximately 10.3 knots.

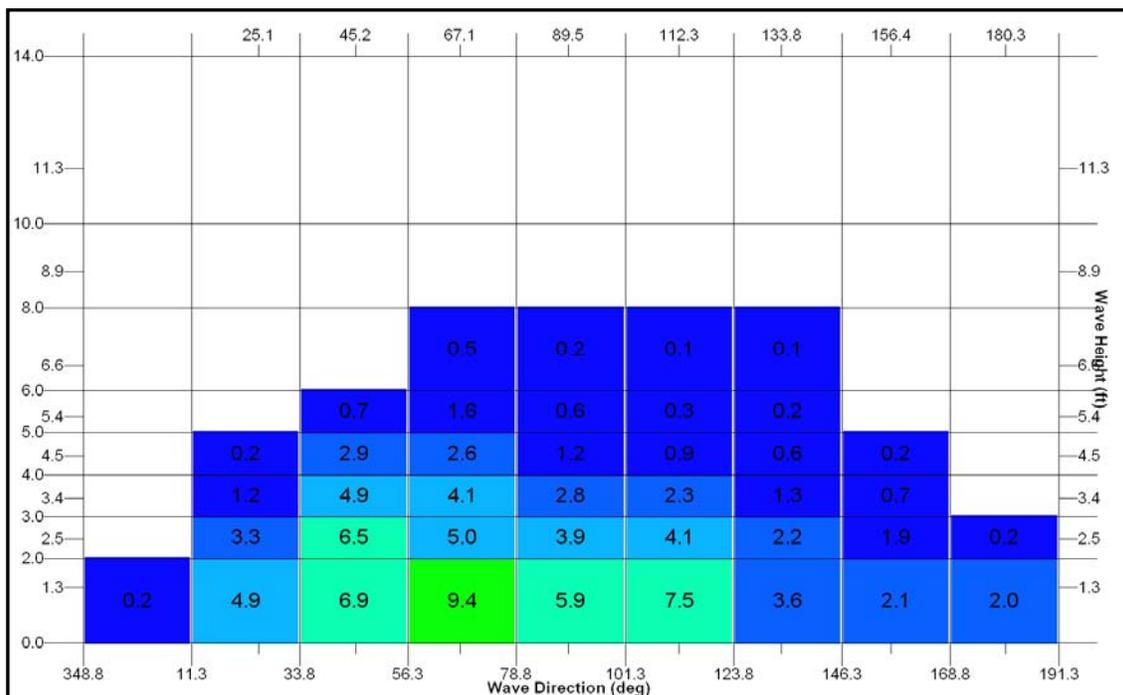
**Figure 12 – Wave Occurrence (Direction versus Height)**

A histogram of the wave heights versus wave direction is shown in Figure 12. For the shoreward propagating waves, approximately 70% of the waves are 3 feet or less, and approximately 87% of the waves are 4 feet or less. The histogram shows that the wave heights are generally larger for waves propagating from the northeast. Waves from 33.8° through 78.8° (NE and ENE) 5 feet or less account for 42.3% of the record; whereas, waves 5 feet or less from 78.8° through 123.8° (E and ESE) account for 28.3% of the record.

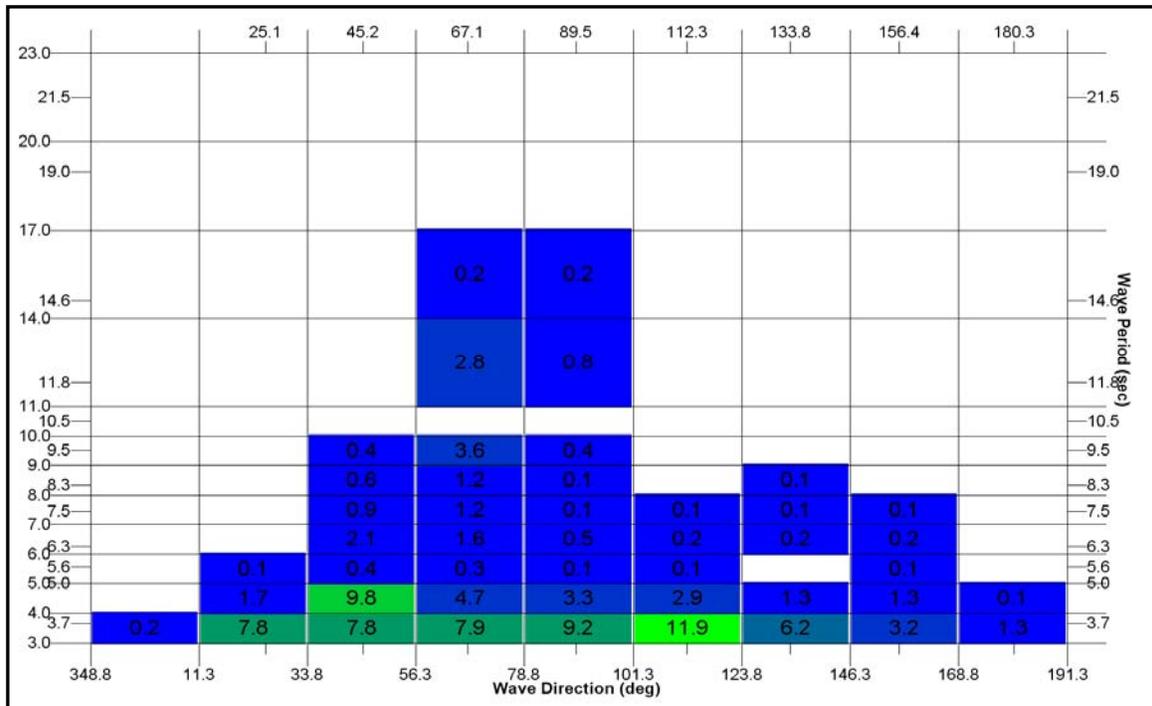
Figure 13 – Wave Occurrence (Direction versus Period)

There are swell conditions to note when examining Figure 13. When examining the wave data for the 56.3° to 78.8° degree band (ENE direction), approximately 6.4% of the waves have a period of 9 to 14 seconds. This is greater occurrence than waves from the ENE with periods of 5 to 9 seconds; thus, there are two sea states that commonly occur, waves with periods of 5 seconds or less (characterized as wind waves) and waves with periods of 9 to 14 seconds (characterized as swell). Similarly, looking at the wave periods for the 78.8° to 101.3° band (E direction), there are swell conditions with wave periods of 6.3 second and 11.8 seconds.

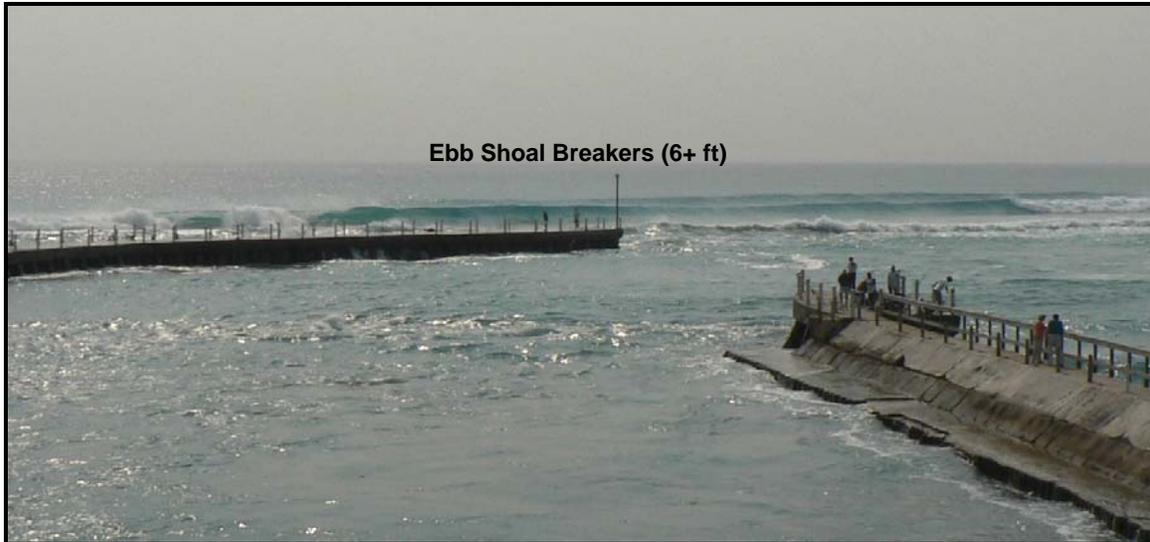
As evidenced in the photographs below, breaking waves on the ebb shoal bar are not conducive to safe navigation, especially to inexperienced boaters who are unaware of the sea conditions or do not know how to time ingress and egress between sets of breakers. The results have been numerous capsizing incidents, where boaters had to be rescued by lifeguards, PBC Marine Enforcement officers, FWC Marine Patrol units, and other responders.

The controlling depth of the ebb shoal bar varies temporally and spatially, but generally ranges from 4 to 8 feet deep. Larger vessels with deeper drafts will occasionally have to find the break in the ebb shoal bar, or time ingress and egress with the tides and waves to avoid bottoming out or running aground on the shoal. Referring to the general depths along the ebb shoal, Captain Alan Lebrun of the *Lady K* stated that he has to time the approaches depending on tides and waves, but there is always a way to get across the shoal (personal communication August 8, 2007).

Photograph Taken 5/9/07 – Ebb Shoal Breaking Waves / Incoming Tide / NE Swell

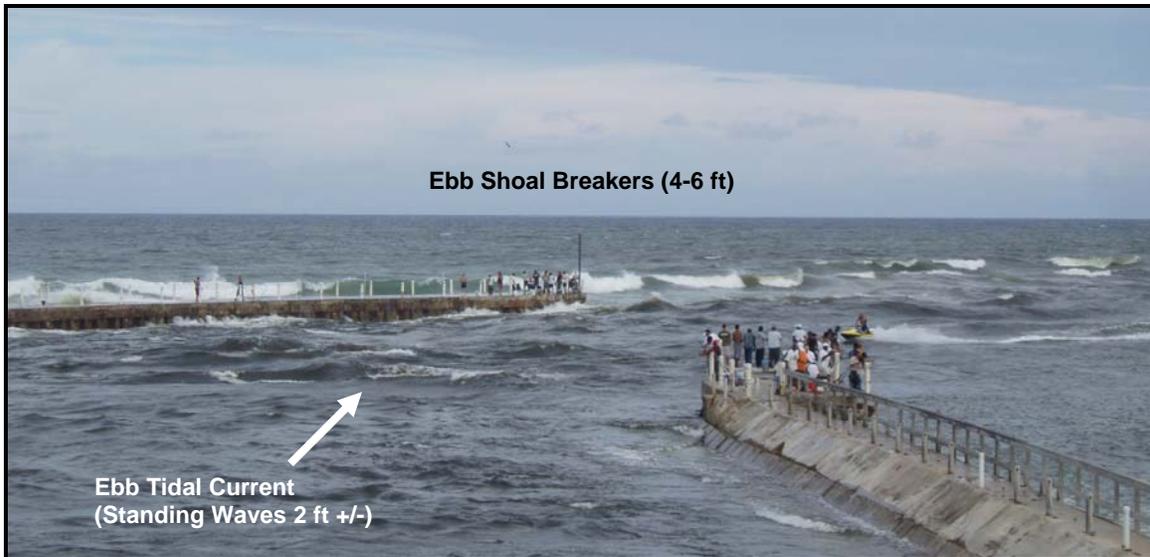
Photograph Taken 10/2/07 – Ebb Shoal Breaking Waves / Outgoing Tide / NE Swell

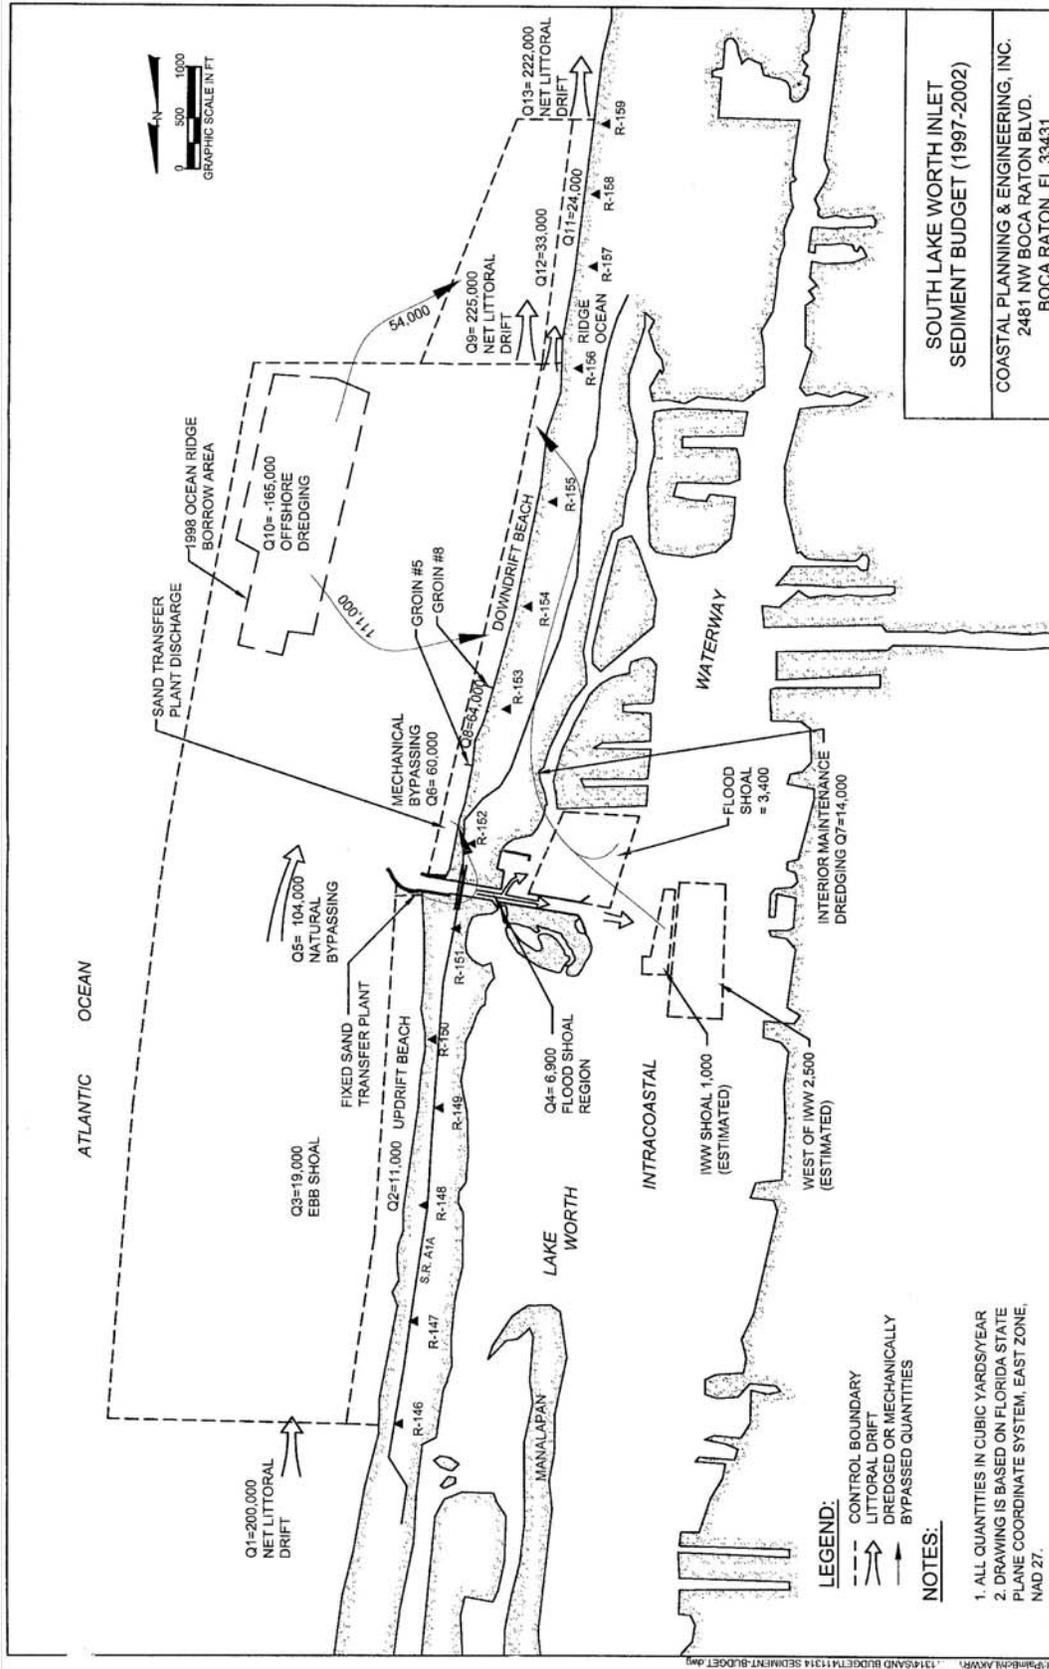
Figure 16 – South Lake Worth Sediment Budget (CP&E, 2004)

Olsen Associates first established estimates of the inlet's sediment budget in 1990. Coastal Planning & Engineering updated the inlet's sediment budget in 2004 as reflected in Figure 16. The following table summarizes key littoral budget estimates from the CP&E report.

From north to south, a net of approximately 200,000 cy/yr of sand is transported into the inlet's sphere of influence. Approximately 11,000 cy/yr is stored by the updrift (northern) shoreline, 19,000 cy/yr is stored in the ebb shoal, 6,900 cy/yr is stored in the flood shoal, 104,000 cy/yr is naturally bypassed along the ebb shoal to the southern shoreline, and 60,000 cy/yr is

mechanically bypassed to the southern shoreline (balanced sediment equation:  $Q_1 - (Q_2 + Q_3 + Q_4 + Q_5) \approx 0$ ).

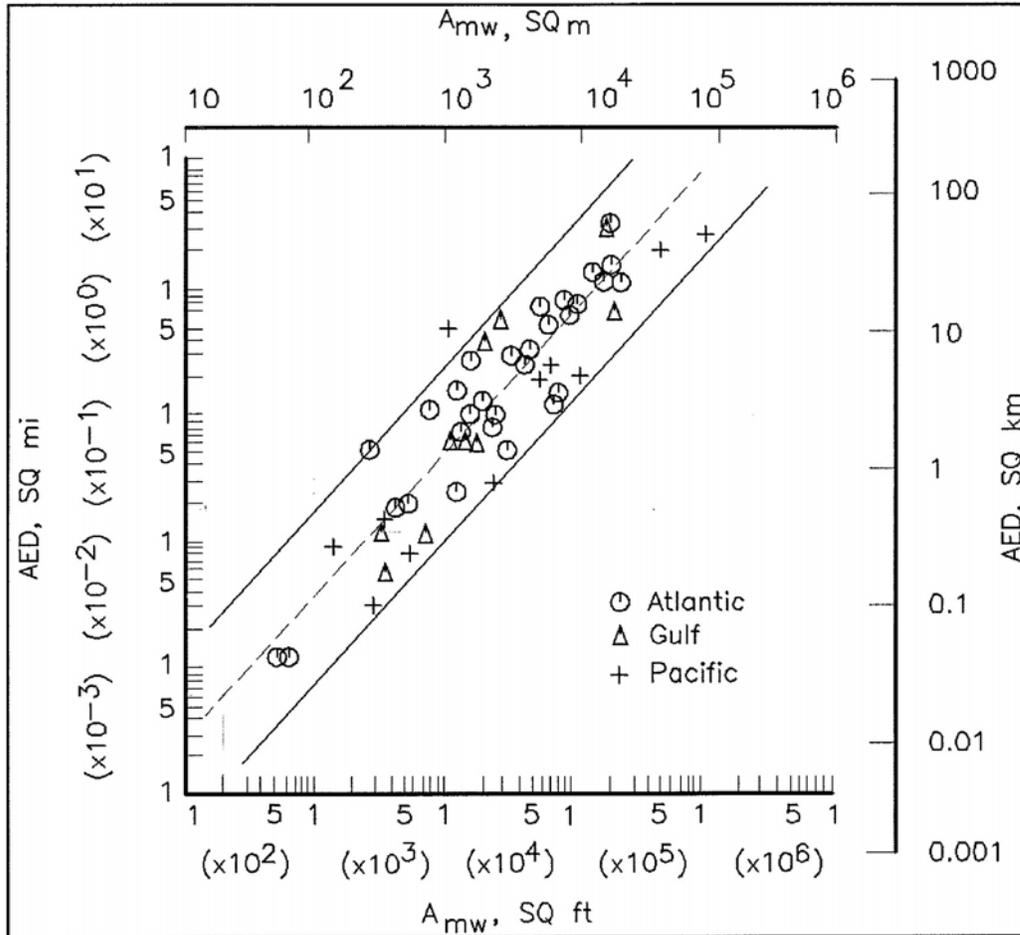
Figure 17 –  $A_{mw}$  versus ebb-tidal delta area (AED) (Vincent and Corson 1980)

Changes to an inlet can result in substantial changes to a shoreline system, the most extreme responses leading to “sand starvation” of downdrift beaches and shoreline erosion. One important aspect of this study is to evaluate the impact of any proposed inlet modification on beach management requirements. Based on studies of inlets in the Gulf, Pacific and Atlantic, stability curves relating inlet cross-sectional area to ebb-tidal delta (shoal) area have been developed by the Corps of Engineers. Figure 17 below represents the finding of the studies as a graph that can be used to estimate ebb shoal growth induced by a change in the inlet cross section.

*Example: A threefold increase in the inlet cross-sectional area from 1,000 to 3,000 square feet (similar to a 200-ft widening of South Lake Worth Inlet) can increase the area of the ebb-tidal shoal by more than three times.*

According to the 1990 Inlet Sand Management Plan by Olsen Associates, the ebb shoal volume is estimated to be between 1.6M and 3.0M cy. If the ebb shoal were to grow three times in size, the holding capacity could conceivably grow to more than 9.0M cy. This estimate represents a significant reduction or deficit to the existing sediment budget and does not include growth of the flood shoal which would also occur to a lesser degree. Obvious concerns stemming from the growth of the ebb and flood tidal shoals are the loss of sediment to the downdrift beaches that would otherwise have bypassed naturally.

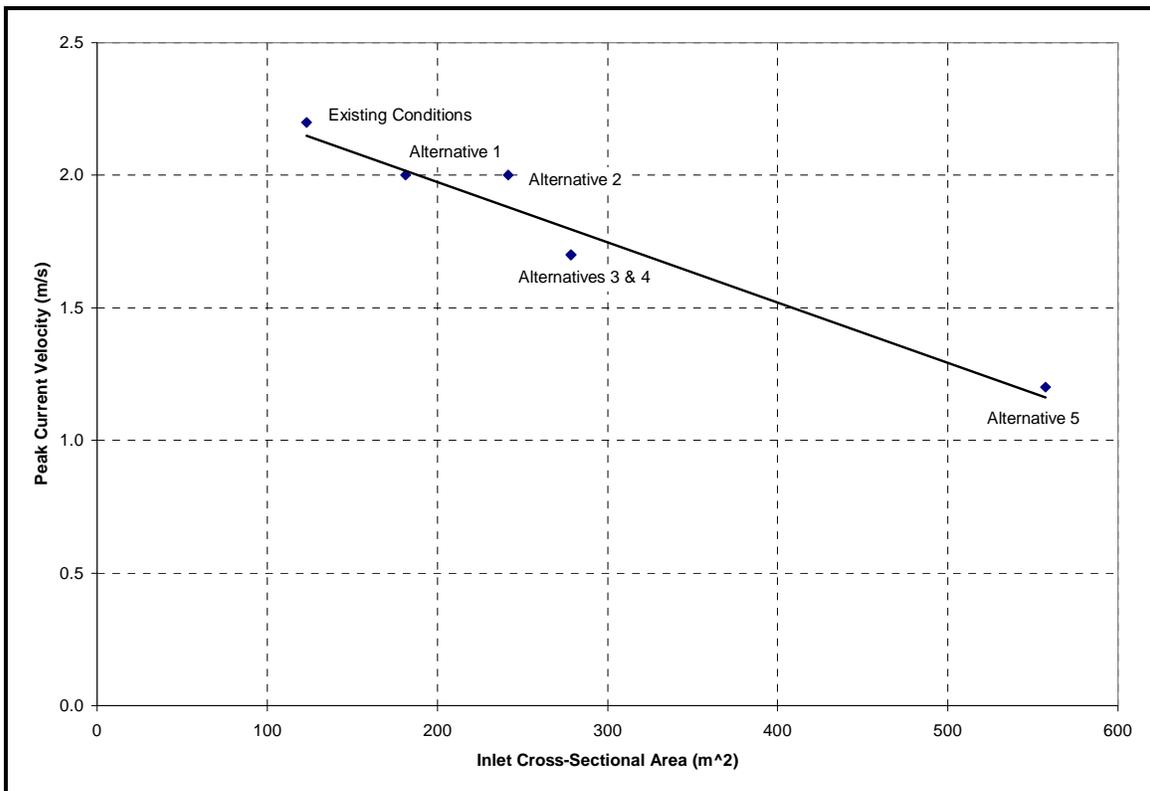
**Figure 18 – Tidal Current Velocity Versus Inlet Cross-Sectional Area**

The peak simulated current velocities are shown in Table 4. The alternatives show decreasing velocities with increasing inlet cross-sectional area, as shown in Figure 18.

of 1.1 m/s is considered sufficient to maintain an inlet cross-section and avoid deposition of sediments in the inlet. Alternative 5 shows the smallest velocities at 1.2 m/s (i.e., the most desirable from a navigation safety perspective), but these velocities are still sufficient to scour sediments from the inlet throat.

Inlet stability should also consider the impact of sand deposited in the inlet from a storm event on the currents. For some inlets, a reduction in inlet cross-section will result in a decrease in inlet currents. If an event sufficiently reduces the inlet cross-section, and the resulting currents are too low, this can potentially lead to instability with the gradual reduction in cross-section leading to further reduced currents until the inlet closes. As shown in Figure 18, if any of the alternative inlet configurations is constructed, a subsequent reduction in the inlet cross-section will cause the current velocities to increase. This means that if any of the alternatives were constructed, and then a storm event deposits a volume of sand in the inlet throat (reducing the cross-sectional area to as small as that for the existing conditions), the current velocities will increase, scouring the sand from the inlet throat. It should be noted that cross-sections smaller than the existing conditions were not evaluated. At some point, a reduction in cross-section in area will lead to a reduction in velocity (near the left end of the x-axis in Figure 18).

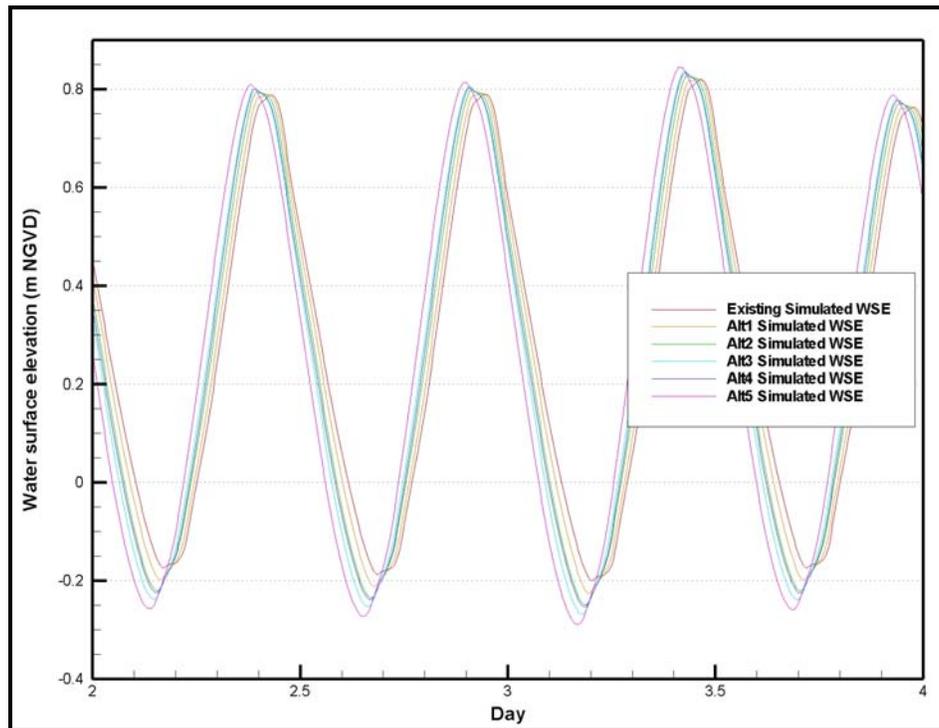
**Figure 19 – Simulated Tides**

The simulated tides near the shoreline immediately west of the inlet are shown in Figure 19. The spring tide ranges are summarized in Table 7. The results indicate that the inlet alternatives will allow a greater tidal range in the estuary. Alternative 5 has the greatest impact, with the high

spring tide reaching 3 cm (~0.1 ft) above the existing high tides. The more pronounced effect is that low tide extends 9 cm (~0.3 ft) lower for Alternative 5 than the existing conditions. The results of this analysis show that the inlet impacts to the tide range in the estuary are relatively small, but they are not insignificant. If the results showed that the changes were insignificant, then one could reasonably assume that the potential impacts to storm surge levels in the estuary would also be insignificant. Based on this analysis, conclusions regarding potential impacts to storm surge levels cannot be drawn. There is a potential that enlargement of the inlet may have some impact on coastal storm surge levels, and further detailed storm surge studies may be required by FEMA prior to inlet construction of a project that enlarges the inlet.
