PITI-ASAN WATERSHED MANAGEMENT PLAN

Technical Report No. 138

September 2012

Hydrologic Unit Code (HUC) - 20100003-000-006

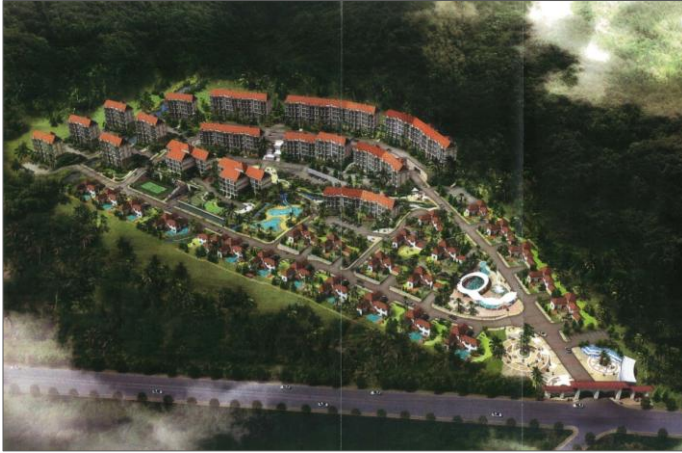
Figure 23. Model of the proposed JHP development.
Source: FC Benevente, 2007.

A 240-unit residential subdivision is planned on a 10-hectare (25-acre) lot east of Nimitz Hill Estates and Nimitz Towers (Figure 23). JHP Development intends to build 21 single-family detached homes, 22 two-story townhouses (86 units), 15 five-story condominiums (133 units), tennis courts, swimming pool, parking facilities, walking trails, convenience store, *etc.* (FC Benavente, 2007). The developer first applied for a zone change from agricultural “A” to multi-family residential “R-2” and a zone variance to the GLUC in 2007. Concerns by the Application Review Committee were primarily infrastructure-related (freshwater supply and wastewater system) and the proximity to the streams, which the developer wanted to address. The application was approved by the GLUC in May 2008. To date (July 2012), the property has remained undeveloped.

The proposed development lies on uneven terrain with steep slopes. The Asan River and a small unnamed stream pass through the property. A small pond that is located on the west side of the lot. The development, which may be up to 60 feet high, will be visible from many areas in the watershed (Figure 23), including the NHP Asan Units.

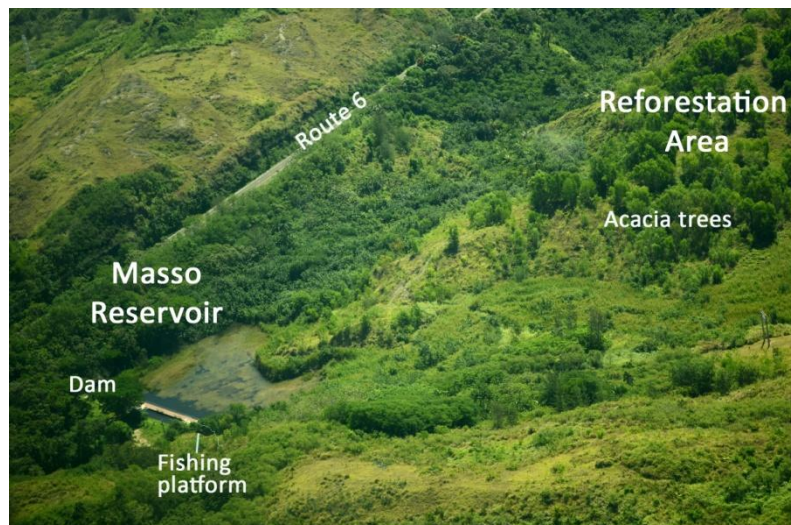
Figure 28. Aerial view of Masso Conservation Area. Photo was taken June 20, 2012.

The Masso Reservoir was constructed by the Navy in 1945 by damming the Masso River (Tibbatts, pers. comm.). It was only used as a water supply until 1951 because of severe sedimentation problems (Wiles & Ritter, 1993). Between 1978 and 1982, DAWR upgraded the site by repairing the spillway, removing Phragmites, planting exotic plants, and stocking the reservoir with fish for public fishing. In 1983, the management program was stopped because of vandalisms and illegal fishing methods (Wiles & Ritter, 1993). In 1999, the local government planted about two acres with Acacia trees, which mostly established well (Figure 28). In 2004, extensive improvement and restoration efforts of the reservoir and adjacent area began (Tibbatts, pers. comm.). Since the recent completion of the restoration work, the Masso conservation area has attracted an increasing number of recreational fisherman, hikers, and campers.

The Masso valley at the southern part of the Piti-Asan watershed boundary is a conservation area that the Navy turned over to the Government of Guam under the condition of developing and maintaining it as a conservation area as referenced in Executive Order No. 2006-14. The Masso Reservoir is intended for public benefit use, public fishing and recreation, conservation, protection, and management of fish and wildlife, and the restoration of native and/ or endangered species and ecosystem function (GovGuam, 2006).

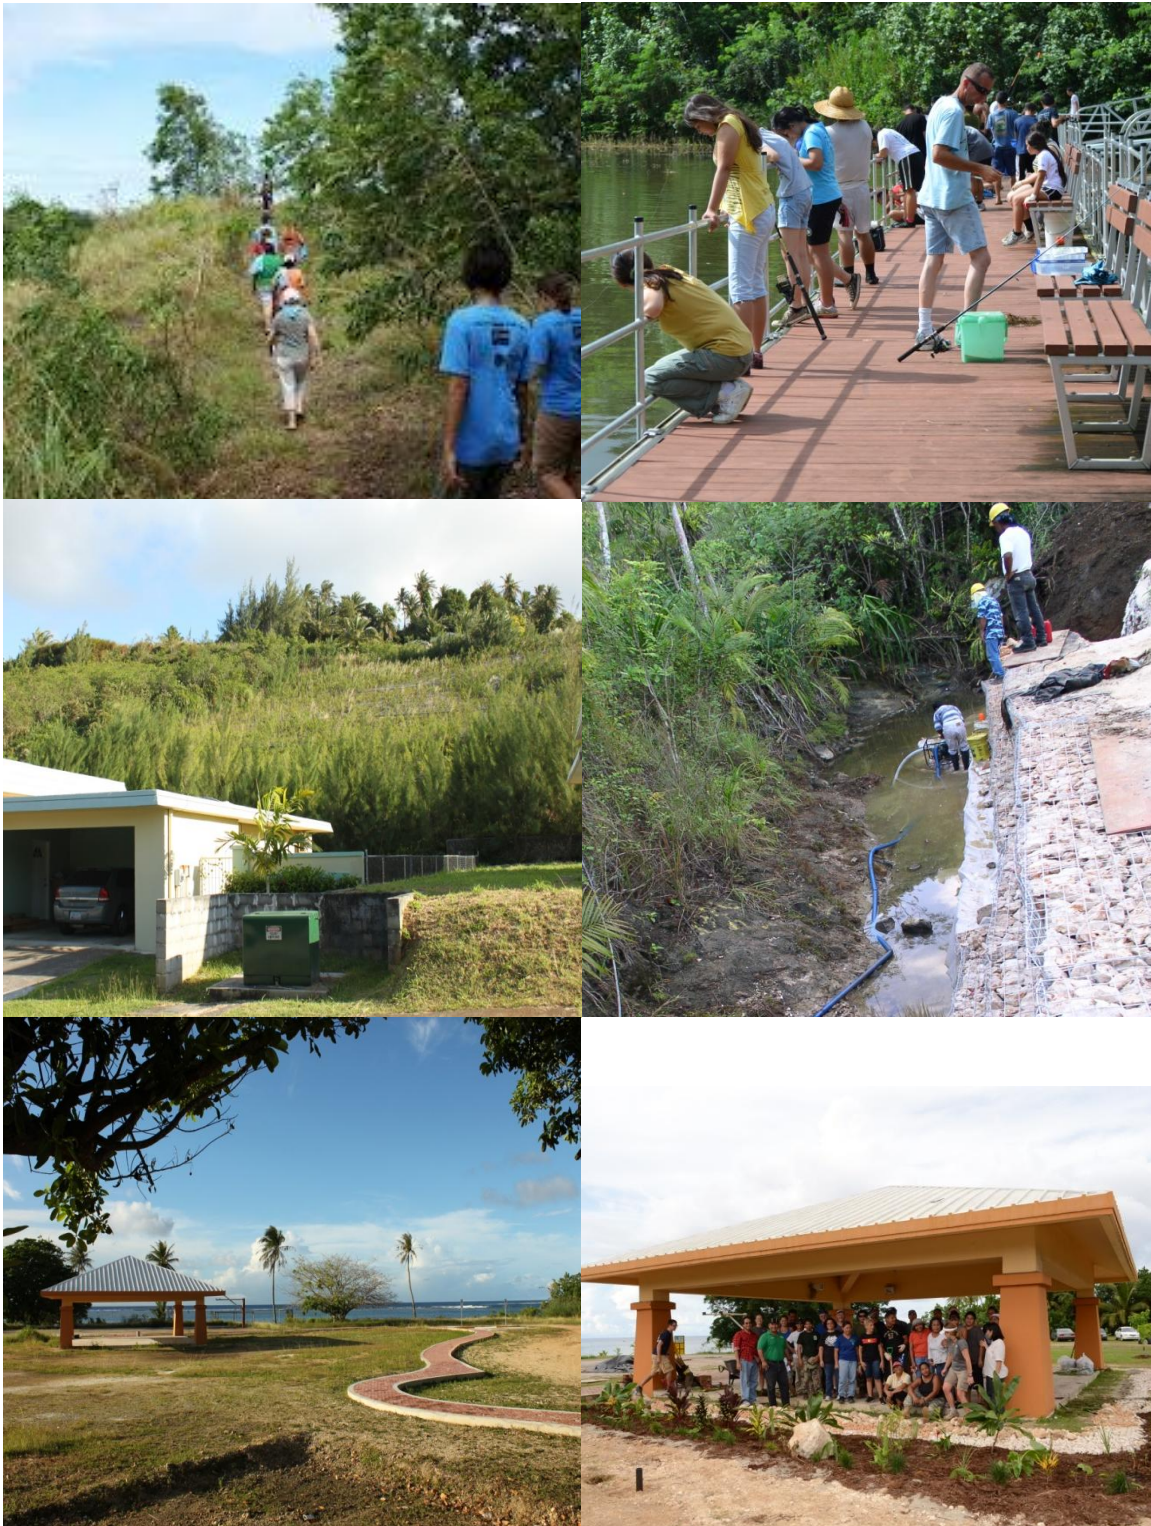
Figure 29. Examples of restoration sites in the Piti-Asan watershed. From top left to bottom right: re-vegetation site in Masso watershed above the reservoir; Masso Reservoir with fishing platform; slope stabilization site (behind house) of 2004 land slide; NRCS streambank protection with gabions; Pedro Santos Memorial Park improvements; and raingarden installation at Pedro Santos Memorial Park.

The following section describes completed and on-going restoration projects in the Piti-Asan watershed. Some of the projects are also shown in Figure 29. A summary of all the projects listed here as well as proposed projects can also be found in Table 26 on pages 67-69. The map IDs listed here refer to Figure 40 on page 70.

This project was conducted in response to the damage of Tropical Storm Tingting in 2004. The streambank was stabilized with gabions to protect the property (including the sewage line from the house) and to prevent sediments flowing into the river (Wheaton, pers. comm.).

This project was in response to a serious landslide on Sanhilo Circle in the Nimitz Hill Estates also caused by Tropical Storm Tingting. After investigation by NRCS experts (Garjo, 2005), the slope was stabilized with a combination of “hard” and “soft” techniques.

The 6.5-acre Pedro Santos Memorial Park has been closed for many years. After the completion of a feasibility study (DC&A, 2009), the Guam Coastal Management Program (GCMP) contracted a company to upgrade the park. The improvement project aims to reduce erosion and sedimentation, minimize recreational overuse of the Fish Eye area, and serve as an educational park on stormwater stewardship by incorporating best management practices. Some of the recommended concepts include “green” parking lots and bioswales collecting roadway runoff. Phase I of the project (pavilion, bathroom, and walkway) is already completed. Phase II (landscaping and bioswale) is pending.

A raingarden workshop was held September 7, 2012. The one-day workshop included presentations and hands-on installation. Over 40 people from various governmental agencies and the community participated. The raingarden was installed on three sides of the pavilion encouraging infiltration of the roof runoff. The raingarden is a slightly depressed area filled with sand, compost, and mulch and planted with various mostly native plants. It includes also a slightly slanted ditch filled with small rocks to convey the roof runoff to the raingarden.

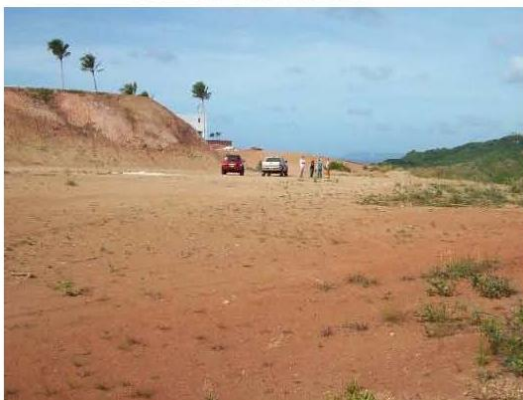
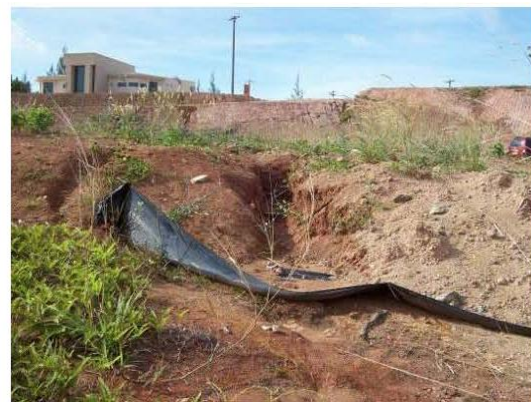
Figure 38. Exposed soil (left) and deep gullies (right) on a development site on J Street on Nimitz Hill in 2008. Silt fences were not effective as they did not trap the eroded sediments from the gullies and nearby areas. *Photos courtesy of CWP/HW (2010).*

Current Guam Soil Erosion and Sediment Control Regulations (PL 25-152) focus mostly on construction-related sedimentation and stormwater management but have little to no post-construction requirements. However, revisions to these regulations, currently under review, include managing post-construction stormwater runoff from new land development and/ or re-development which needs to be contained on-site or adequately treated to meet current water quality standards before discharging it off-site. The large development on J Street (Figure 38) is documented in a time series 2003—2009 in Appendix C.

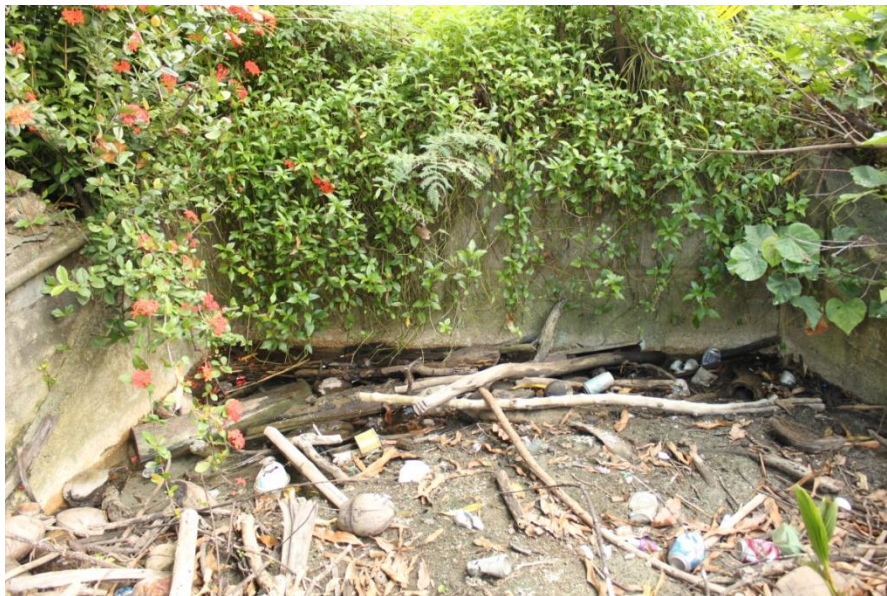
Figure 39. Clogged culvert along Marine Corps Drive in Piti.

Improper stormwater management not only degrades water quality but may cause or exacerbate flooding problems. An example of improper stormwater management is shown in Figure 39. Some areas in Piti village have flooding problems; at Jose L.G. Rios Middle School classrooms frequently flood during heavy rains (see Appendix E).

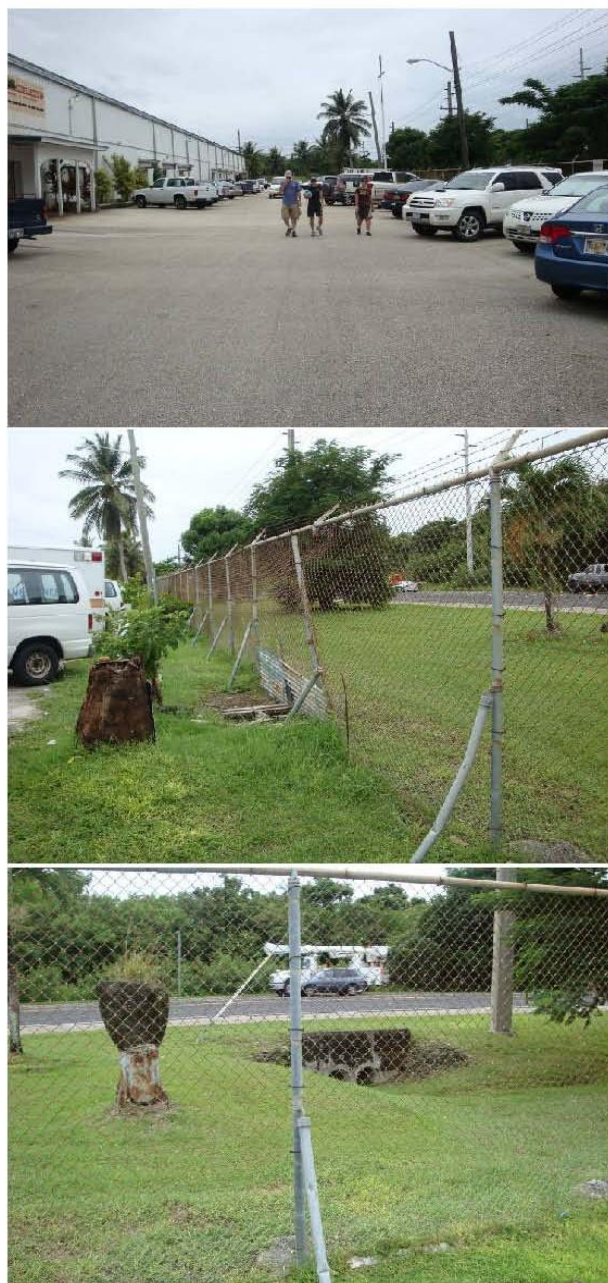
Figure D-1. Runoff from portion of rooftop and front parking drain to grassed area, then through culvert under Marine Corps Dr.

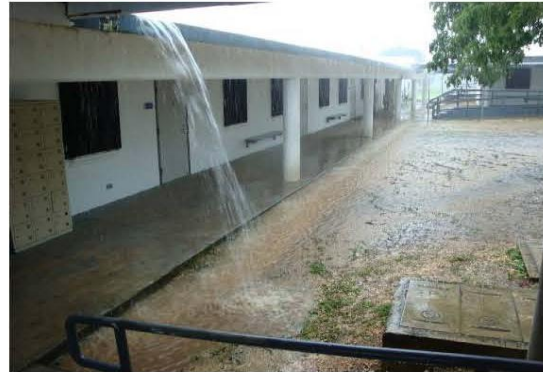
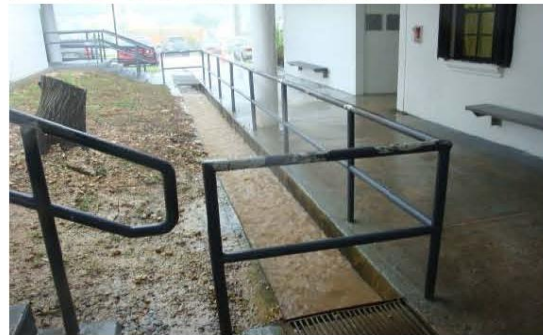
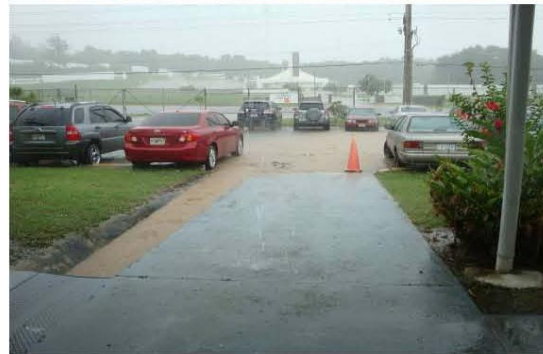
Figure B-5. Sediment in runoff is conveyed over the courtyard, into a channel then trench, and continues out across the parking lot. Runoff leaves the site and enters the street conveyance system (ditch), carrying sediment to the bay.

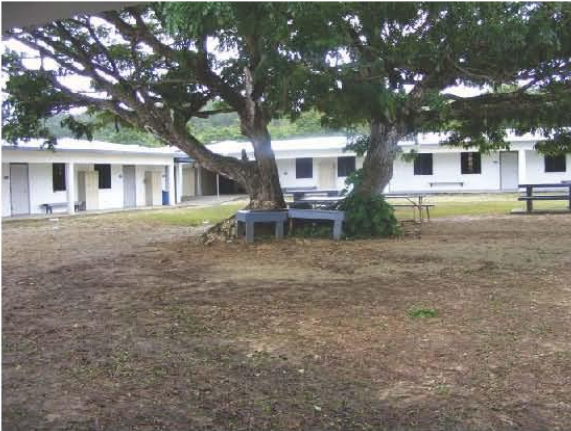
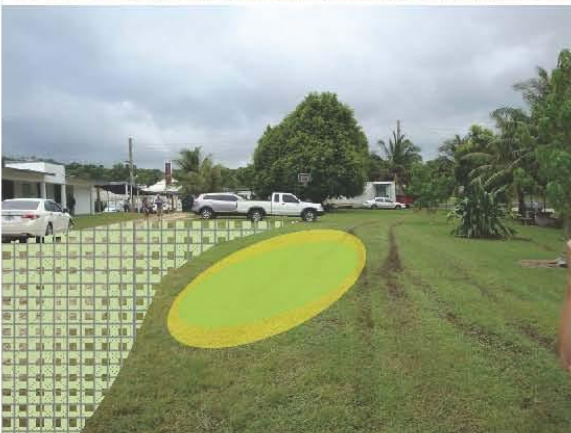
Figure D-6. Existing site conditions and proposed location of the retrofit.

In order to reduce stormwater sediment loads, the courtyard areas should be stabilized with mulch (Figure D-6). Construct a drainage channel with a grate top to convey runoff out of the courtyard and around the front of the school. Continue this trench around to the large grassed area adjacent to the dirt parking lot. Construct a rain garden with 1-2 feet of ponding depth to capture and treat the conveyed runoff. Additionally, replace the dirt parking lot with grassed permeable pavement (Figure D-7).

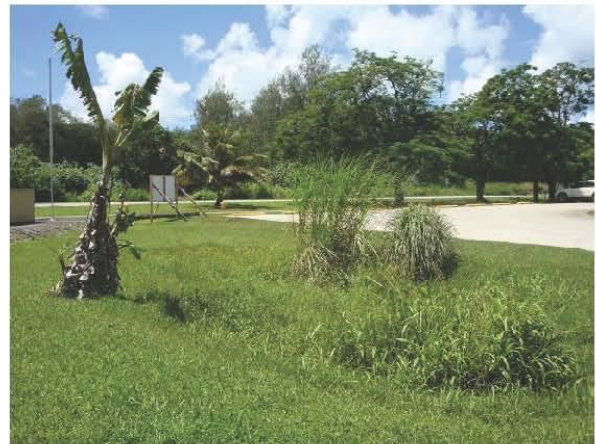
Figure D-8. Example of a rain garden in Saipan.

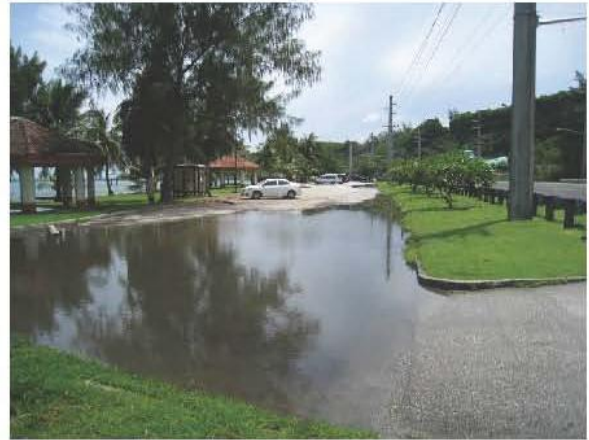
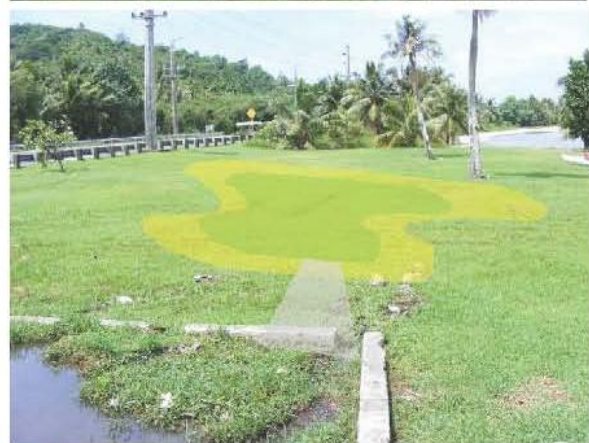
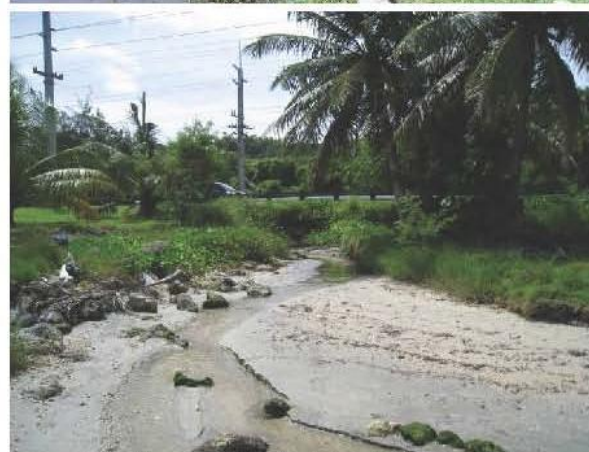
Figure D-9. Images of the flooded parking lot area (top), adjacent open space for a proposed wetland (middle), and the roadway outfall channel (bottom photo).

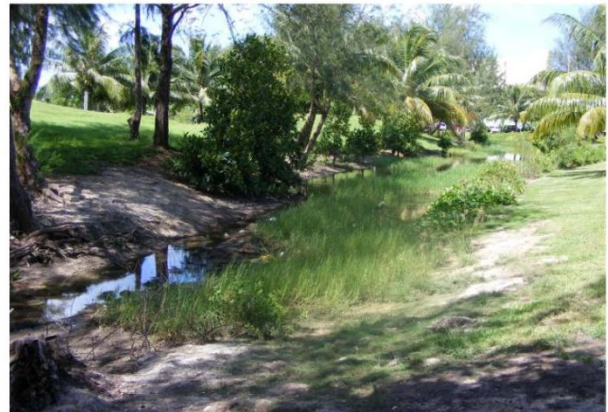
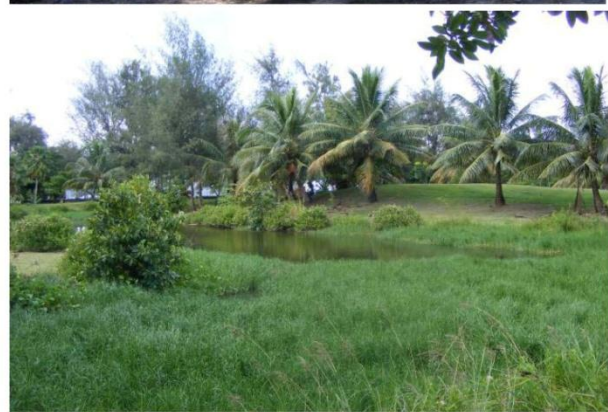
Figure D-11. Example of a wetland treating parking lot runoff in (upper photo) and wetland plantings in a stormwater channel (lower photo) in Saipan.

Project examples are shown in Figure D-11.

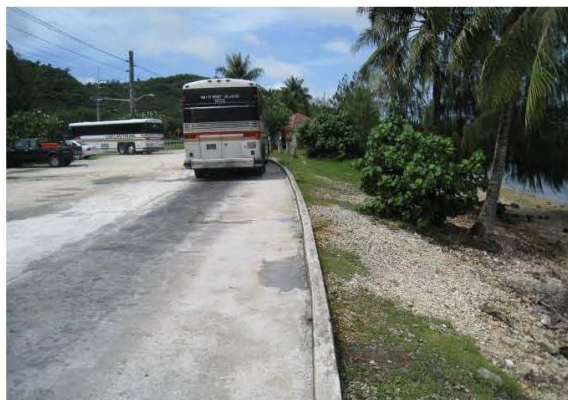
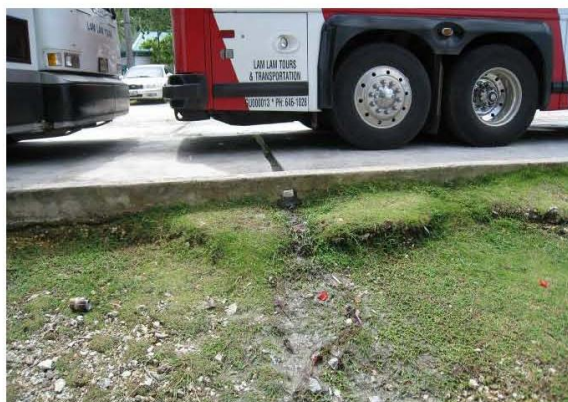
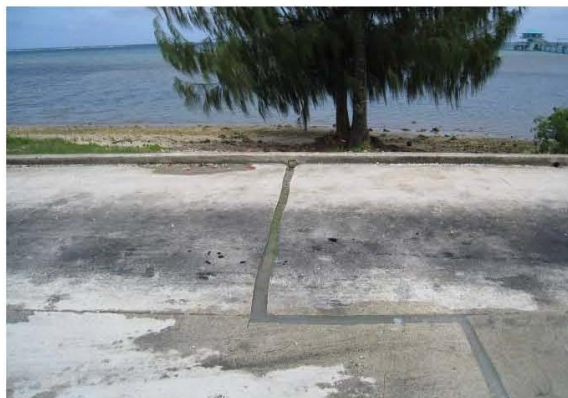
Figure D-12. Runoff from the concrete bus loop is conveyed across the concrete pad via grooves and sheetflow, and discharges through square notches in the curb to the nearby beach and water. There are oil stains on the concrete pad and bus exhaust deposits other pollutants on the concrete.

Runoff from the concrete bus loop and parking lot drains directly to the beach and water. There are several grooves in the concrete that drain runoff through slots in the concrete curb. There are many oil stains in the area, and the bus exhaust also deposits pollutants onto the concrete. There is currently no filtering or treatment mechanism for the pollutants (see Figure D-12).

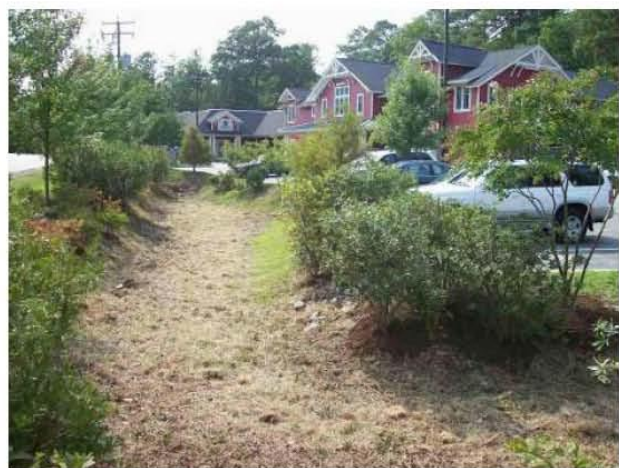
Figure D-14. Example of a surface sand filter treating parking lot runoff.

Figures D-14 and D-15 show examples of two types of sand filters.

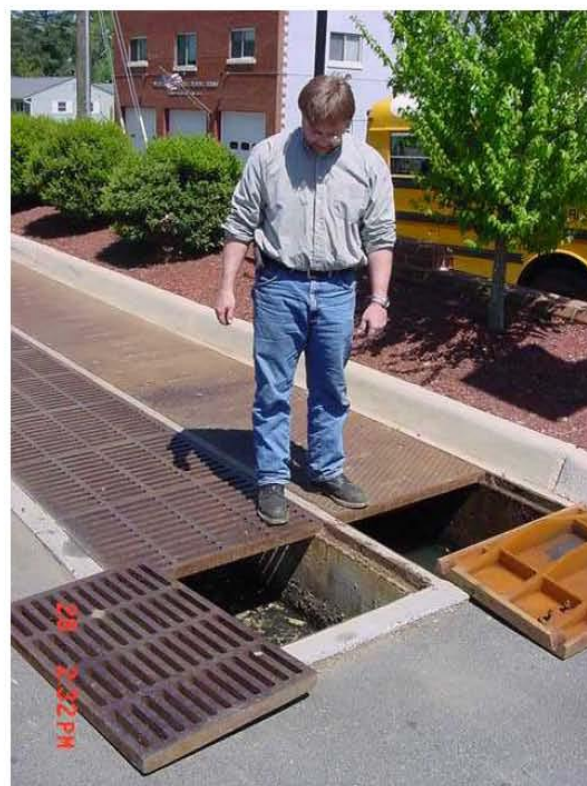
Figure D-15. Example of sand filter with grate top. The grates provide maintenance access.

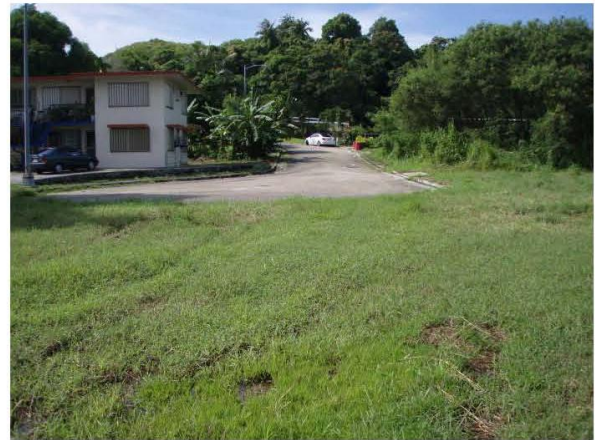
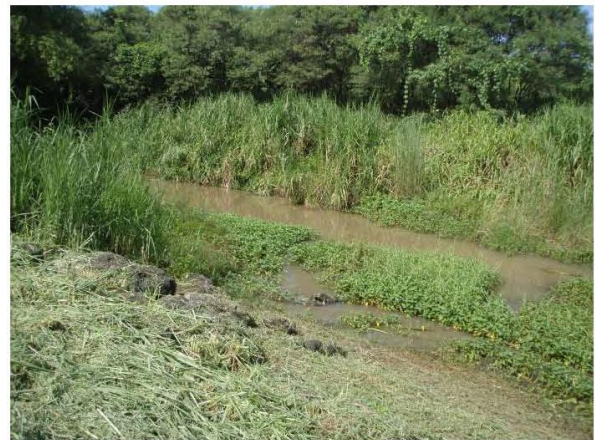
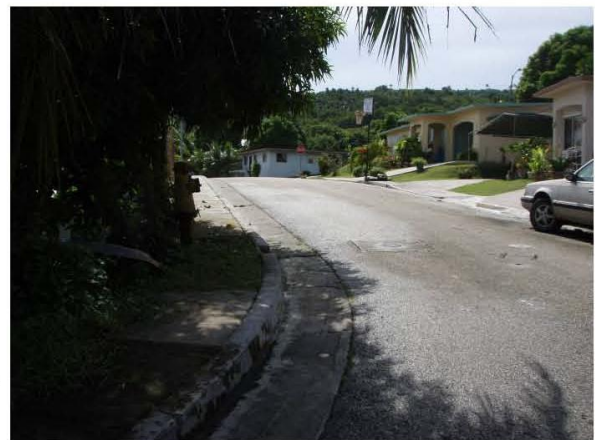
Figure D-16. Open space area for community bioretention (top). Plant native trees and buffer vegetation along Asan River (middle). Notice turbid flow in stream. Runoff to cul-de-sac is generated on Limitaco St. and includes residential driveways and, in some cases, rooftops (bottom).

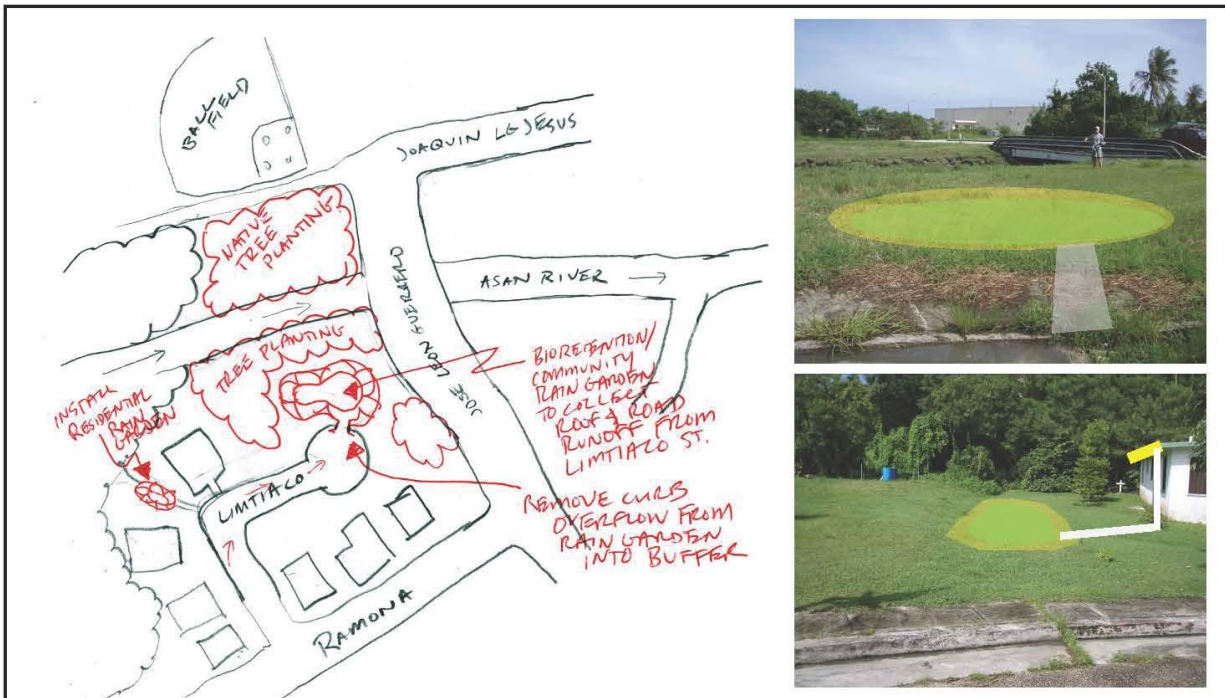
Figure D-17. Plan view of proposed bioretention/community rain garden (conceptual – not to scale) adjacent to the cul-de-sac (top photo) and small rain garden at house up the hill (bottom photo).

Runoff will enter a pretreatment forebay to remove sediment and debris before flowing into the bioretention cell. Overflow volumes will spill out as sheet flow into the stream buffer (see Figure D-18).

Further up the hill is a location at a private residence that is a good candidate for installation of a rain garden in an existing depression between two houses. Installation of gutter and downspouts can direct rooftop runoff to the rain garden, which can be used to grow harvestable species such as taro, banana, white lily, or kang kung.

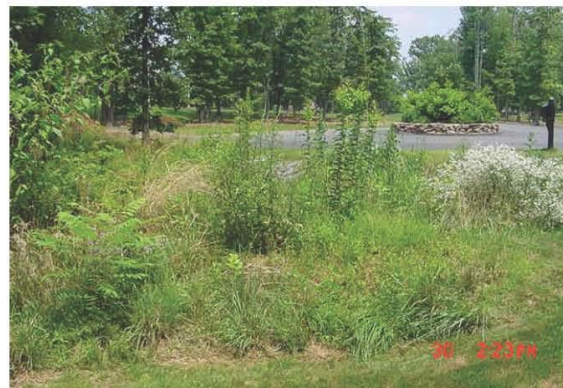
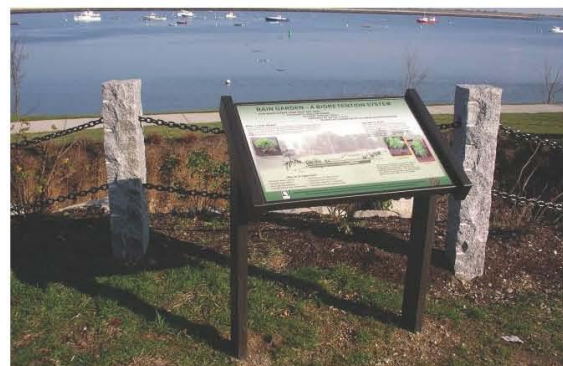
Figure D-18. Example of a large bioretention facility collecting runoff from a cul-de-sac and educational signage describing a rain garden along the waterfront (bottom).

Figure 18 shows examples of a bioretention facility at the end of a parking lot and educational signage. While these are examples from mainland US, they can be adapted for Guam.

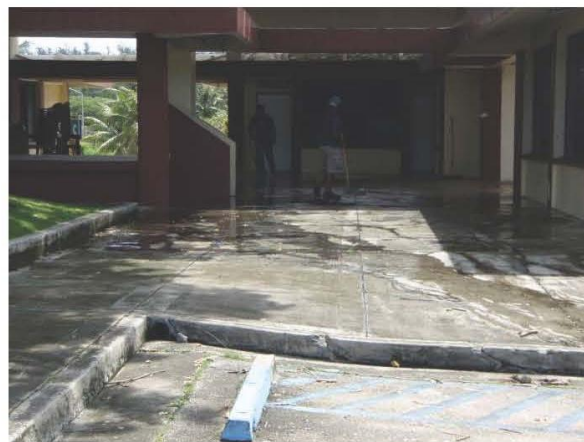
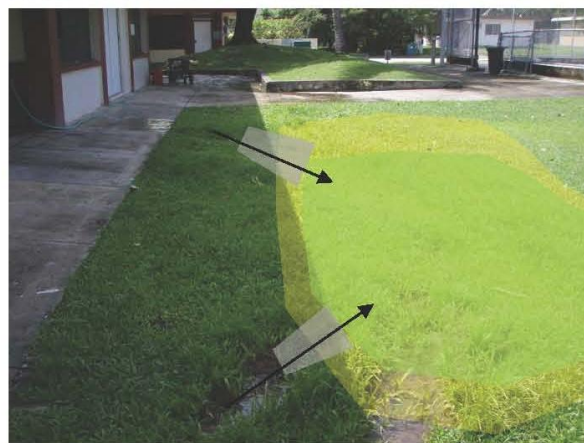
Figure D-19. Rooftop downspout through curb and onto parking lot. Washwater drains to parking lot, which drains to river (top). Proposed rain garden location in rear where roof leaders open into grassed area (lower).

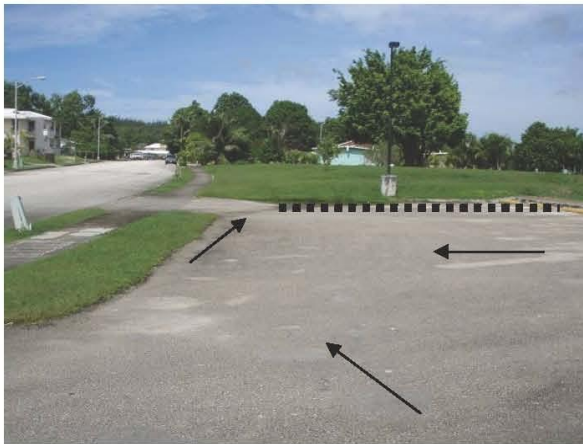
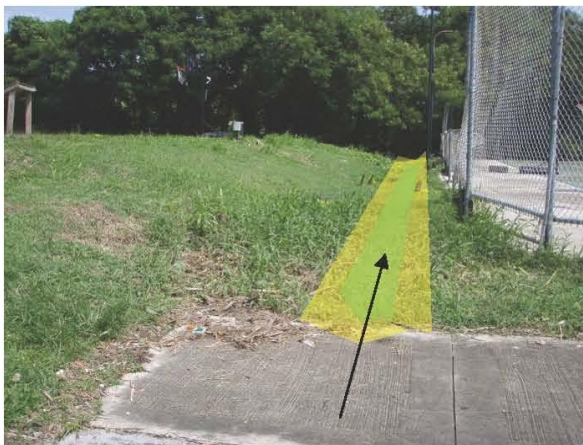
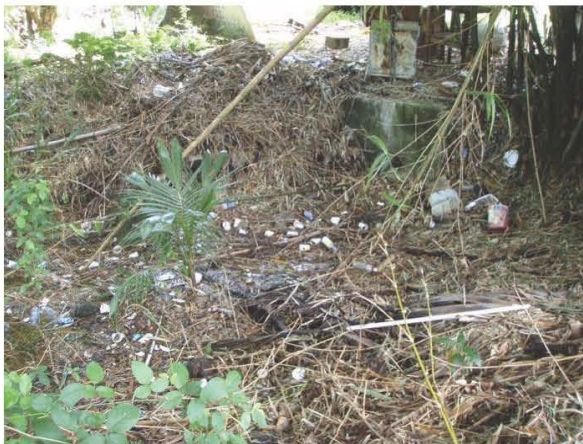
Figure D-21. Water collects in small side parking lot. Install trench drain to convey water to existing swale (top photo). May need to excavate swale to appropriate depth for trench drain invert to achieve positive drainage. Enhance swale with vegetation (middle). Trash in wetland area (bottom).

Grade and elevations of side lot may make getting runoff into swale difficult. Trench drain can have reverse slope, but swale may require additional excavation to obtain proper invert. The design should consider an appropriate method for crossing the existing sidewalk.

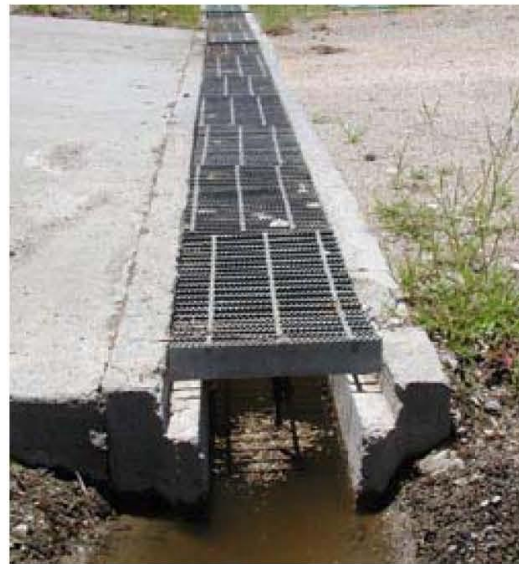
Figure D-24. Example of a trench drain that can be used to convey runoff from parking area to bioswale.

Figures D-23 and D-24 show examples of a rain garden and a trench drain. The rain garden for the Asan Community center should use local plants.
