# Rio Fajardo Watershed Pollution Threat Analysis

## Recommended Integrated Watershed Management Actions Demonstrative Pilot Project March, 2017

**Submitted By:**  
Protectores de Cuencas, Inc.

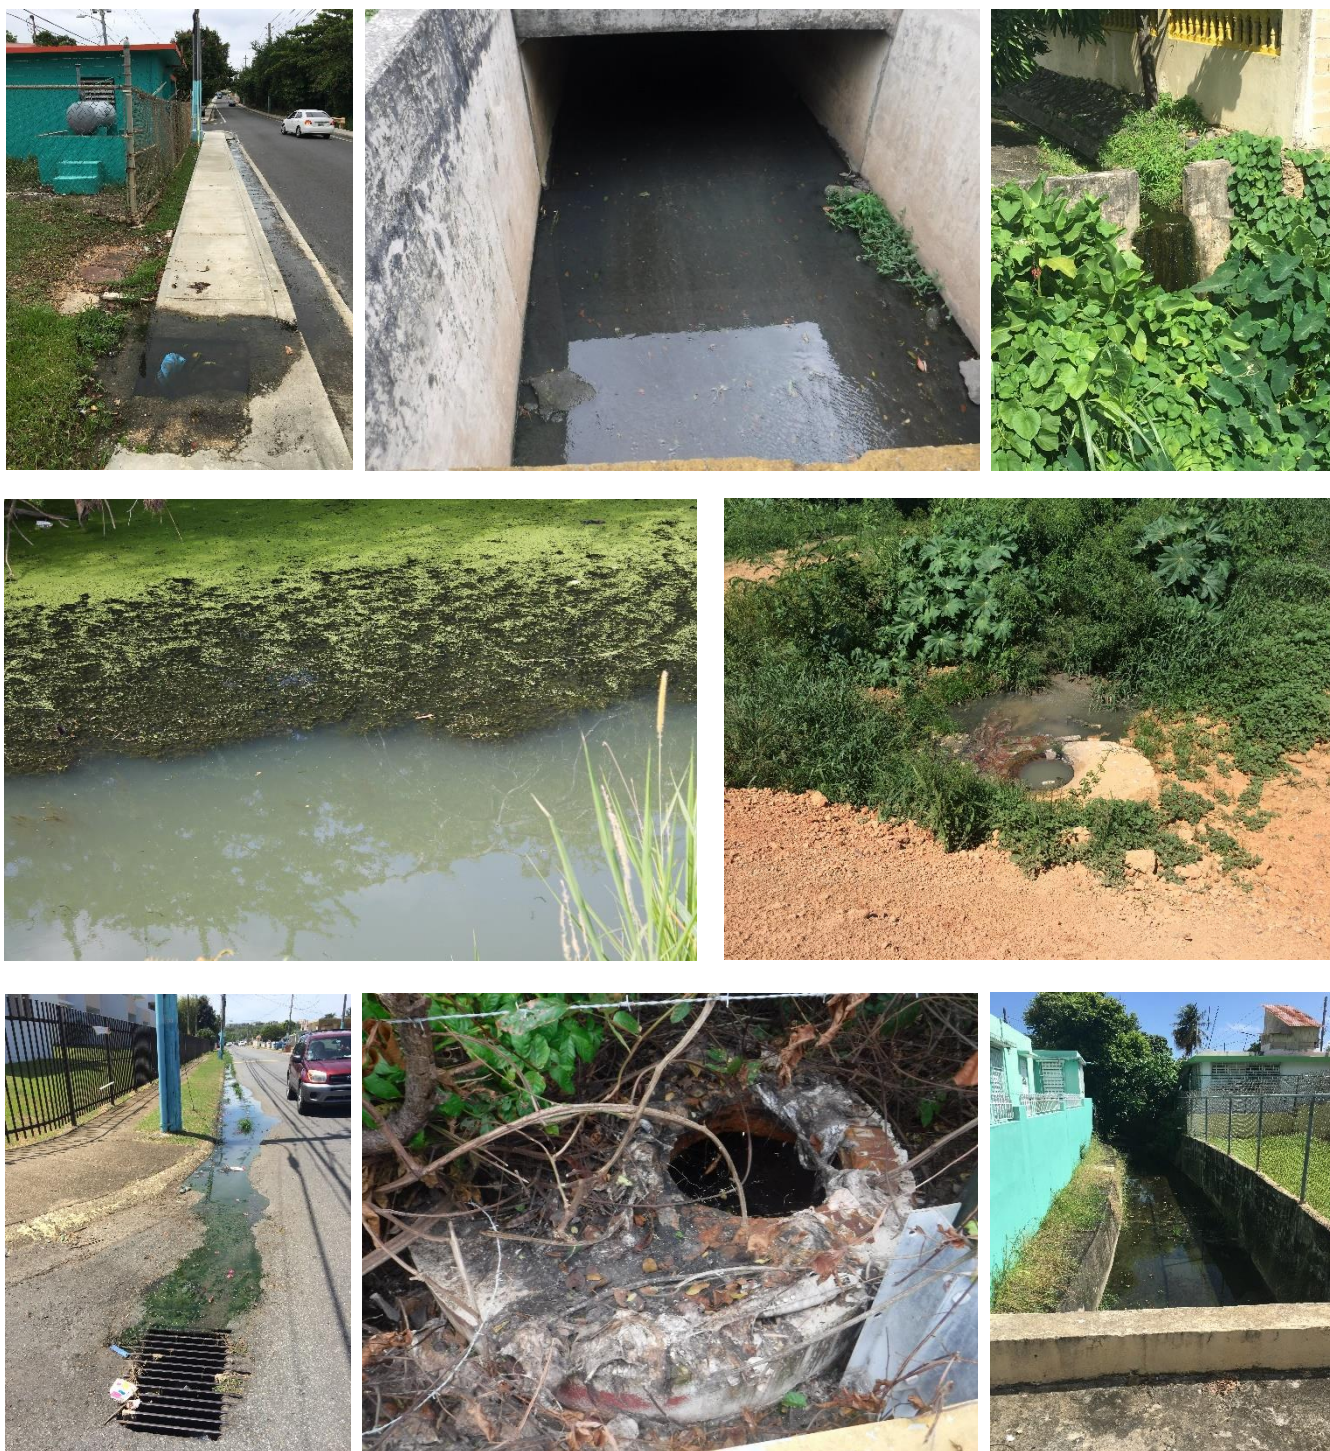
Figure 8. Examples of failing sewer infrastructure across the RFW area. Images provided by Hector Sanchez from the Fajardo Municipality Planning Board and PDC staff. Pictures are from 2014, 2016 and 2017 showing persistent problems of sewage overflows.

It is important to mention that even if most of the urban areas are serviced for sewer treatment, it is a system that has constant failures and overflows to the stormwater system (Figure 8). This is mainly caused by clogged manholes and pumping issues. The system requires an intense, constant maintenance protocol. The other main problem encountered with the sewer system is that there's a high percent of homeowners that are not connected to the system and there is very little information about the percent of people that are actually connected. The main reasons causing these problems are in most cases, the lack of financial resources from the homeowners, the lack of enforcement protocols and actions. PRASA charges a fee to homeowners when a sewer system is available in the area and the connection point offered to people is installed adjacent to each property and the homeowner is responsible for the cost and installation and connecting their home or business to the system. Sometimes in the lower parts of the watershed, it requires a pumping system at the expense of the owner. The best scenario estimates that people

connected to the system are less than 40% of the total population of areas with sewer system in place (from conversations with PRASA personnel, 2017).

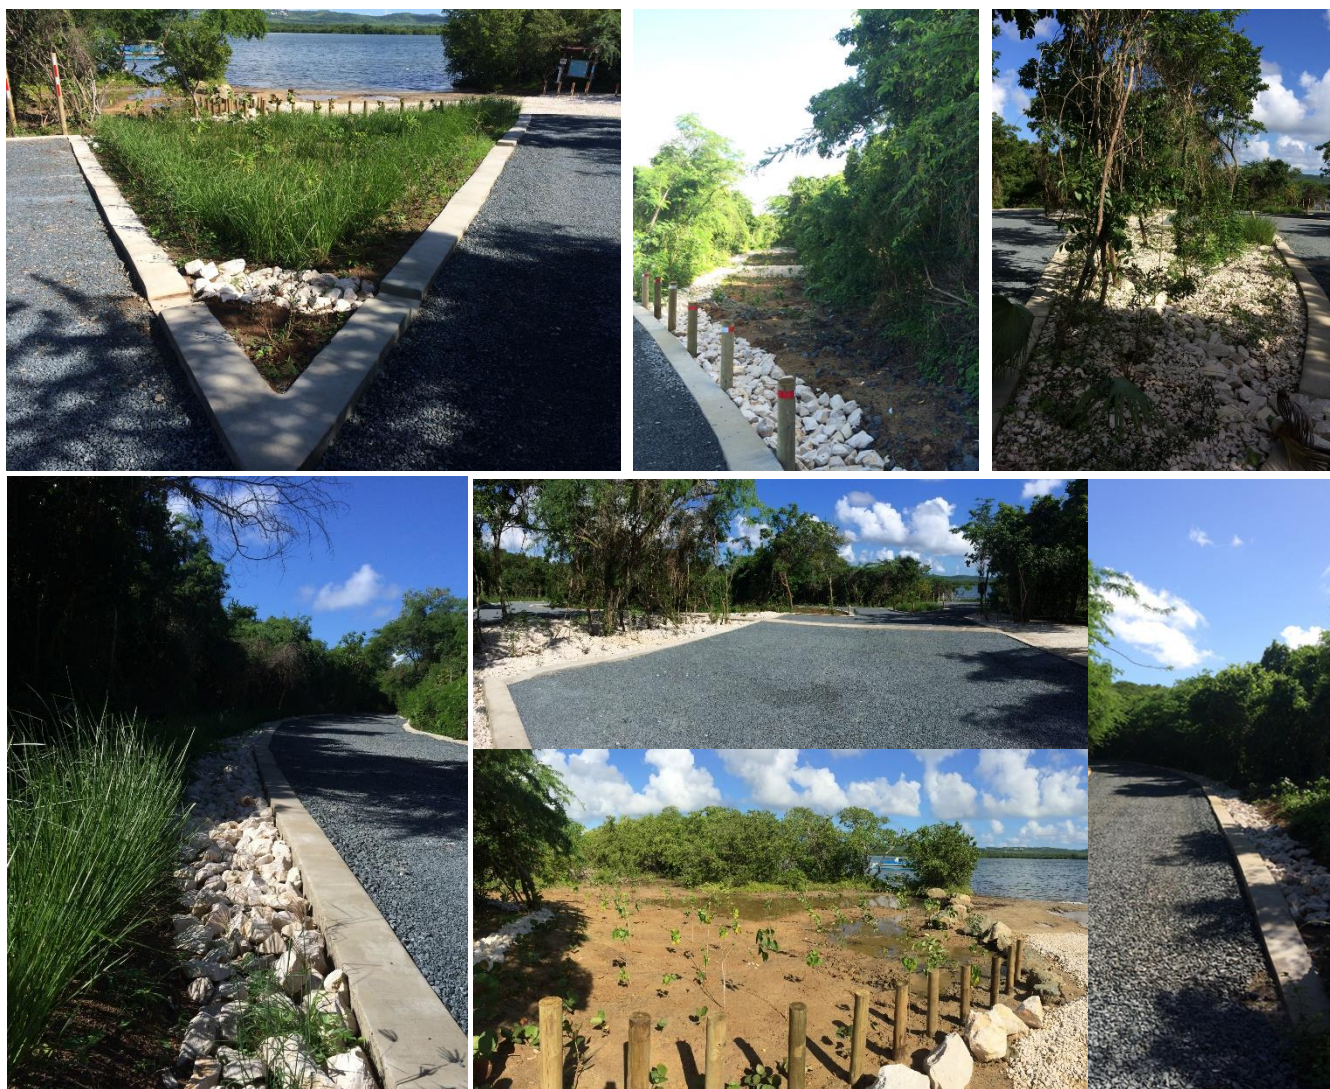
Figure 23. BMP's implemented following a train treatment approach in Mosquito Bay in Vieques Puerto Rico. Practices include bioswale, bioretention, raingardens, constructed treatment wetlands and permeable parking.

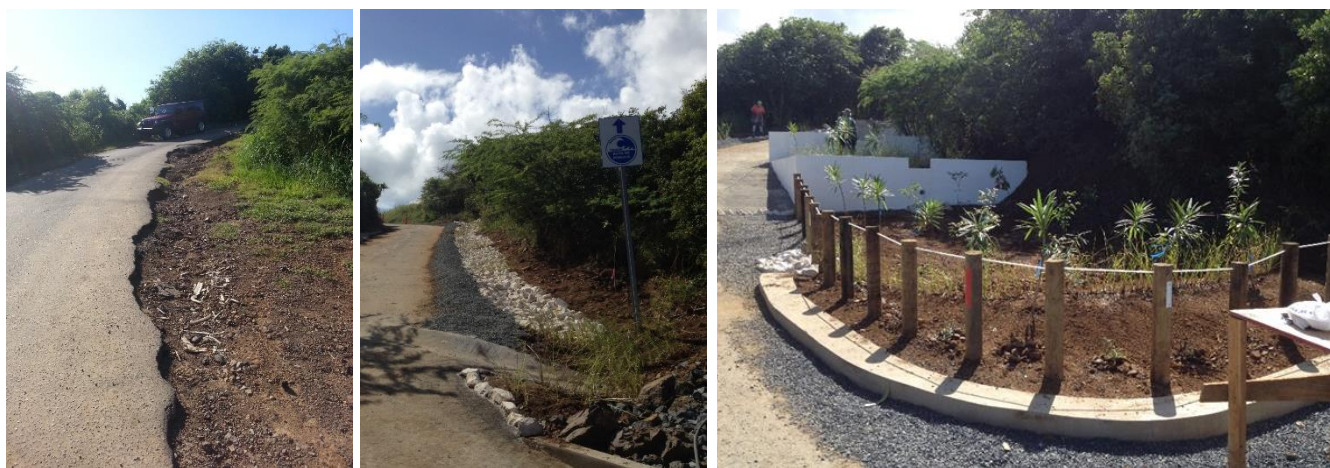
Figure 24. BMP's implemented following a train treatment approach in Zoní Beach at Culebra Puerto Rico. Practices include bioswales, bioretentions, raingardens and permeable parking.

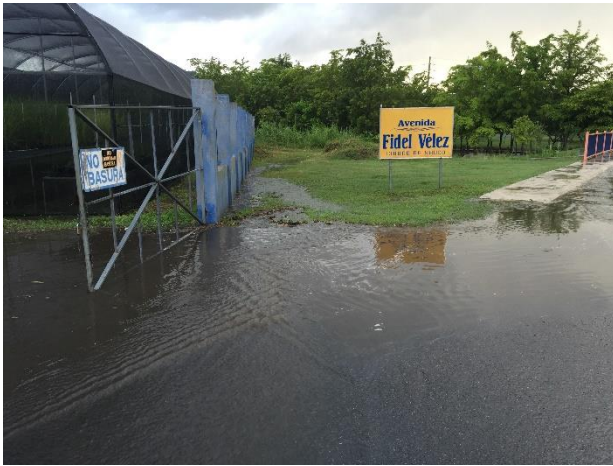
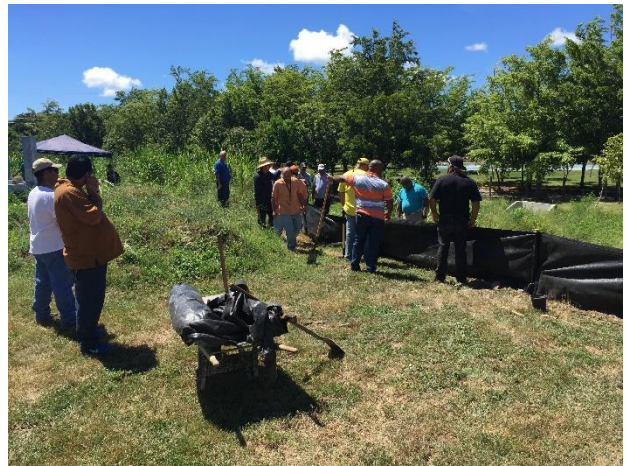
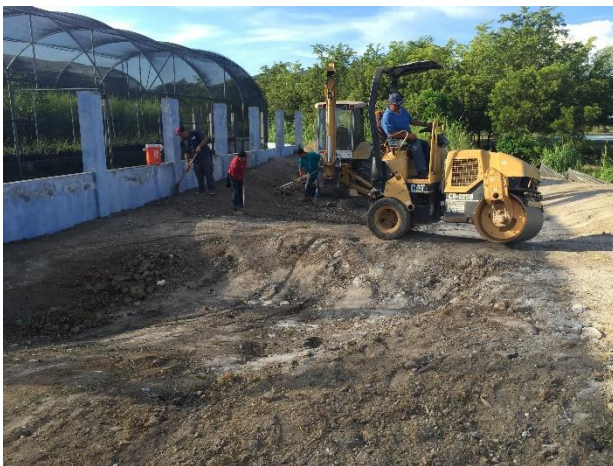
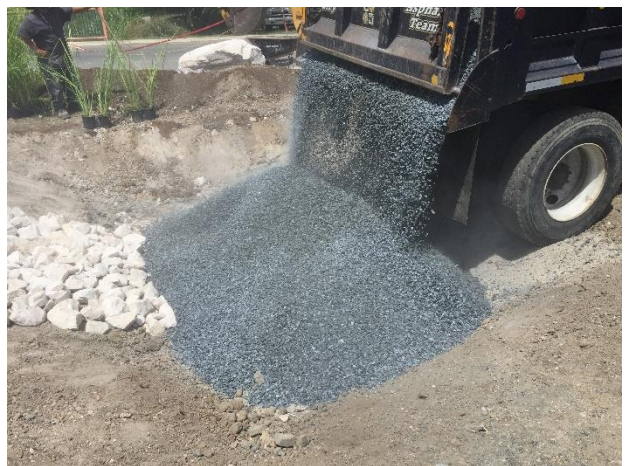
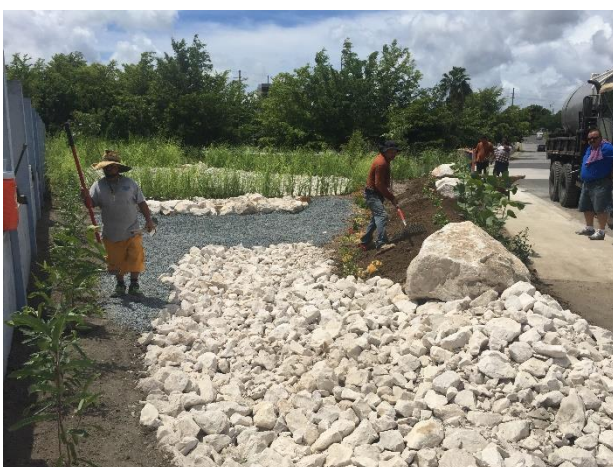
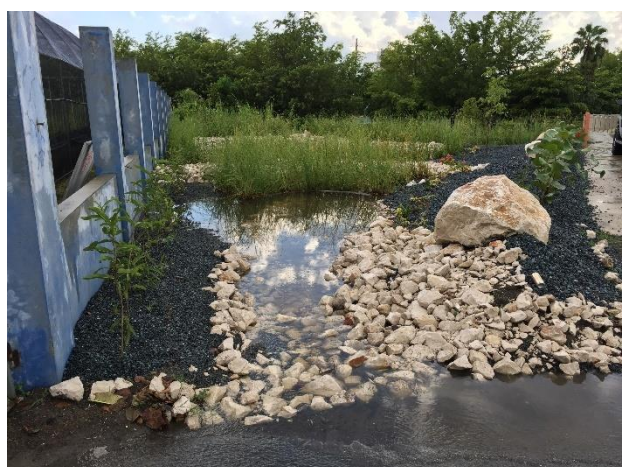
Figure 28. BMP's implemented following a train treatment approach in Yauco, Puerto Rico. Practices include bioswales, bioretentions and raingardens.

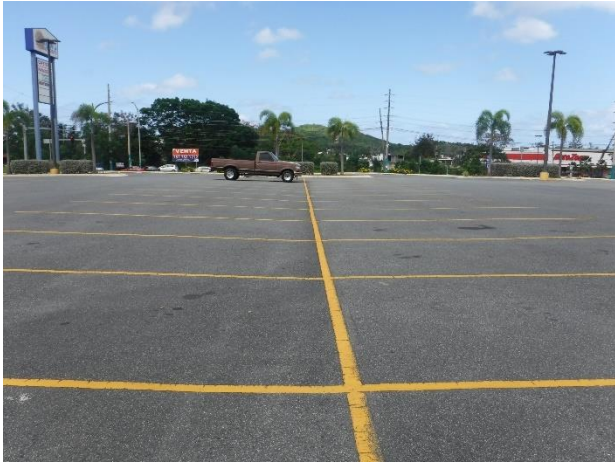
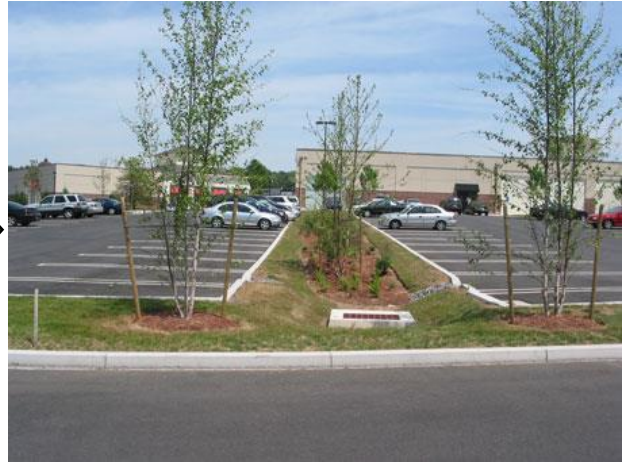
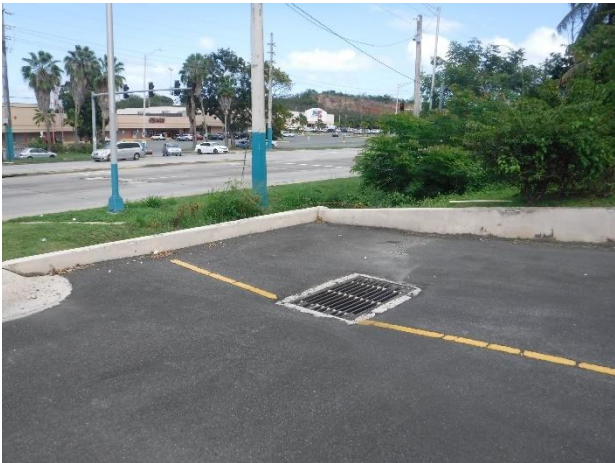
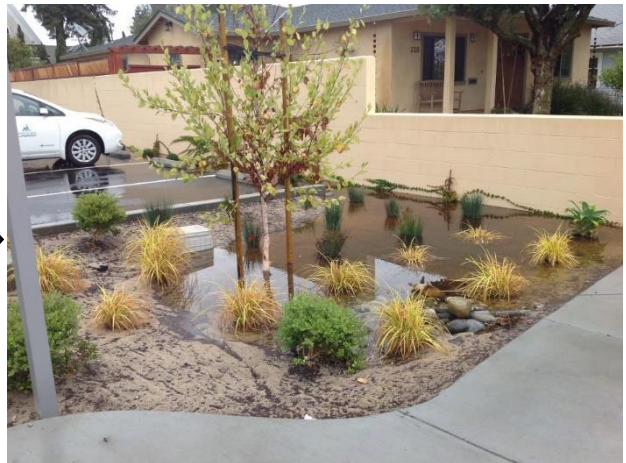
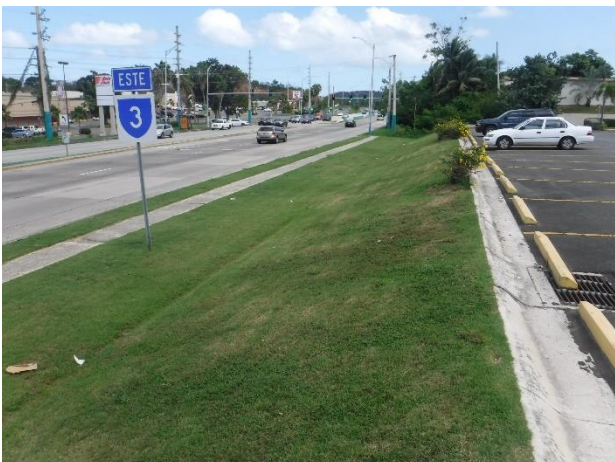
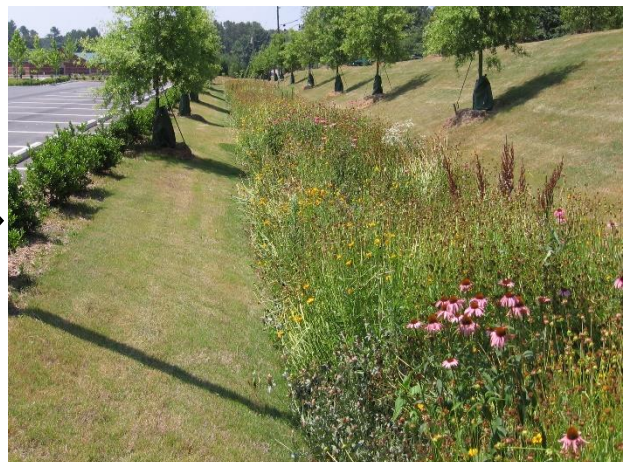
a river, stormwater from these impermeable surfaces can be transported first to a series of planters that will serve as biofilters constructed with a series of gravel layers and vegetative cover. Where the space is available, multiple BMP's should be constructed so that they will hold the water until pollutants settle and are filtered. The treated runoff is then released slowly into the river, reducing flooding and pollution in the rest of the system. The following Illustrations serve as an example of the transformations that can be achieved with the implementation of BMP's on existing parking lot areas. The left side images are from an existing parking area near road PR-3 in the RFW and on the right, we can see examples of the possible BMP's GI practices that can be implemented from similar areas where these practices have been implemented (Figure 30). These practices can be implemented without greatly altering the existing land uses. Minimal parking areas will be lost after BMP's are implemented with high improvements to the landscape as a value added to the sites that can serve as incentives to the landowners to agree to be part of these restoration efforts.

Figure 30. Images on the left are of an actual parking area near PR-3 and on the right comparative areas where BMP's have been implemented (from internet search).

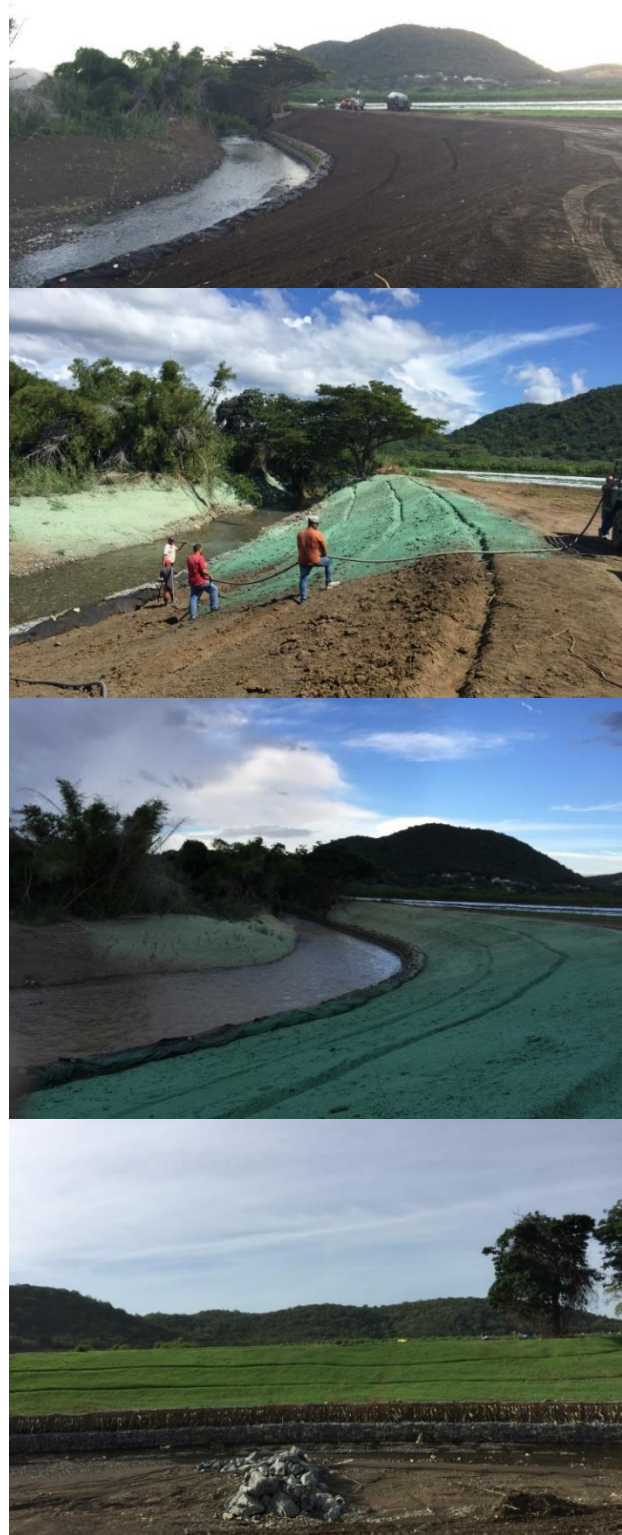
There are different types of machinery or hydromulchers on the market. The main difference between these different options is the size of the machine and its tank capacity. In order to work with wood based mixtures, a specialized machine with greater power is needed. Protectores de Cuencas, Inc. has one of these specialized machines for wood based mixtures, with a water storage capacity of 325 gallons, making it the perfect combination of power and size adequate to reach areas that would be impossible to reach with larger equipment. With this equipment, we can cover an area between 1,200 and 1,500 ft<sup>2</sup> per tank applying close to 10 tanks daily in order to cover one acre of land daily, depending on the slope angle and accessibility to the area (Figure 38).

Figure 38. Hydroseeding implementation by PDC on a riverbank stabilization project in the Río Loco, Guánica Puerto Rico

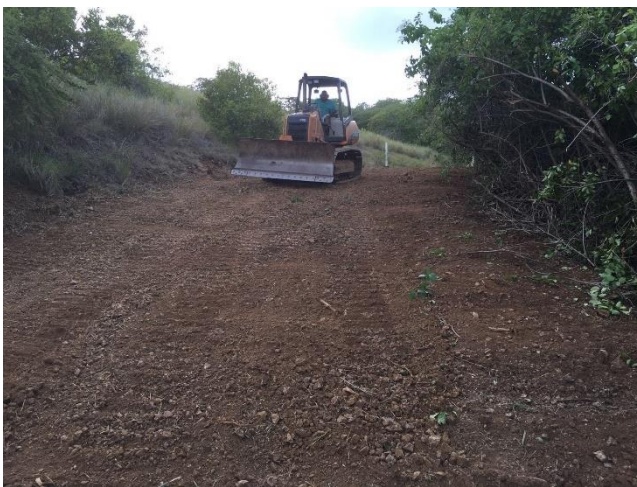
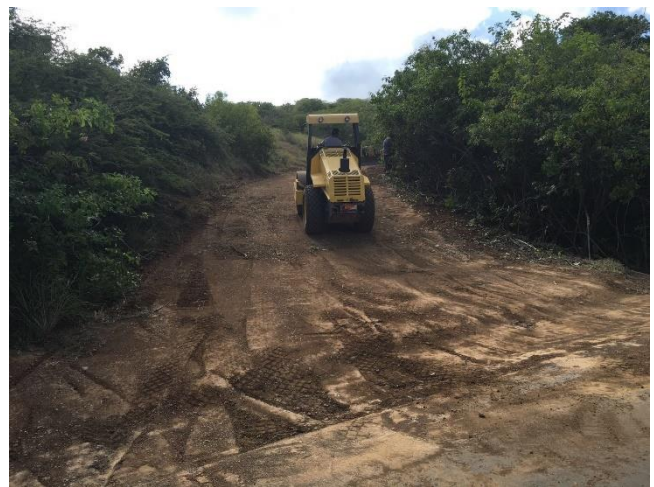
Regrading refers to the process of diverting road incline to desired topography to divert runoff to implemented BMP's. Incline of the road can be done to the inner, outside or both sides of the road depending on the treatment that will be constructed to deal with the runoff and the existing slope grade (Figure 49). This practice is highly recommended as it will be very difficult to impossible to implement other BMP's without regrading. All

Figure 39. Example of regrading and compaction by PDC on a dirt road in Culebra, Puerto Rico.

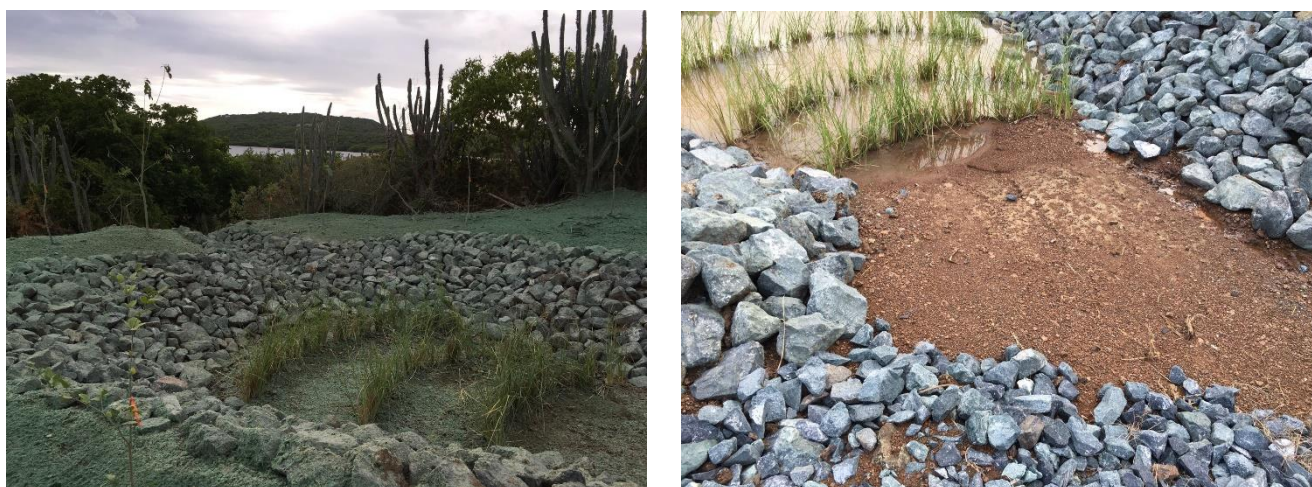
Sediment trapping techniques have demonstrated that work better when constructed with functional redundancy. Integrated sediment trapping is the most effective approach to manage sediment migration when compared with individual and combined measures alone. Sediment traps are constructed to help filter storm water that is causing erosion problems and discharging sediments (Figure 41).

Figure 41. Example of a sediment trap built by PDC in Culebra Puerto Rico.

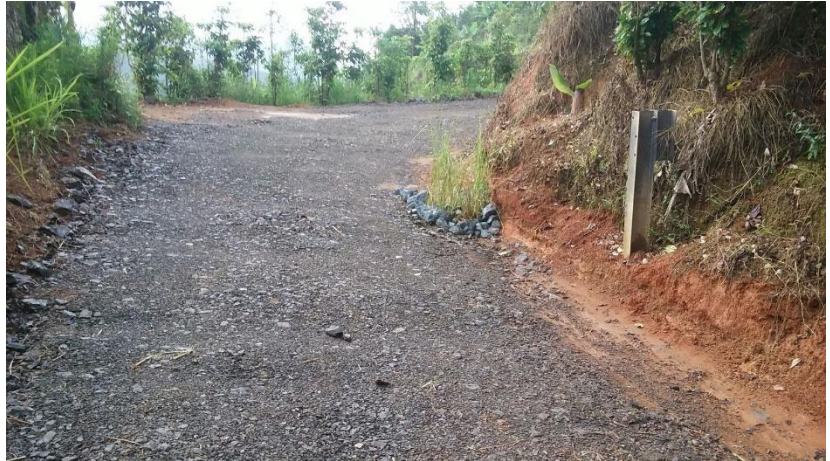
The use of this paving material is one of the most effective practice that can be implemented on dirt road stabilization as it is a cost-effective way of preventing road deterioration by rainfall and subsequent runoff and erosion problems.

*Figure 42. Example of gavel pavement done by PDC on a coffee farm on Yauco Puerto Rico*

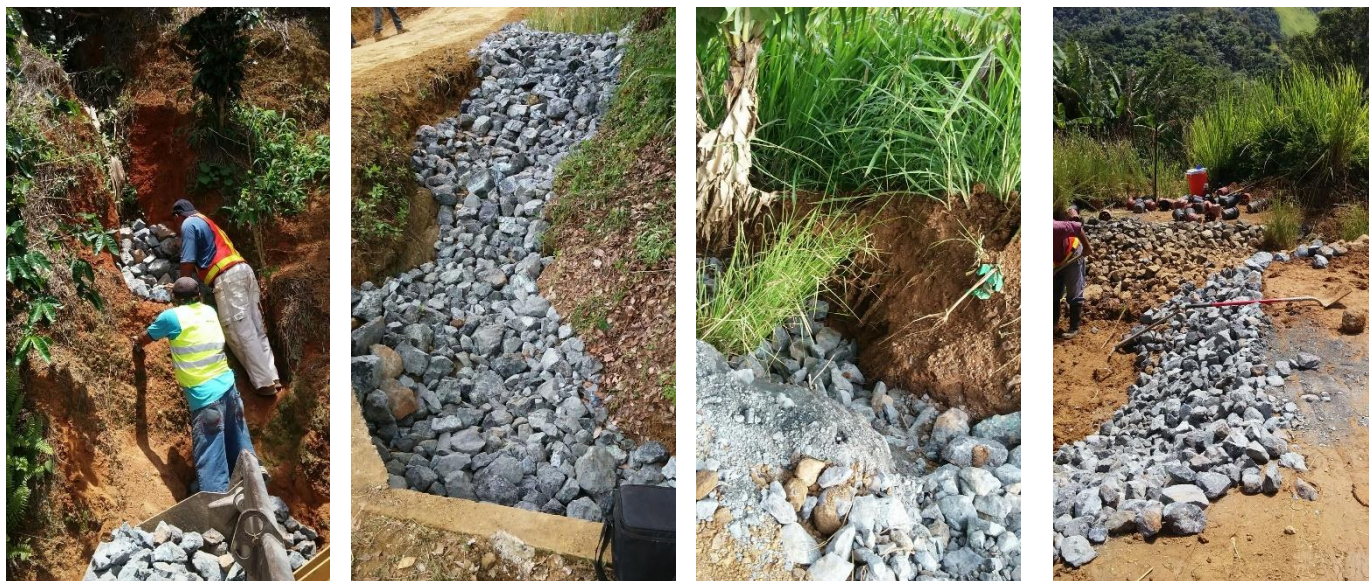
to prevent erosion or undermining of the natural underlying material. Another recommendation is to use hydroseeding on the areas prior to installing the stones. The rock should be placed as soon as possible after disturbing the site, before additional water is concentrated into the drainage system. Over all, rip-rap is cost effective and easy to install, requiring only that the stones be manually arranged so that they remain in a well-graded

Figure 43. Examples of rip-rap practices implemented by PDC on a coffee Farm on Yauco Puerto Rico.

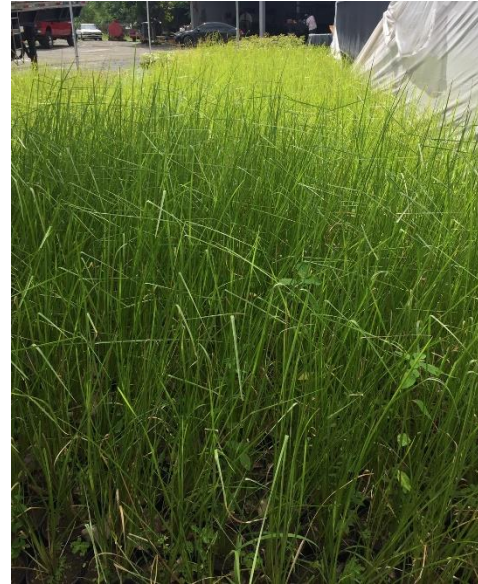
moisture and trapping sediment on site. The extremely deep and massively thick root system of Vetiver binds the soil and at the same time makes it very difficult for it to be displaced under high velocity water flows. This very deep and fast growing plant can also tolerate extreme drought conditions as well as moderate soil salinity concentrations with a highly effectiveness on steep slope stabilization (Figure 44).

*Figure 44. Vetiver plants grown on PDC's Nursery in Yauco Puerto Rico*

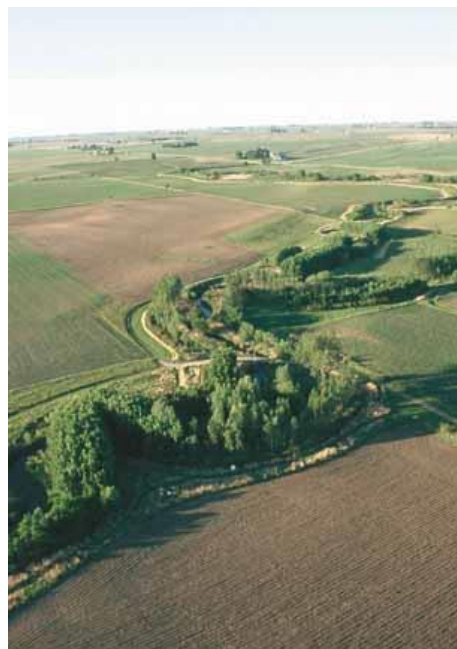
Figure 46. Example of a riparian forested buffer adapted from NRCS.

sediment, nitrogen, phosphorus, pesticides and other pollutants from reaching a stream (Figure 46). RFB are most effective at improving water quality when they include a native grass or herbaceous filter strip along with deep rooted trees and shrubs along the stream. Riparian vegetation is a major source of energy and nutrients for stream communities. RFB provide valuable habitat for wildlife. In addition to providing food and cover they are an important corridor or travel way for a variety of wildlife. Riparian vegetation
