Removal of Grounded, Derelict or Abandoned Vessels as Site Restoration¹

Ian Zelo
NOAA Damage Assessment Center
7600 Sand Point Way, NE, Seattle WA 98115

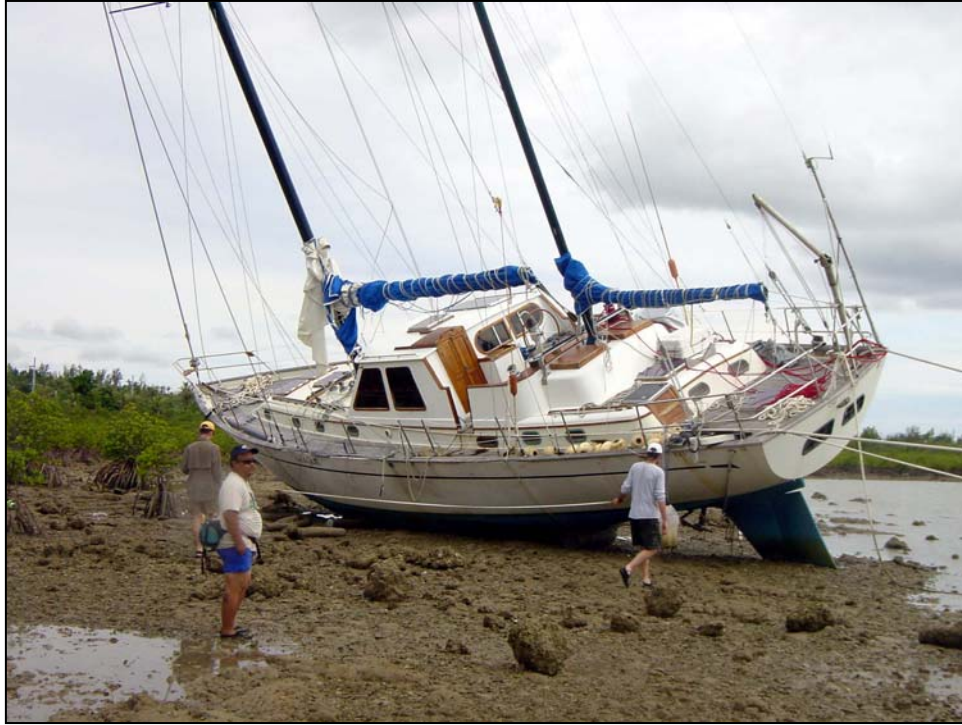
Figure 1. The 58 foot ketch *Seagull*, grounded in Sasa Bay Marine Preserve, Guam

The *Seagull* is a 58' fiberglass ketch that grounded in Sasa Bay, Guam during Super typhoon Pongsona in December, 2002 (Figure 1). It was moored at a nearby marina, broke free during the storm and wound up hard aground adjacent to the mangroves of Sasa Bay Marine Preserve. Typhoons and hurricanes commonly result in similar incidents and in most cases the vessels sustain such damage that post-incident they are virtually worthless. In this case, however, the *Seagull* floated over a very shallow reef on the storm surge and came to rest on the mudflat with minimal damage, creating a situation where vessel removal was financially viable as long as the vessel did not sustain further damage.

Seagull was located in a marine preserve, behind one very shallow reef and surrounded by some of the islands richest mangrove areas. This made accessing the vessel from land or water difficult and potentially very costly. The vessel was owned by 5 Japanese businessmen who were not willing to pay more than the vessel was worth to remove it and repeatedly delayed salvage. There was 128 gallons of gasoline and 40 gallons of oil on board introducing the logistical complications involved with managing these substances. There was also debate over whether the submerged lands in this area were managed by Guam or the US Navy and therefore who was responsible or should be in charge of the operation.

It was Spring, 2004 before these concerns were worked out and the vessel was removed. Government of Guam and ACOE agreed to allow a 12' x60' channel to be cut as long as it was from the water side. The Navy agreed to supply a crane to lift an excavator and small barge over the reef (minimizing impact to mangroves) and to lift the barge back into the channel once the

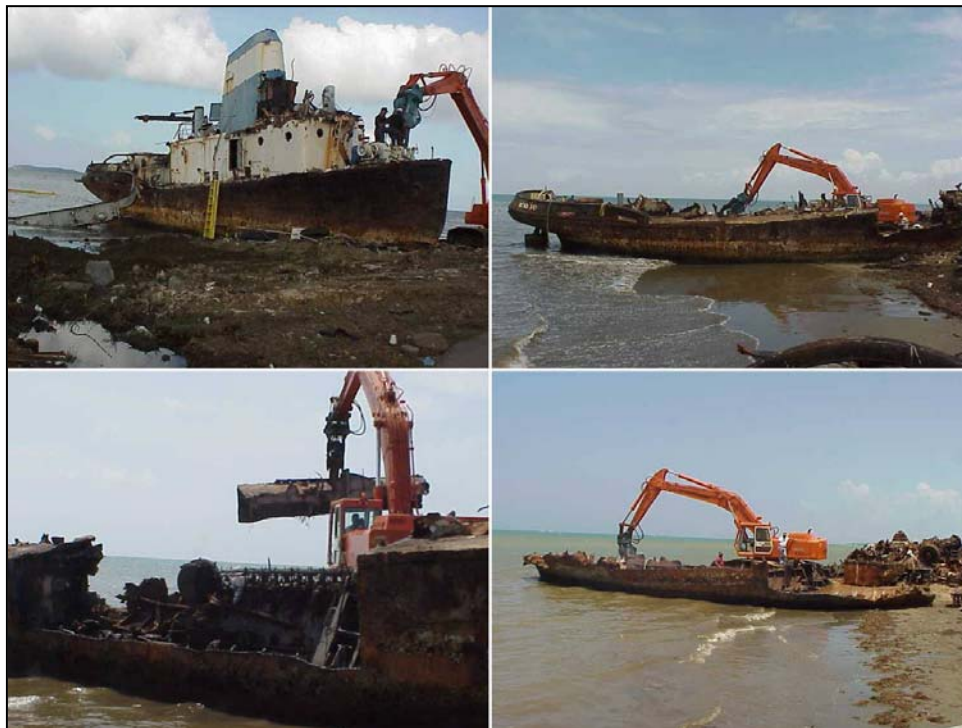
Figure 2. The M/V Kimton being dismantled in place.

In June of 2002 the operation commenced. Before the vessel could be cut up and removed, contractors had to offload 30,000 gallons of oil. While performing this task three separate caches of explosives were also discovered totaling more than 160 pounds of explosives including a large quantity of commercial C-4. Special teams from the USCG, FBI and the Puerto Rico government were brought in to handle this. In the end the vessel was cut up and disposed of inland.

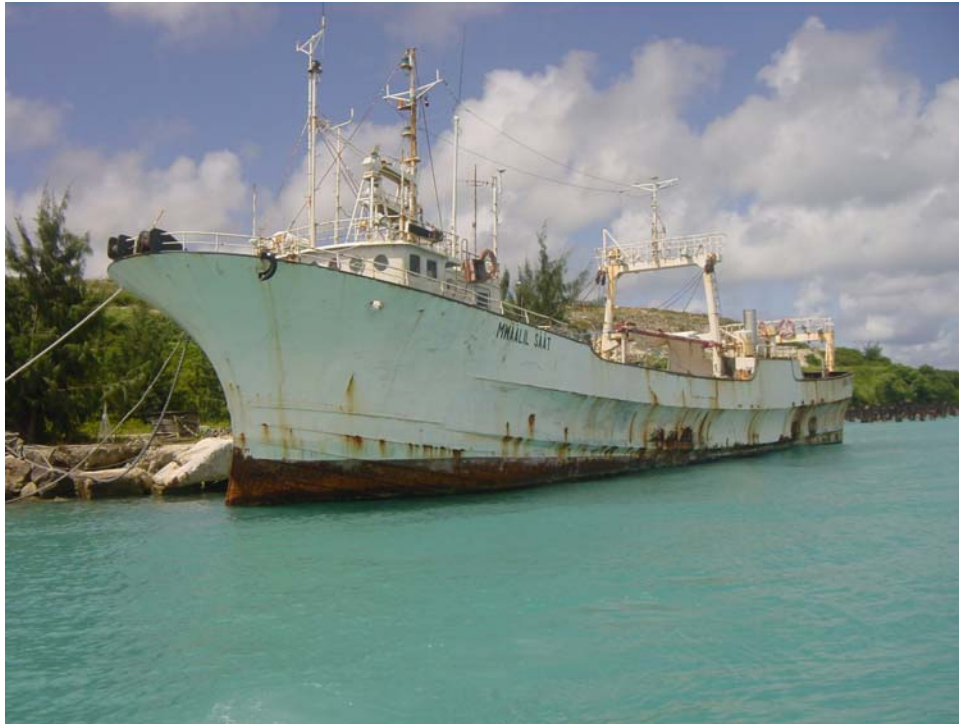
Figure 3. The Mwaalil Saat during AVP vessel surveys in June, 2003

The *Mwaalil Saat* was a 93' derelict steel hulled trawler that was tied up to the Mariana's Public Land Authority in Saipan. The vessel was surveyed by NOAA's Abandoned Vessel Program in June of 2003; a number of threats were identified and NOAA concluded that the vessel removal was a high priority. In June, 2004 the vessel broke its mooring during Typhoon Tingting and was grounded on its side in Tanapag Harbor. The vessel was leaking diesel and oil and was blocking the island's only fuel dock. The situation was critical since fuel for the island's electricity comes through that dock. The vessel rested on a sand and coral rubble bottom with low coral cover and was in close proximity to more sensitive habitats including mudflats, mangroves and coral reefs.

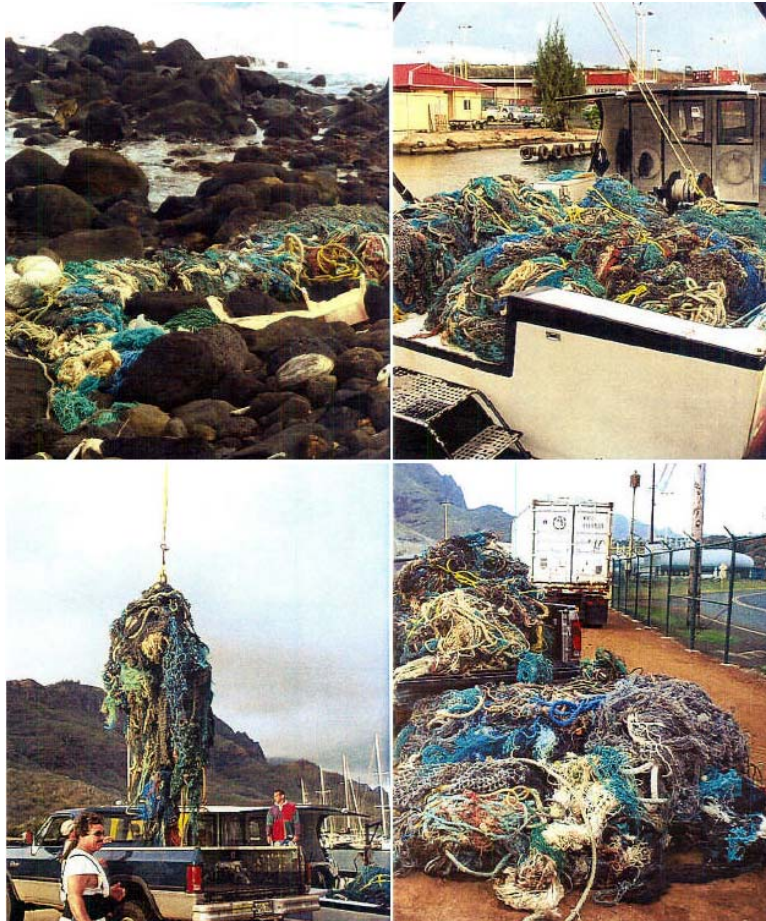
Figure 4. Net cleanup for 1998 Tesoro oil spill, Kauai, HI

scrubbers; tearing up benthic habitats as they moved with current and surf. They were smothering and crushing organisms and habitat as well as abrading what they didn't immediately destroy. The nets were also an entanglement hazard for fish, invertebrates, sea turtles, and marine mammals. The natural resource trustees and Tesoro representatives quickly realized that a net removal project would be extremely beneficial to the local environment, would mitigate most if not all of the damages that resulted from the oil and could provide an opportunity to cooperatively and cost-effectively resolve the situation. All parties agreed to the project and net removal operations were carried out during October, 2001. 20.68 tons of net were removed from the shores of Kawai, shipped to Oahu and recycled.
