St. Croix East End Watersheds Management Plan

U.S. Virgin Islands

FINAL November 2011

Horsley Witten Group, Inc
90 Route 6A, Sandwich, MA, 02563
www.horsleywitten.com

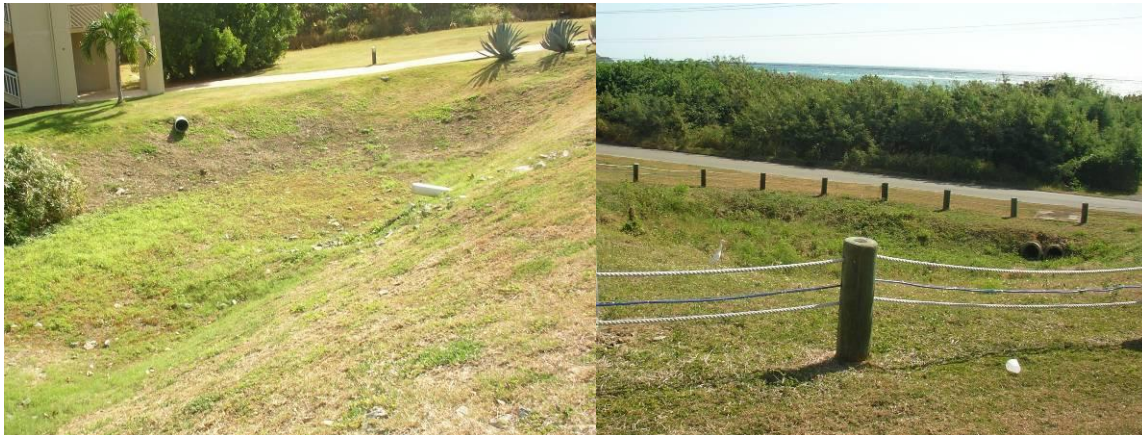
Figure 3. Existing Detention Basins in Turner Hole at Divi

Urban runoff accounts for over 40% and 30% of the total East End TSS and TN load, respectively, and there are over 500 impervious acres currently mapped in the East End. Retrofitting involves going back into existing developed areas and installing new, or improving existing, stormwater management facilities in order to improve water quality treatment and/or reduce runoff volumes to better match pre-development site conditions. With the exception of three existing detention basins associated with Divi Resort/Casino and the Villa Madeline, urban stormwater runoff is largely unmanaged in the East End (Figure 3).

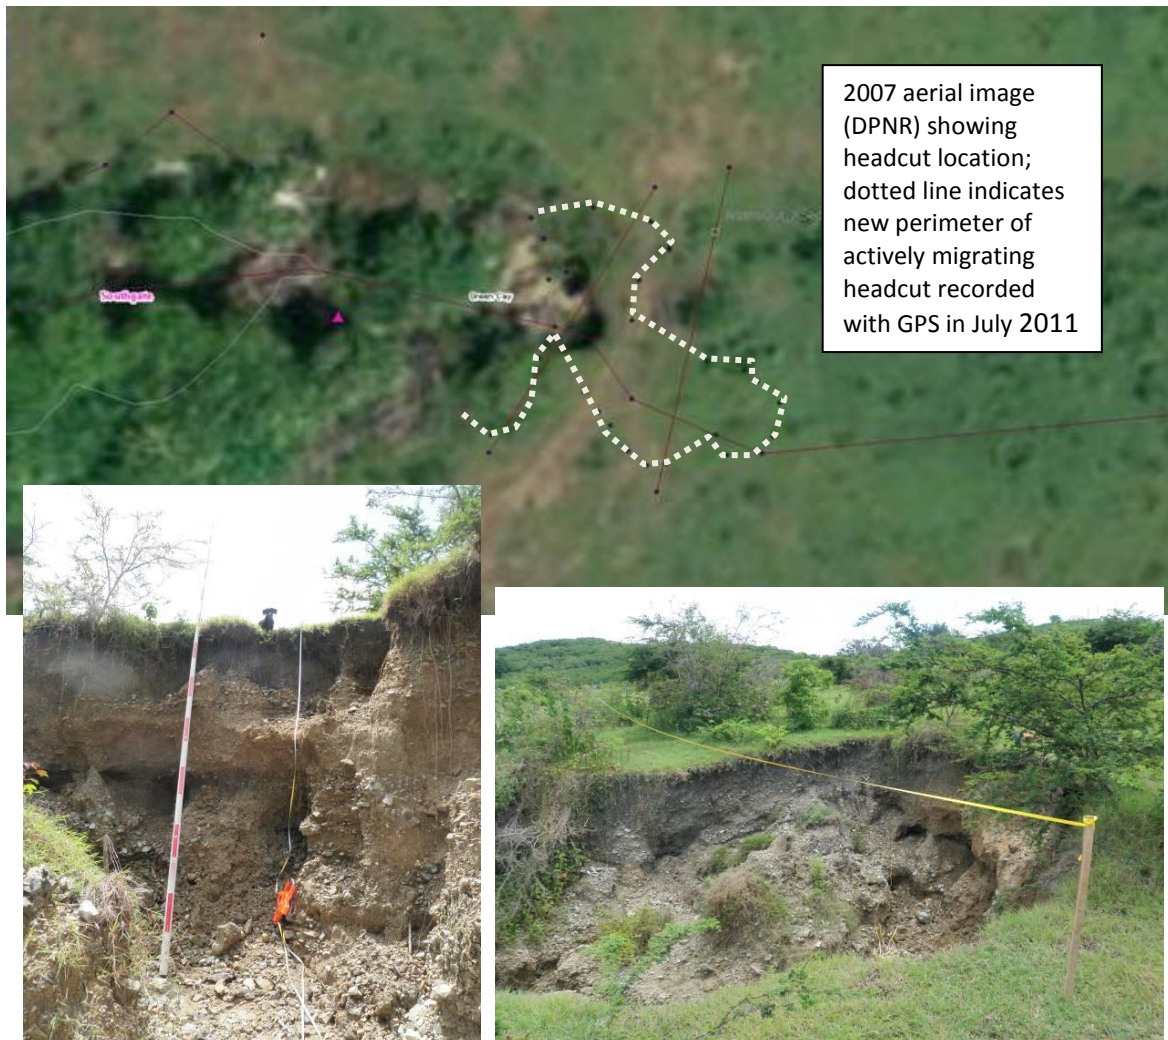
Figure 6. Forty-foot Headcut Migration of Adams' Family Gut over Four Years

Load reductions based on gut restoration were only modeled for Southgate due to the severity of gut erosion problems observed in that particular watershed, and because few projects were identified in the other watersheds. The model estimated that a 17% TSS reduction could be achieved from gut restoration projects in Southgate, assuming that initial TSS loads contribute a quarter of the total watershed TSS load initially. More effort to better understand erosion rates and sediment transport will be required to better quantify actual reductions. Figure 6 shows the perimeter of a massive headcut (recorded with GPS unit in July 2011) on the Adams Farm property overlain on top of 2007 aerial imagery. It appears that the headcut has migrated approximately 40 ft since the aerial image was taken. Assuming the average depth of the headcut is 10.6 ft, the volume change over the four-year period is approximately 485 cubic yards (13,086 cubic feet).

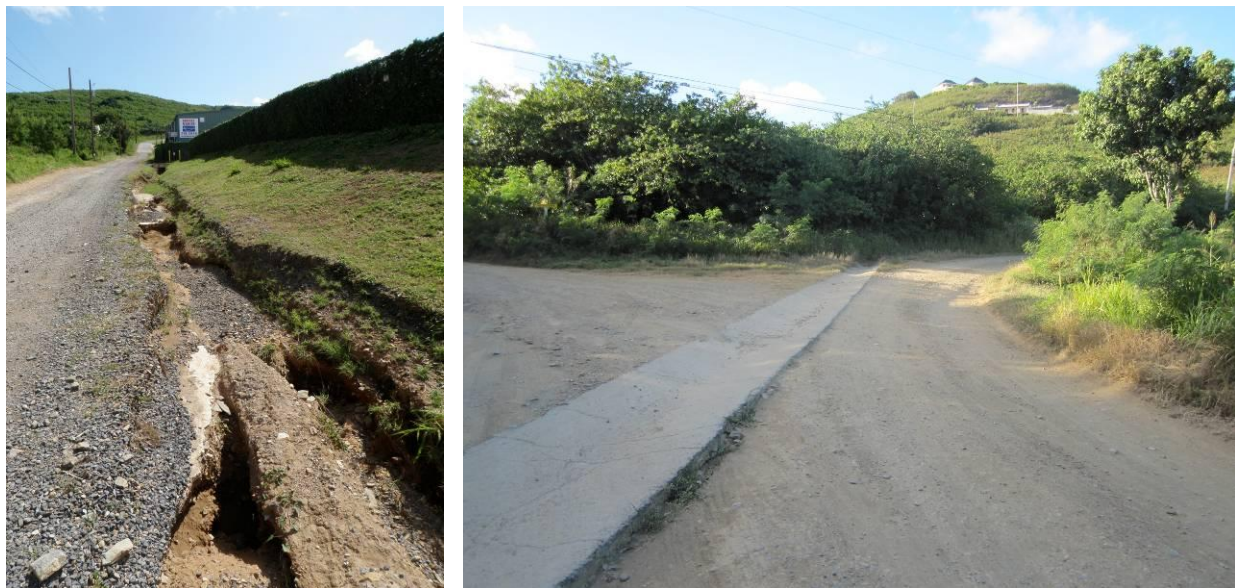
Figure 7. Priority Unpaved Road Projects in Seven Flags and Hope and Carton Hill Areas

Unpaved roads have the potential to be one of the most significant sources of sediment loading in the East End (Figure 7). Modeling indicates that **38% of the urban TSS loading to the East End is from unpaved roads**. This estimate is likely conservative given the sediment production rates measured by Ramos-Scharron and other researchers in the USVI and in Puerto Rico. There are a number of privately-owned roads and residential streets that should be high priorities for repair, paving, or other drainage improvements. The DPW does not extend maintenance authority to most of the private roads; therefore, watershed managers and homeowner associations will likely have to play a large role in securing funding for any road improvement project.

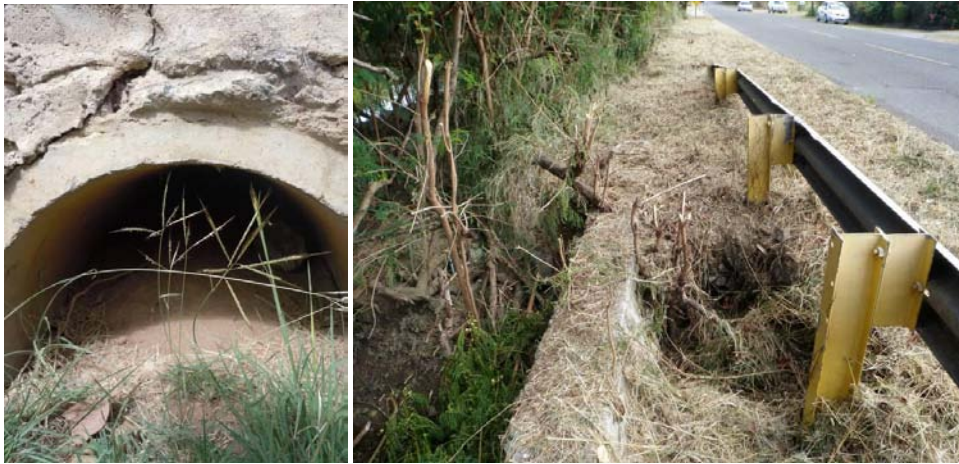
Figure 8. Blocked Culvert (Seven Flags) and Undermining of Culvert Headwall (Southgate East Gut)

Evidence of erosion, sediment transport, and wetland habitat loss from new culvert installations and unstable outfall discharges was observed in a number of the East End watersheds (e.g., Southgate, Turner Hole). Many existing culverts were completely blocked, crushed, undersized, or in need of maintenance/repair (Figure 8). Clogged culverts can cause flooding and/or the re-direction of stormwater flows to areas that are more susceptible to erosion. Data on the location, size, type, and condition of 97 visible culverts was collected and entered into GIS.

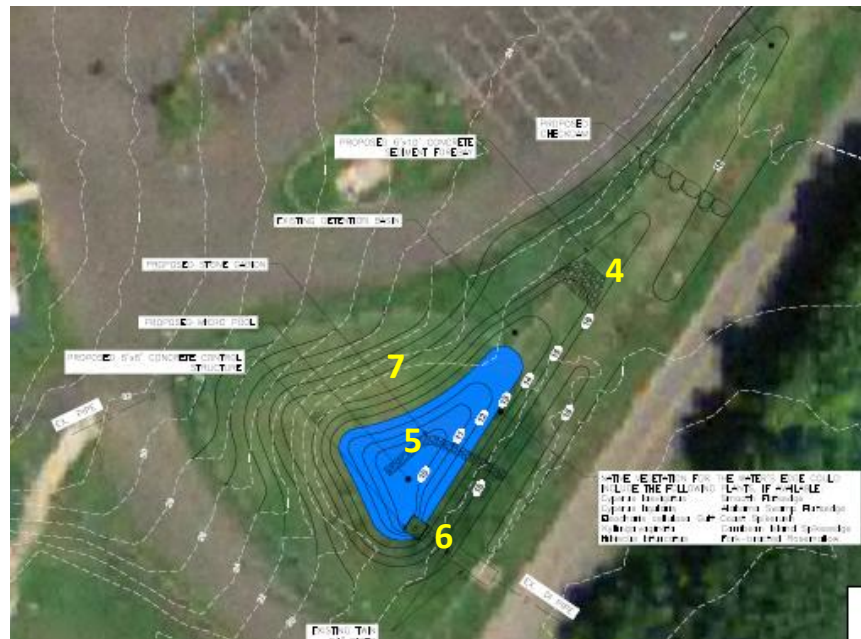
1. Flumes to grass swale
2. Excavated swale
3. Waterbars
4. Concrete sediment forebay
5. Gabion berm
6. Modified outlet structure
7. Native plantings
8. Rain gardens

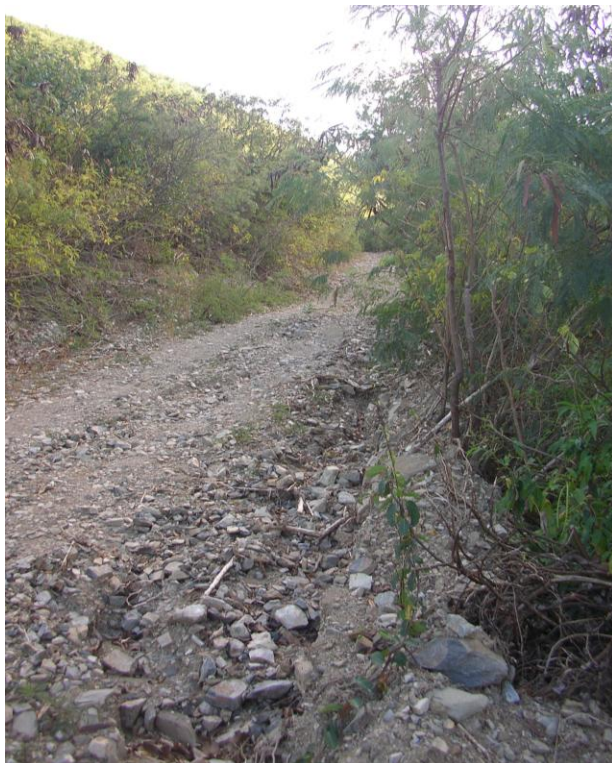
Space alongside road to install stepped/check dam system.

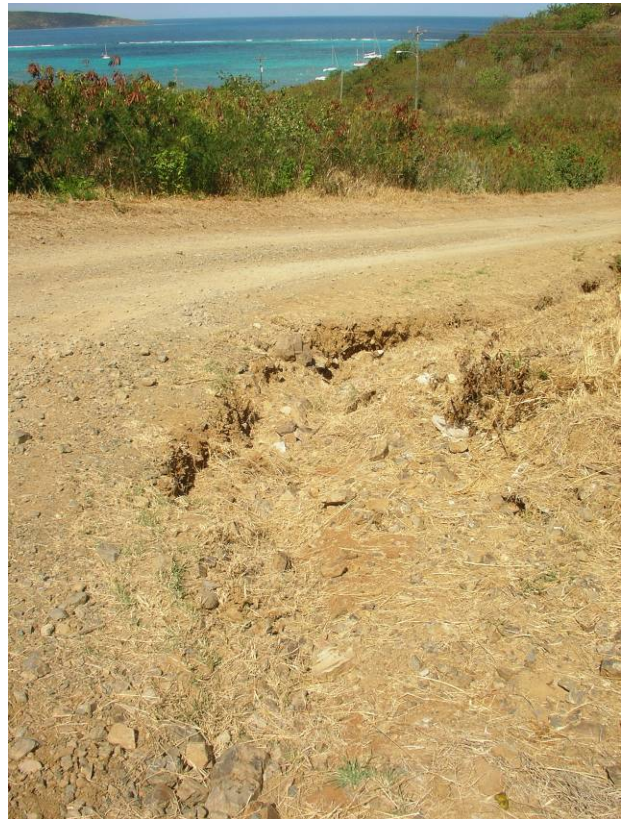
Erosion along ditch at bend in road.

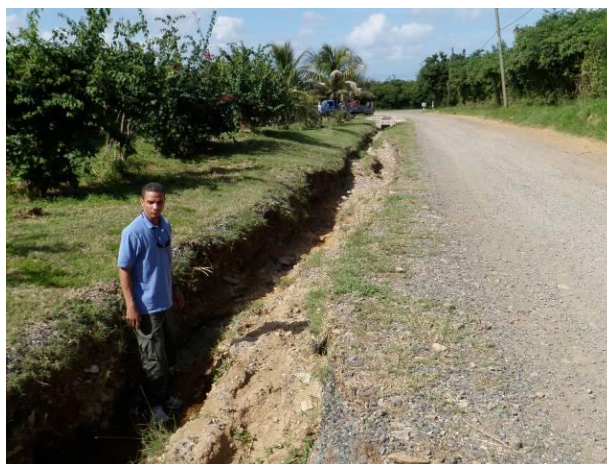
Eroding ditch along lower portion of Seven Flags Rd.

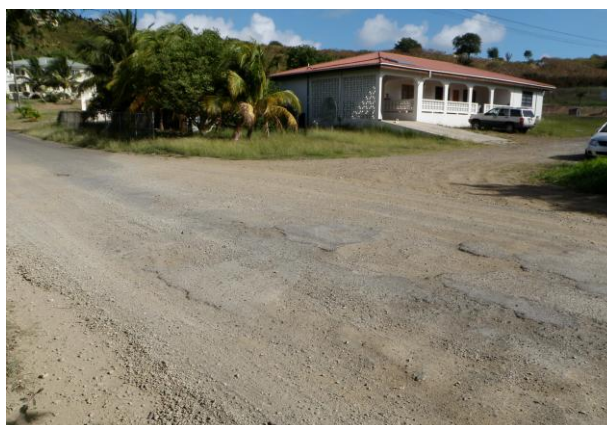
Sediment deposition at outlet location.
